New Zealand Spontaneous Combustion Case Studies

Russell Packham, BSc Hons, MIMinE.

Coal Corporation of New Zealand.

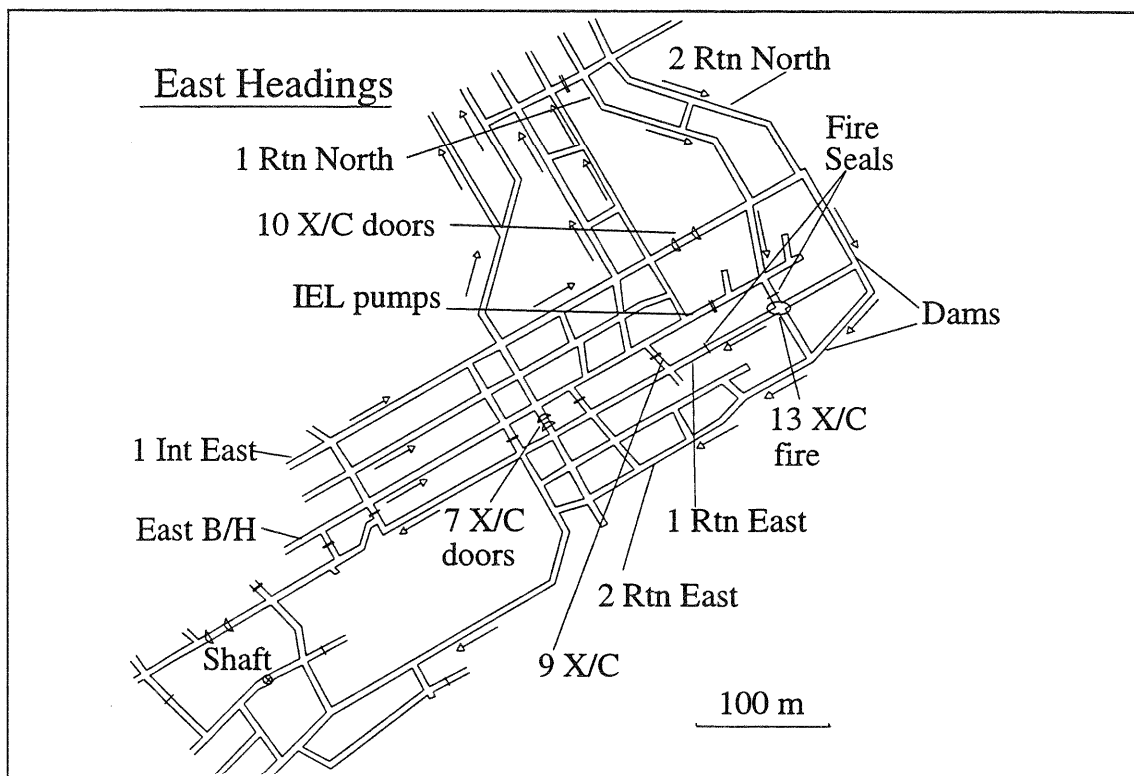
Figure 1. Huntly West Mine East Headings, 1986

- 0910 A deputy contacts underviewer, reports smoke in the Return at 7 X/C (figure 1). He is advised to locate the other official on that side of the mine and check the return via air door accesses.

- 1315 Foam generators established and operational.
- 1345 Foam generation partially reduces smoke and allows access to return side of the fire. 13 X/C observed to have collapsed at the junction of 1 North and 1 East Returns. Coal in the fall and in the roof above the fall is burning.

The collapse of roof at 13 X/C sometime between 1300 16.7.86 and 0900 17.7.86 probably ruptured a 2" compressed air line. The fire had not been detected during the night by the remote monitoring due to software failure. The leaking compressed air force fed a heating that developed into a major fire. Control of the fire was achieved by six rescue brigades over approximately 48 hours.

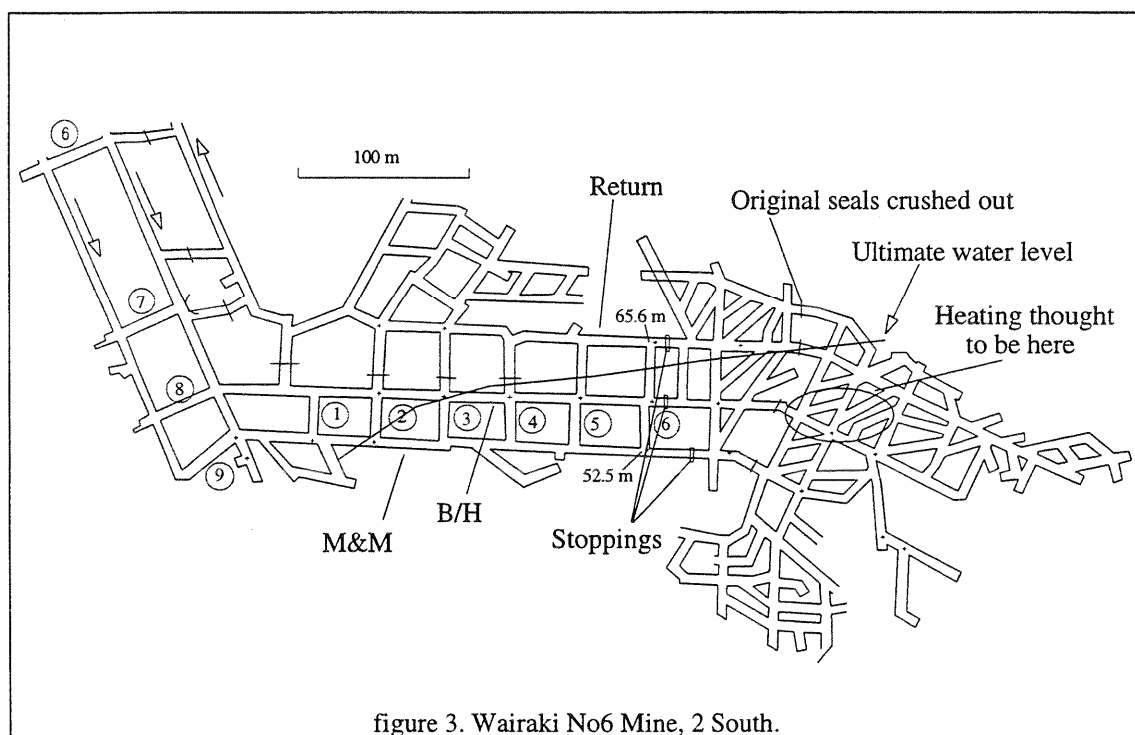
figure 3. Wairaki No6 Mine, 2 South.

- 0920 Weekend inspection of the 2 South (figure 3) production area identifies a smoke haze in the return. Two men are deployed to erect board and brattice stoppings on the B/H and M&M intake roadways. Return airway CO level measured as 380 ppm (figure 4).
- 1030 Mine manager and rescue station superintendent don breathing apparatus and examine the goaf area inbye of 6 X/C in 2 South. The general location of the heating was located by the haze/smoke, 100 metres of 25mm hose is run out to deliver water into the area.
- 1130 The return preparatory stopping site had been previously established, rescue personnel complete the return stopping, working in a CO level of approximately 760 ppm. A distinct firestink smell is noticeable in the return.
- 1530 Stoppings completed. All men leave out of the mine. Surface fan upcast air CO level is measured as 32 ppm.

- 0830 Examination conducted in 2 South return. Smoke still visible, 80 ppm CO in the return, firestink noticeable. Intake roadways flooded to roof level (see figure 3).

The heating in 2 South goaf developed unexpectedly. The stoppings erected to seal the goaf and allow it to naturally inert, blew out on three occasions. The first two occasions were believed to be due to concussions from roof falls. The last occasion resulted in the displacement of one of the surface fan explosion doors and indicated that an ignition had probably been responsible. The only acceptable measure left to secure the mine was to flood the goaf.

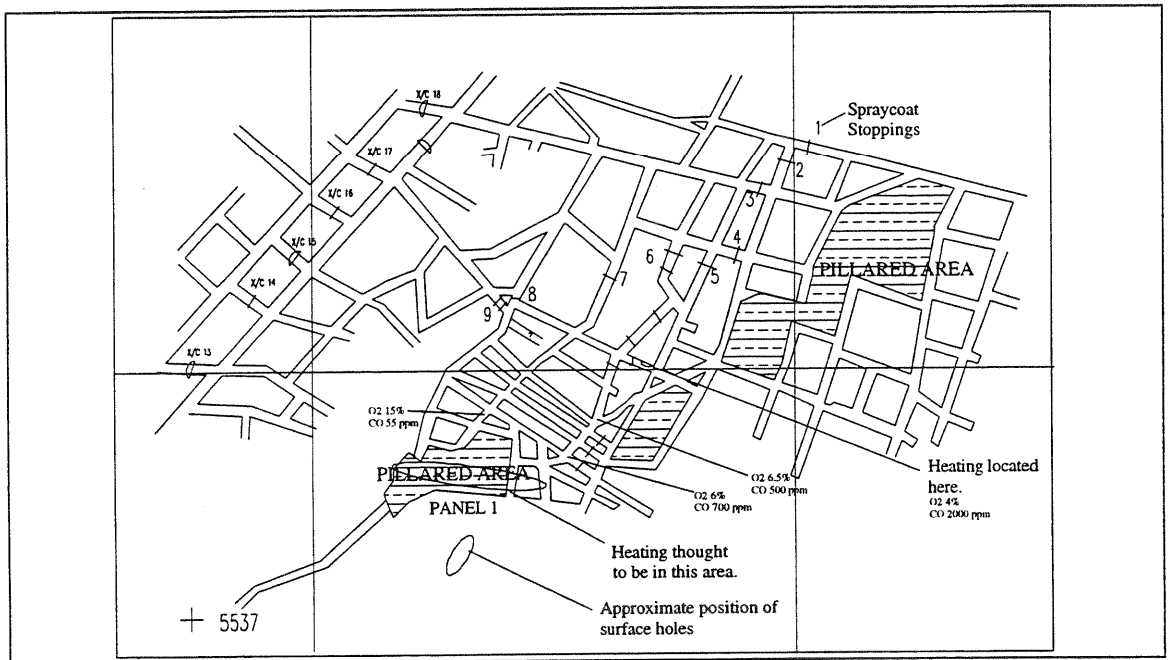
figure 5. Benneydale Mine No1 Panel

Benneydale mine is situated approximately 150 km south of Hamilton in the King Country region of the North Island. The mine workings lie under a conservation area. The coal seam is worked from an outcrop via single intake and return adits. The coal is ranked sub-bituminous class "B" and is highly prone to spontaneous combustion. The coal is not gassy and methane is not detected U/G at the mine. The mine was in "care and maintenance" up to the time of the heating. Panel 1 workings had previously created open subsidence fissures to the surface approximately 23m above the seam (October 1989). It was speculated that this may be source of oxygen and associated with the heating activity. First indications of spontaneous combustion activity were reported by the mine deputy as "firestink" from No 9 stopping (figure 5) on the 29.1.95.

A site examination was conducted by the ventilation engineer and mine manager. It was established that all of the stoppings (No's 1 to 9) were, despite a rising barometer, on positive pressure - tending to blow gas into the ventilated workings. It was clear that a link to the surface was present behind the stoppings.

Rescue team reconnaissance conducted of roadways behind No 9 stopping. Heating located, hot coal identified in an area approximately 2 by 2 metres at the goaf edge of a heading. Water delivered to hot coal through 38 mm pipe, flow rate inadequate to wash out or completely quench the hot material.

- examine the surface fissure with respect to effecting a seal;
- to remove the loose coal in the roadways in the sealed area;
- establish a remote monitoring system in the return;
- continue with daily Dräger tube readings.

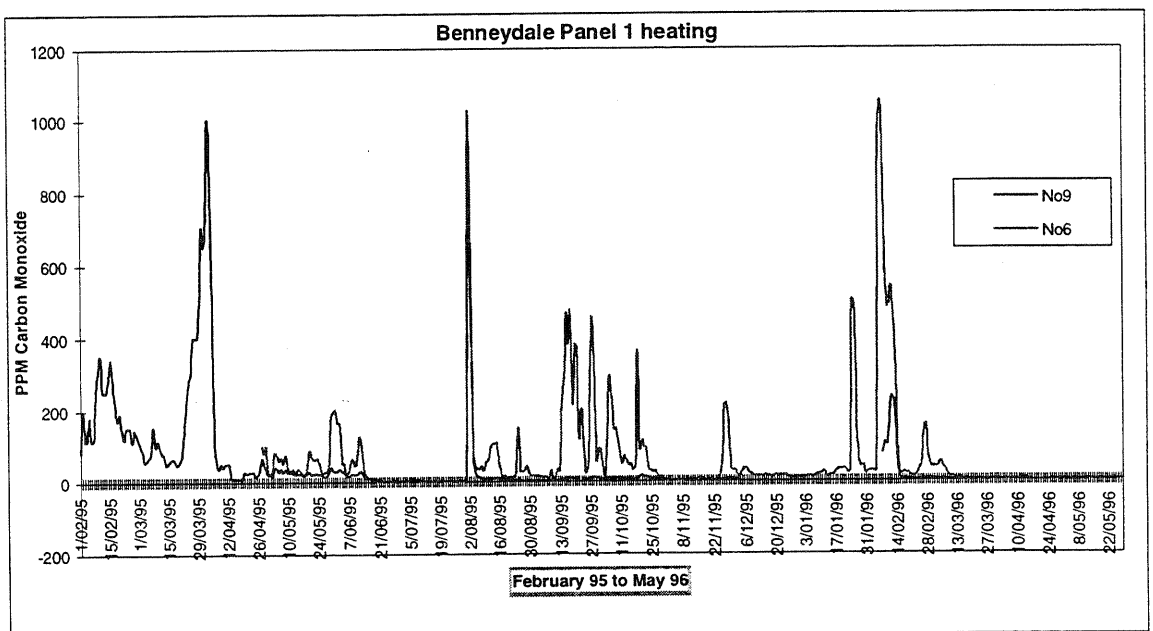
figure 6. CO level Panel 1 Stoppings

Due to increasing CO levels (figure 6) the decision was taken to conduct a reconnaissance using rescue teams. A re-entry chamber was prepared outbye of No 9 stopping incorporating sample tubes and a valved water pipeline.

Heating flares up in sealed area (figures 6, 7). Mines rescue conduct examination and re-establish water line to heating site. Water delivery pipe to the heating site found to be blocked with fines and hose parted.

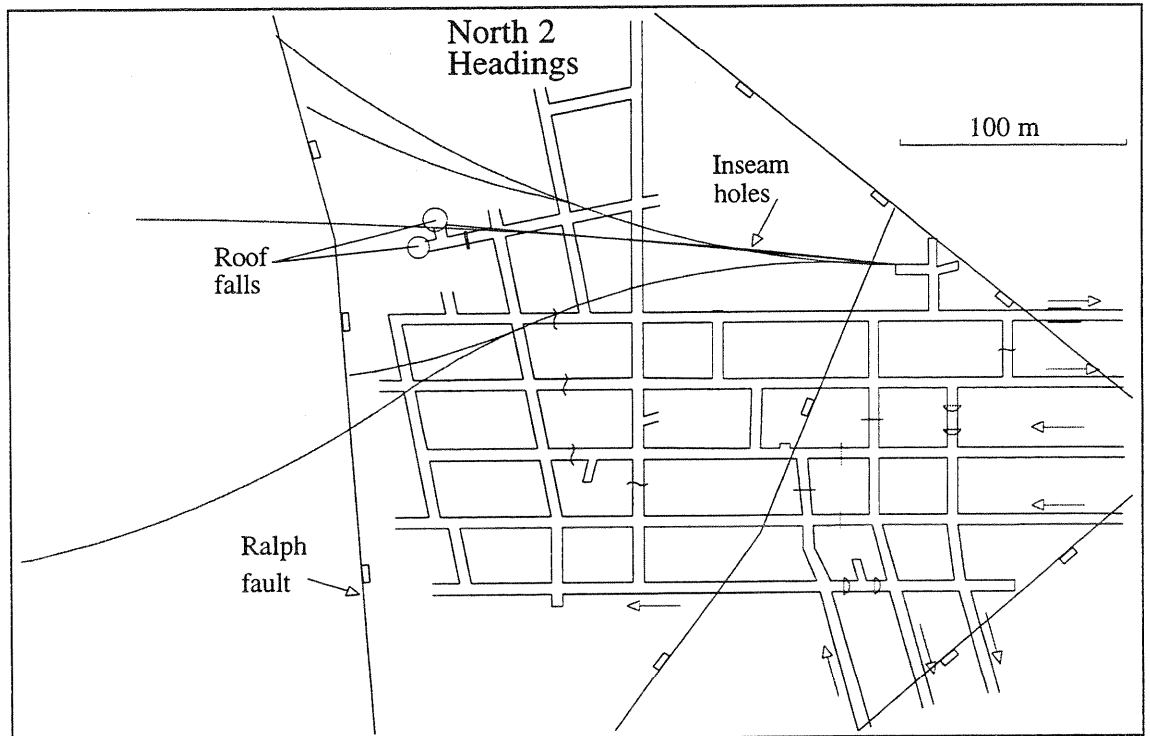
Figure 8. Huntly East Mine North 2 headings

- 17.5.95 Carbon Monoxide levels in the return from North 2 (figure 8) began to rise slightly around the 17 May. This resulted in the decision being made to seal off the heading.

The possibility that a source of oxygen was available to the sealed heading was not initially acknowledged. The construction of an explosion proof stopping to isolate the fall was perceived as the best option to minimize the risk arising if the coal in the fall developed a heating. No intake to return ventilating pressure was present to cause an air flow through the fall. It is considered that the Maihak sample line generated sufficient air movement through the crushed coal to develop an advanced heating. Flooding of the stopping extinguished the heating.

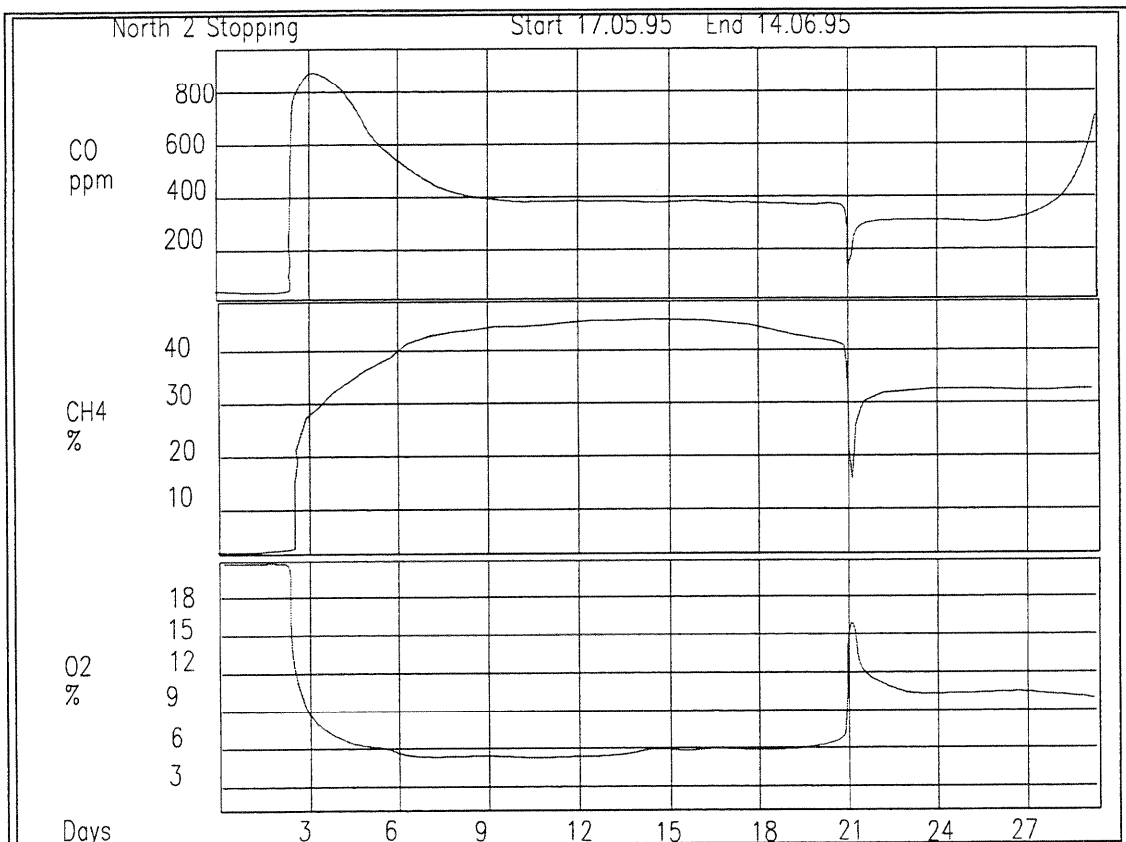
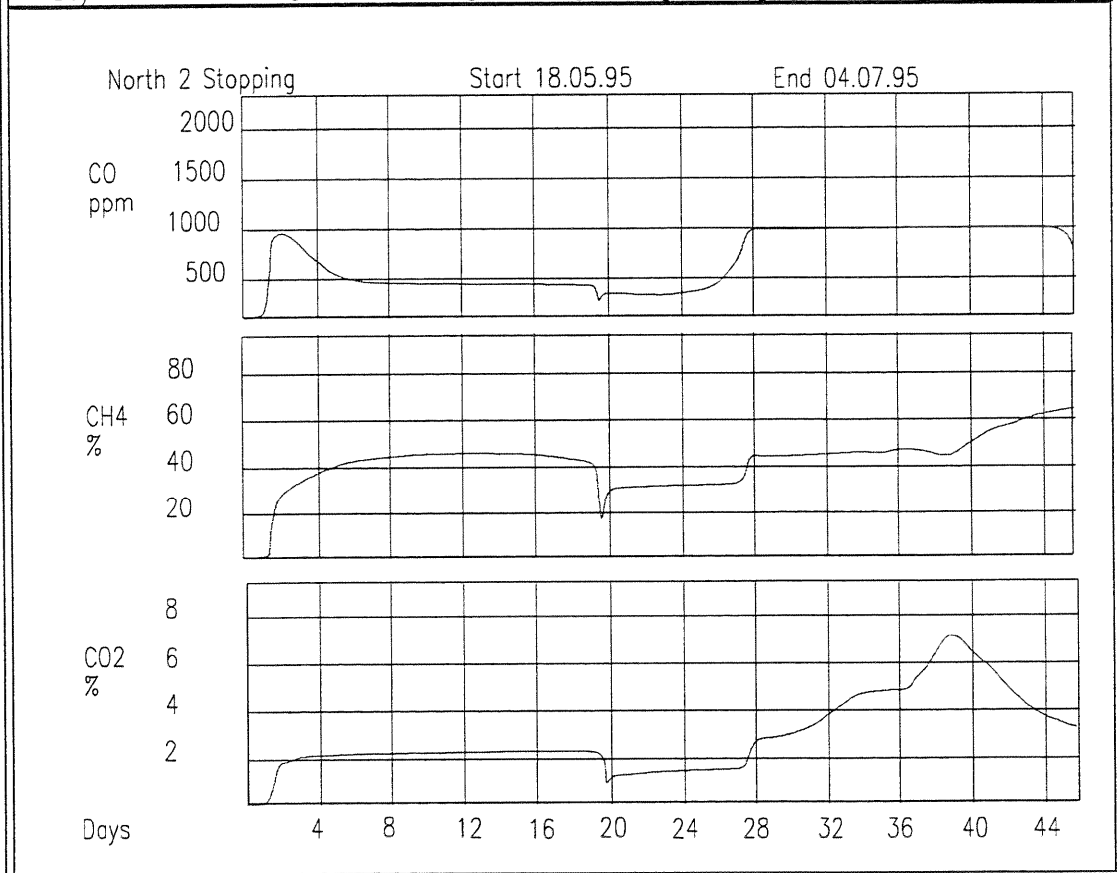
Figure 10. Maihak analysis North 2 stopping

- 19.5.96 A brattice temporary seal was erected across the heading. A Maihak sampling point was installed through the stopping to monitor the waste. Sample analysis indicates that the initial CO response is typical for a recently sealed area (figure 10).
