DRAGLINE FIRE AT BLACKWATER MINE - A CASE STUDY

Graeme Smith

Safety Superintendent / Registered Mine Manager
BHP Australia Coal - Blackwater Mine

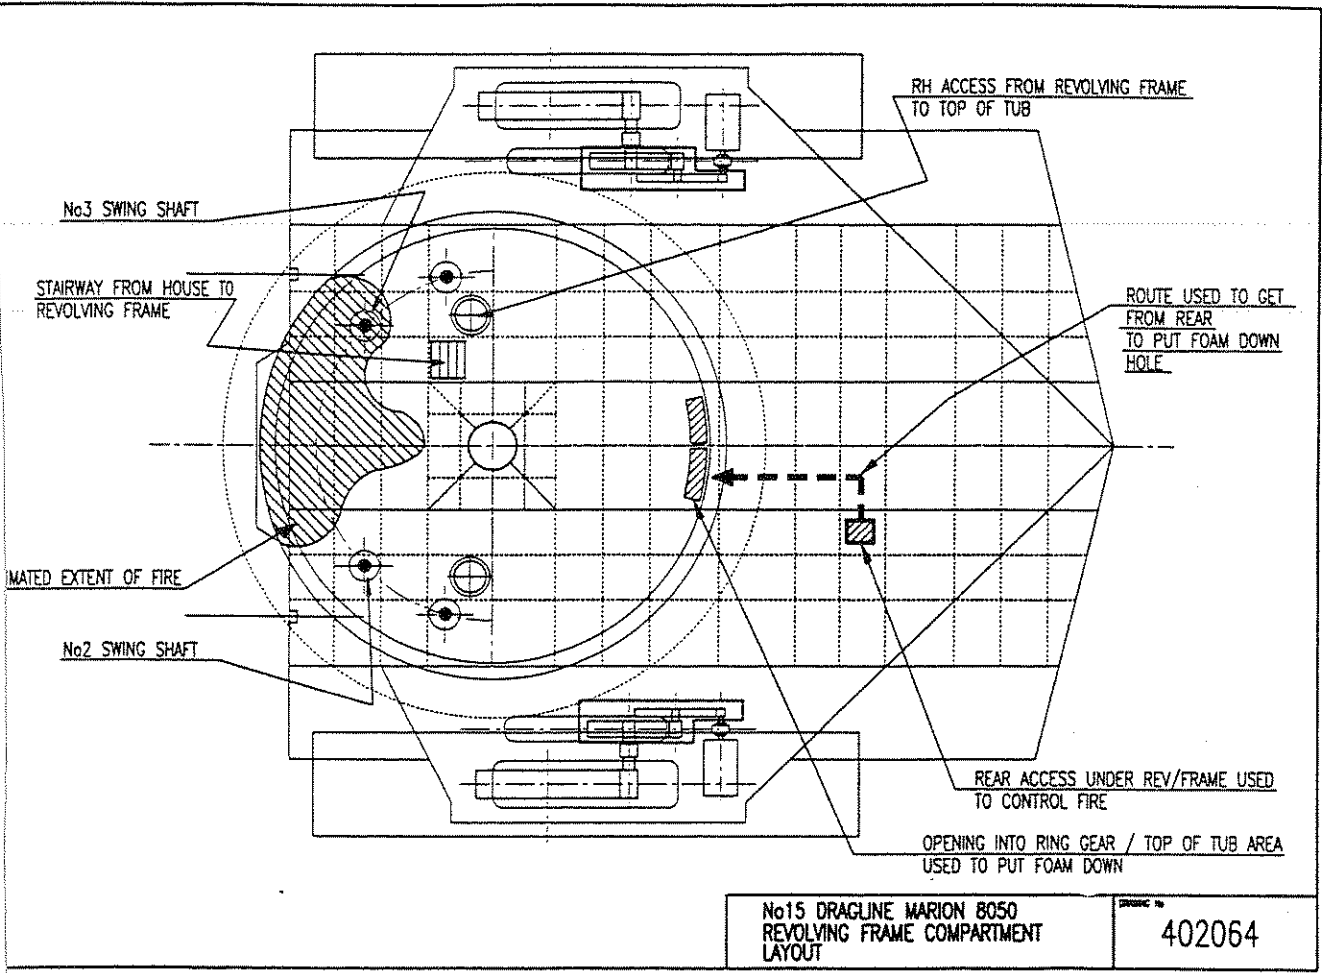
Figure 1 Layout of Dragline 15 revolving frame and top of tub

- ⇒ Reported by crews/maintenance personnel of ongoing problems with lubricant apparatus (oil lubricating etc).
- ⇒ No 3 lower swing bearing housing (see Figure 1 for location) had previously been 'difficult' to repair being jammed into place. For this and other jammed bearing housings there was a procedure of air gouging to remove the inner and outer bearing casings.

- 2330 ⇒ Two BA teams (4 people) in dragline
 - (1) FR1 and FR2 put 4 to 6 drums foam down No 3 swing shaft hole - little positive effect apparent.
 - (2) MR1 and MR2 ran a hose up through rear entry into revolving frame (from under rear of dragline) and located (see Figure 1) an opening accessing the ring gear and top of tub

- 0010 ⇒ FR1 and FR2 entered rear hatch (see Figure 1) and commenced putting foam down rear access to tub. MR2 carried drums of foam from entrance hatch to tub access (assisted by MR1 from ground). "Five or six" drums of foam were put down onto top of tub and pushed forward to source of fire. Conditions at rear reported to be hot.
