Goonyella Riverside Mine

BHP Billiton Mitsubishi Alliance

Dipper Trip System Improvement Project

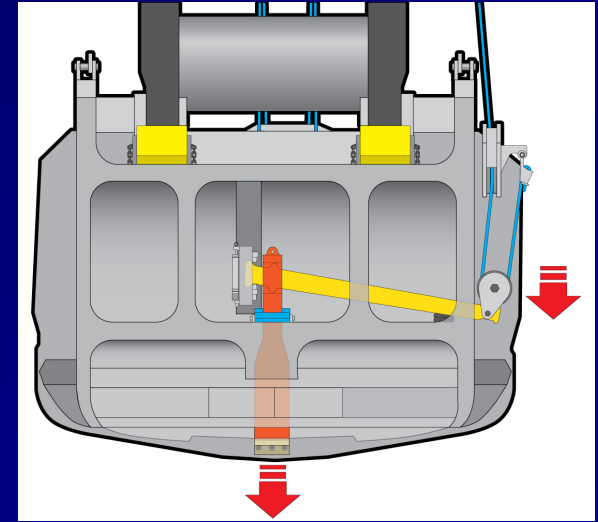
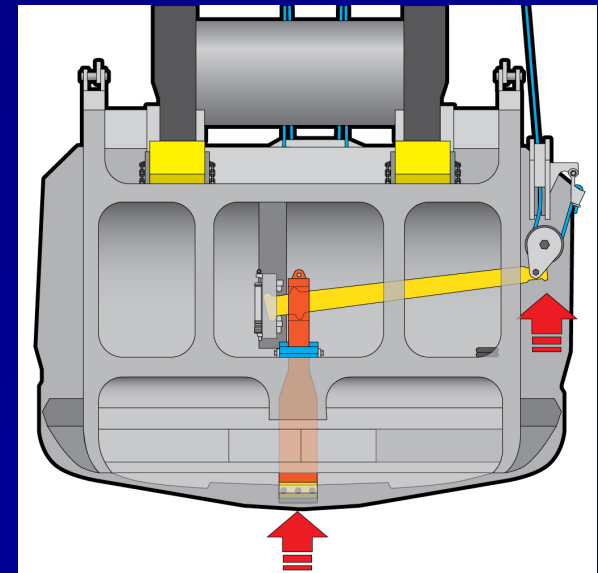
- *Shovels at Goonyella Riverside Mine were regularly experiencing production delays due to the dipper trip mechanism jamming and failing to release the dirt load.*
- *Once this mechanism failed, the shovels were rendered inoperable*
- *To repair the problem, the shovel was required to be shut down causing this shovels pre-strip fleet to be placed on stand by.*

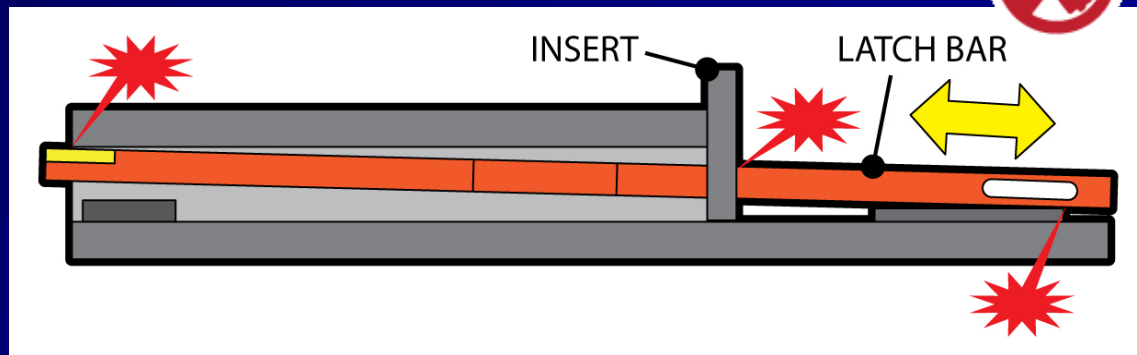
Re-aligning Latch Lever Path

Latch lever path was out of alignment causing steel on steel drag, friction and wear.

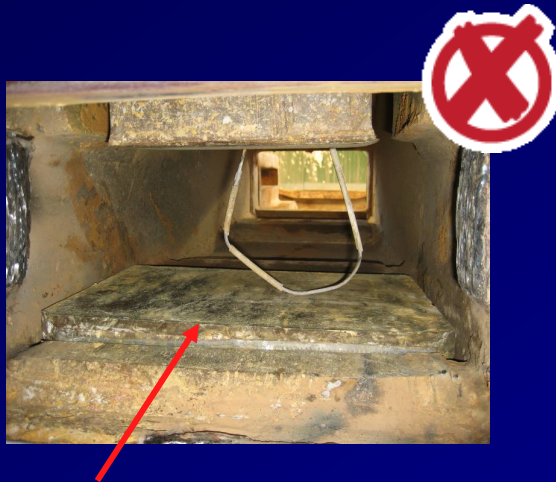
Securing Bottom Latch Tube Wear Plate

This photo demonstrates how the Maintenance Crew held the bottom latch tube wear plate in place while lowering the latch bar into the tube. This plate also dislodged and became a wedge jamming the latch bar.

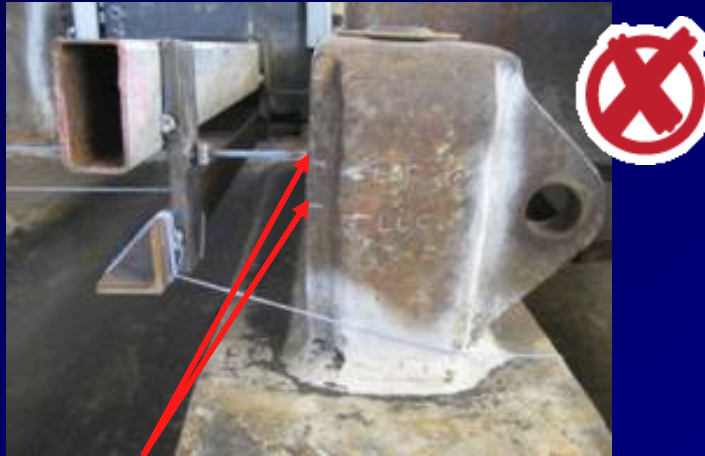
Re-aligning Shim Box

This photo depicts the 35mm mis-alignment from the centre of the shim box to the centre of the latch bar creating wear and friction

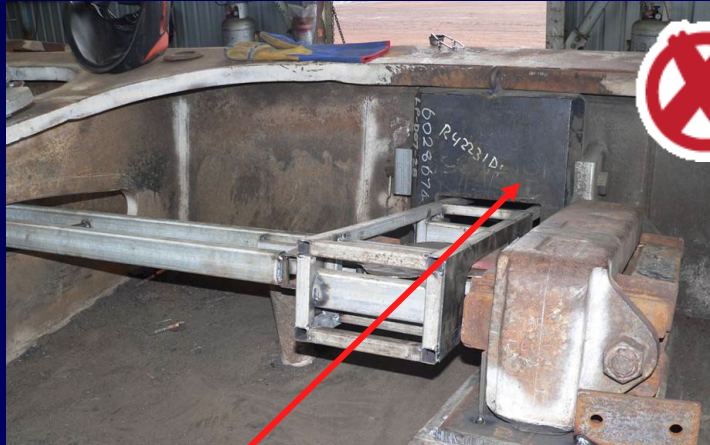
Nylon Lubricated Upper Insert

Upper insert was constructed of steel and weighed **45kg**.

Hard to extract prior to removing latch bar
Potential for strain/sprain and line of fire injuries.

While in operation, this steel insert created steel on steel friction which caused the latch bar to jamb and wear.

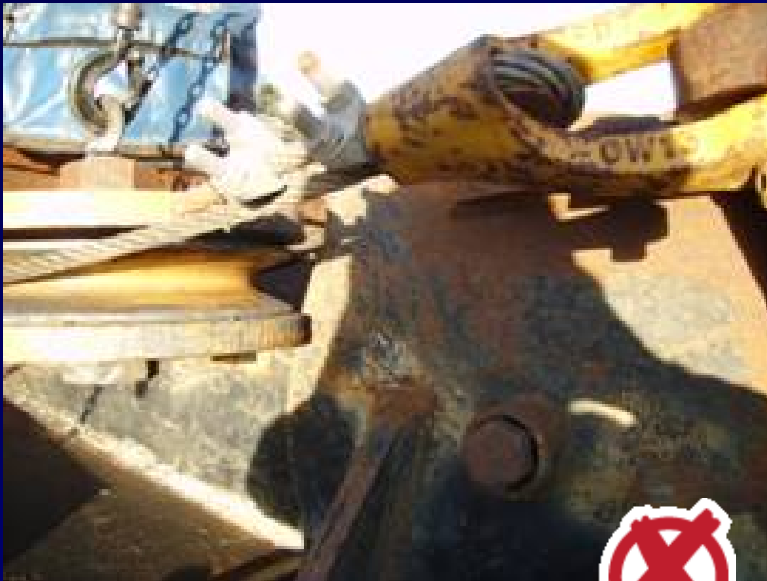
Re-aligning Trip Sheaves

Upper and lower trip sheave were misaligned and too close together, resulting in twisting of the latch lever and causing sheaves to double block.

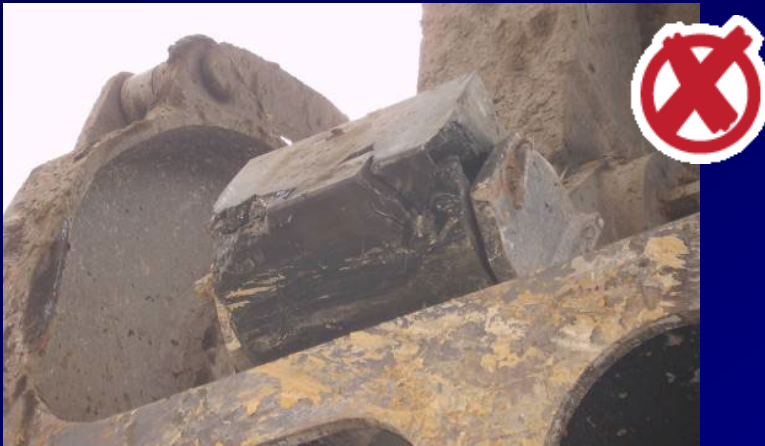
Dipper Door Buffer Blocks

Old buffers were made of rubber and retained by a 50mm pin. When these buffers became damaged, the steel lugs would hit the shovel boom, squashing the lugs and jamming the pin in place, making the buffers impossible to remove. These buffer blocks only lasted approximately **6 weeks**.

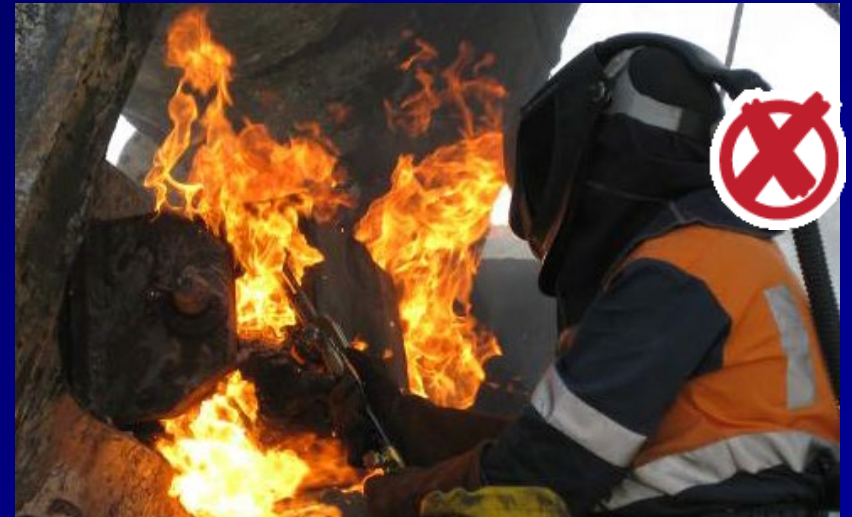
Flame cutting the pin inside the rubber buffer is the only way to remove the damaged pins. This area is surrounded by combustible lubricants and grease lines, creating fire hazards and potential burn injuries.

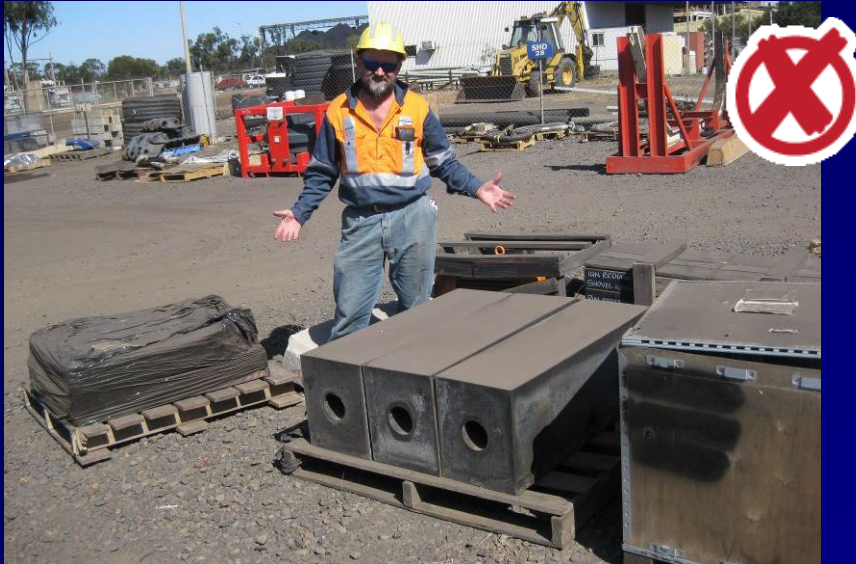
Replacement of Boom Buffers

Old buffers were approximately 80kgs each. Buffers were required to be lifted manually into place – approximately 7 meters up on the shovel boom.

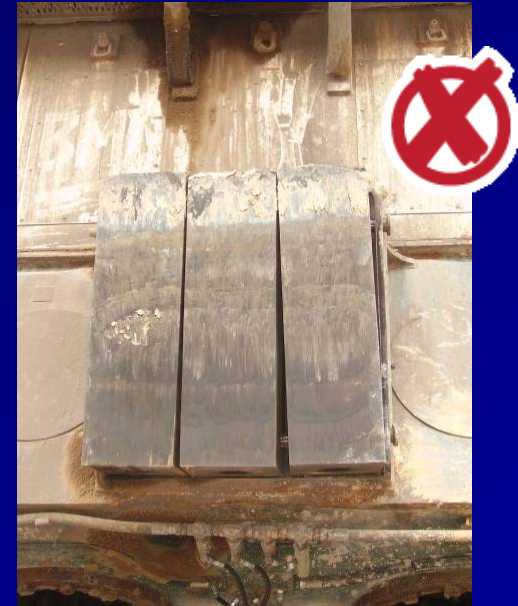
Rubber buffers in place before solution. This took 4 - 5 maintenance personnel to manually put the buffers in place. The job generally took 5 – 6 hours.

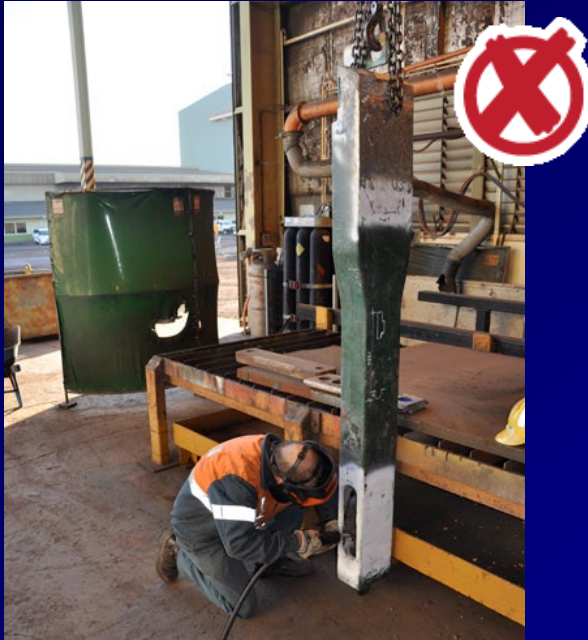
Latch Bar Maintenance Stand

Welding the latch bar to the bench while holding it in position with a crane required employees to squat in an awkward position to perform the task. This created ergonomic issues for the welder.
