# PIKE RIVER MINE DISASTER

What went wrong

**STEWART BELL**

**Commissioner for Mine Safety and Health**

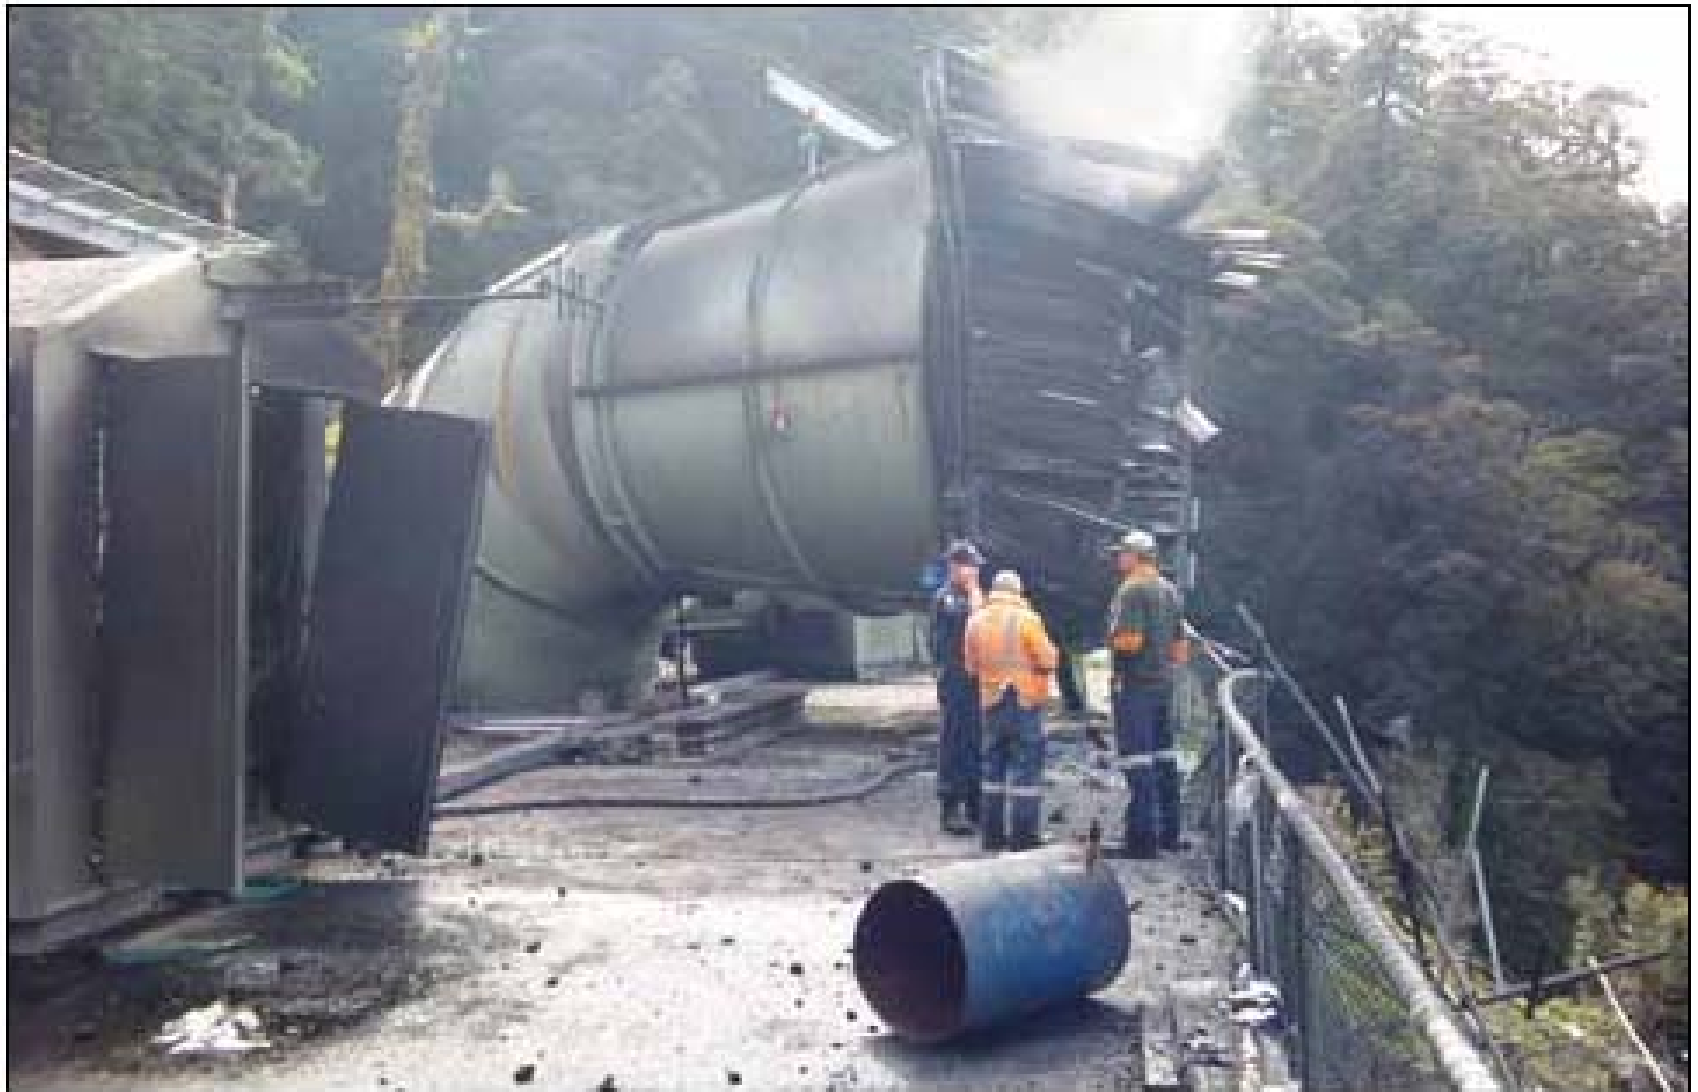
Figure 8.10: The surface fan after the first explosion

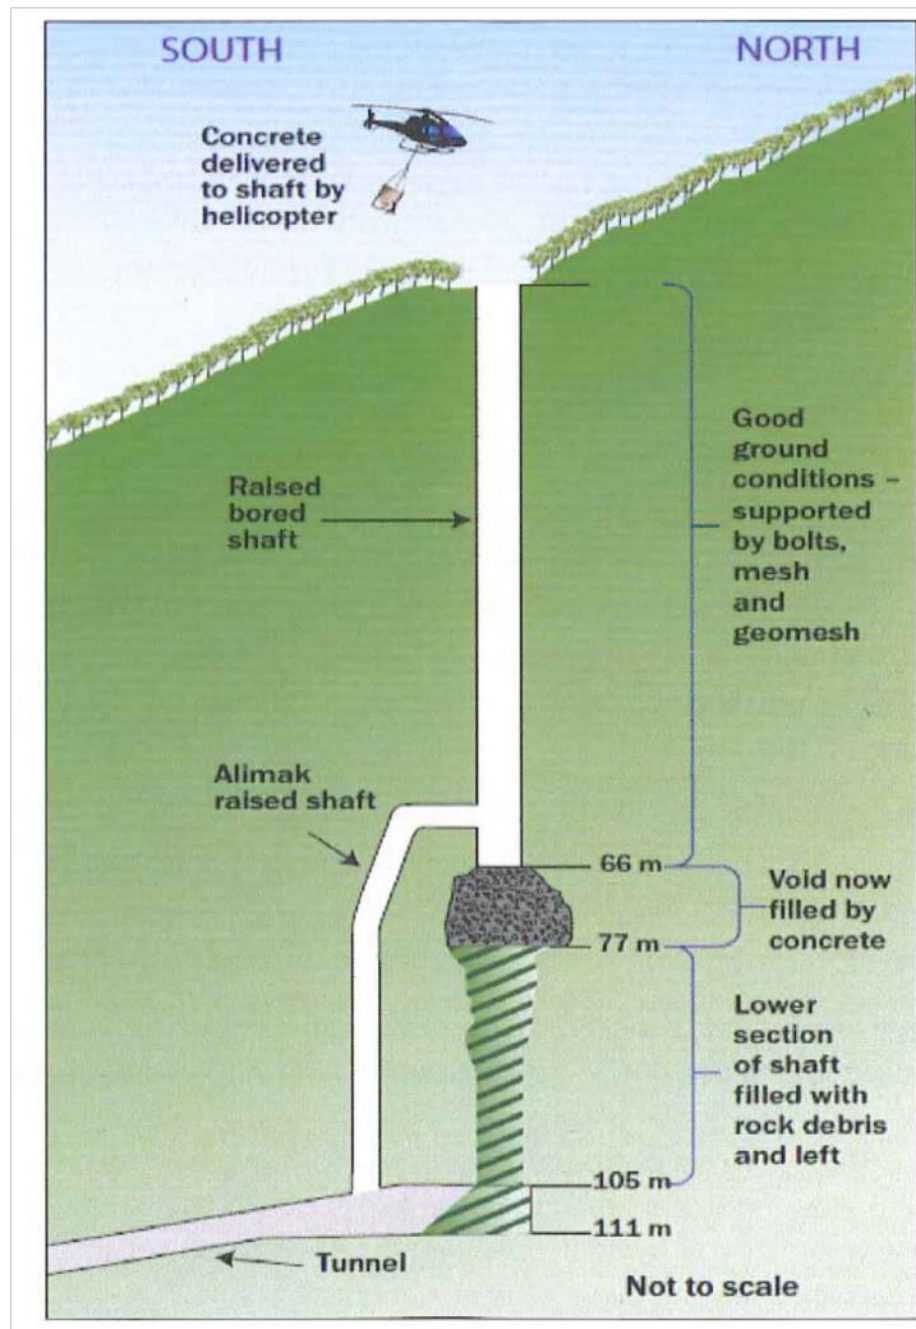
NO EFFECTIVE  
SECOND MEANS  
OF EGRESS

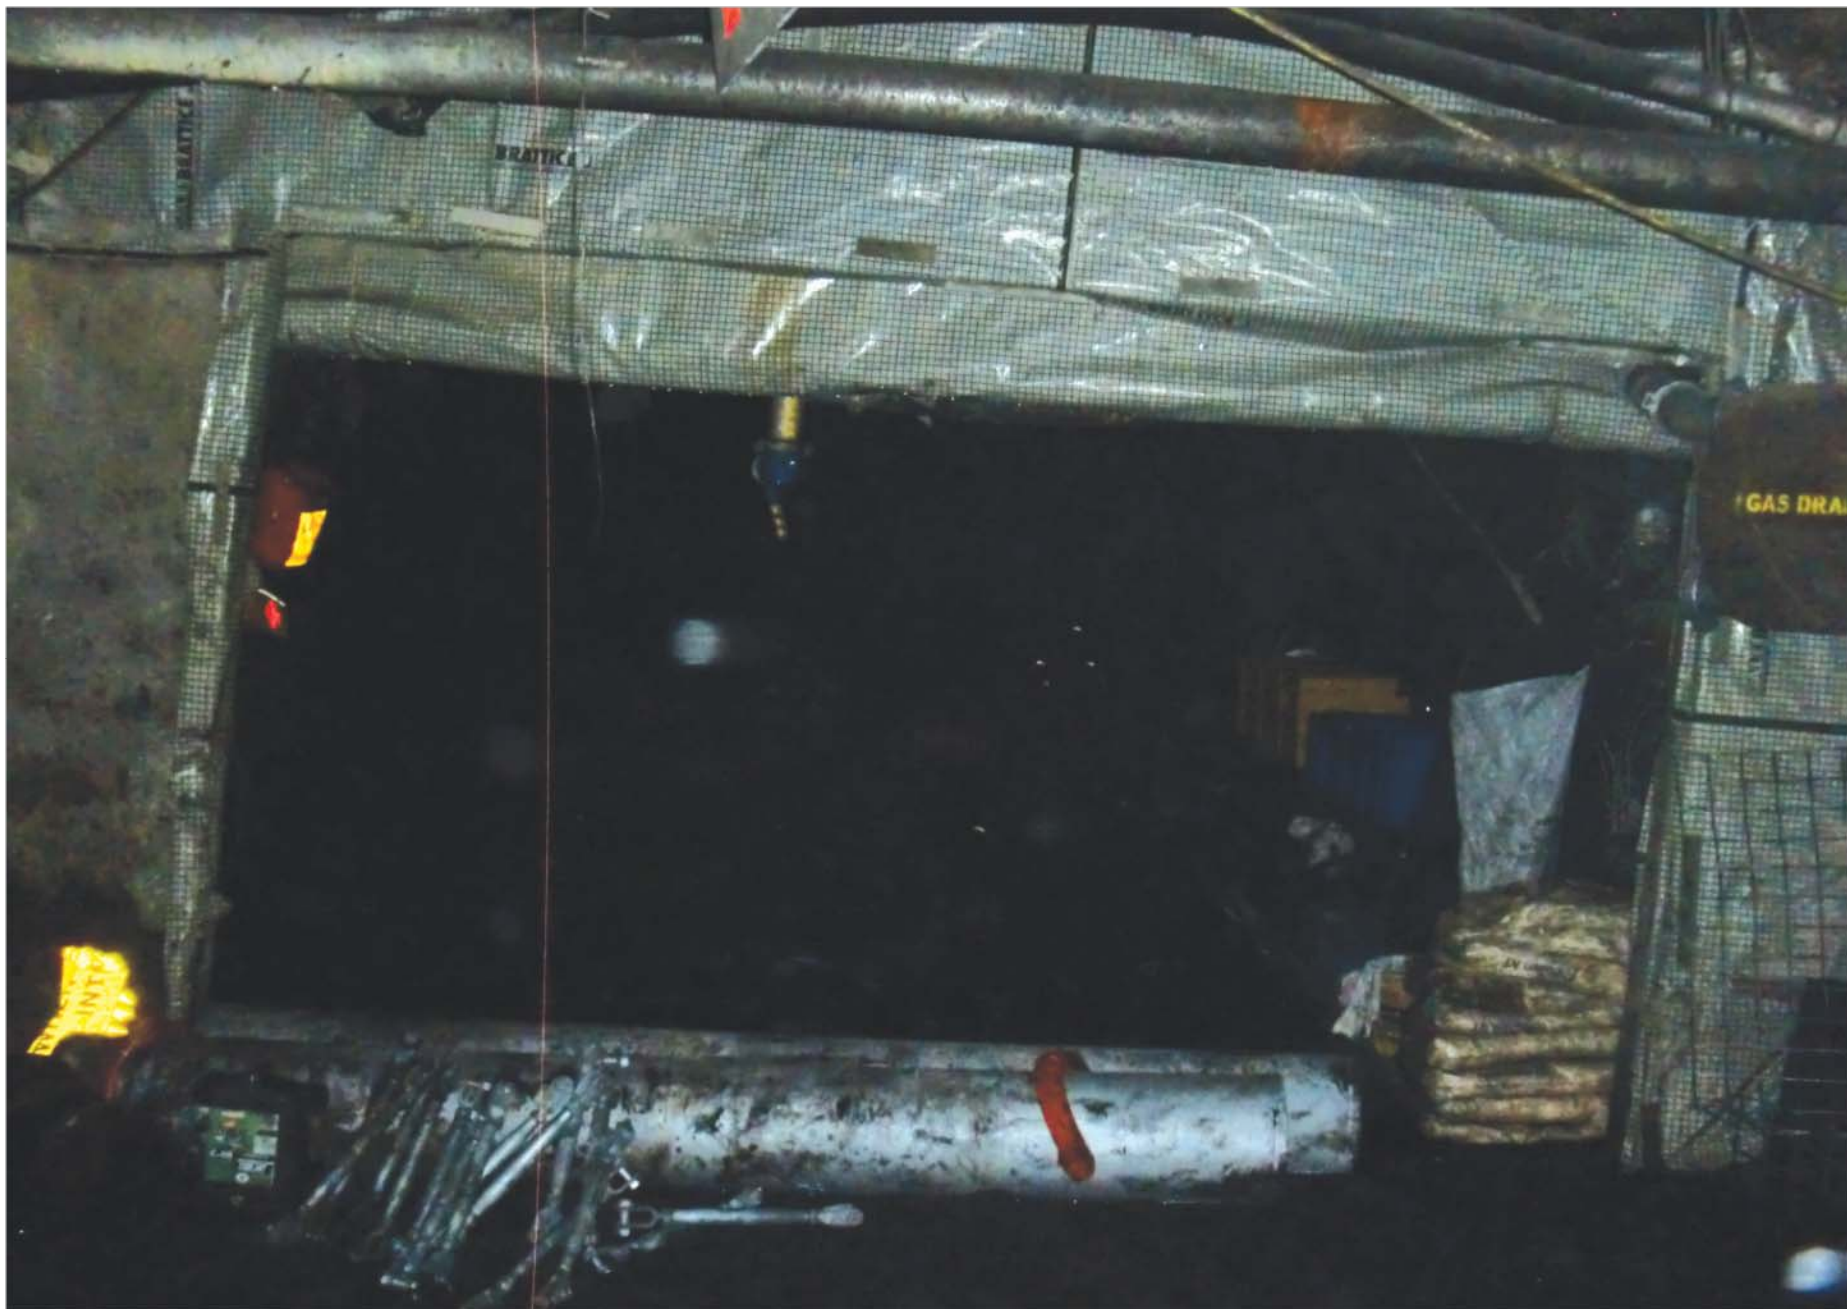
# UNDERGROUND MAIN FAN

- VENTILATION  
SHORTFALL
- POORLY BUILT  
STOPPINGS

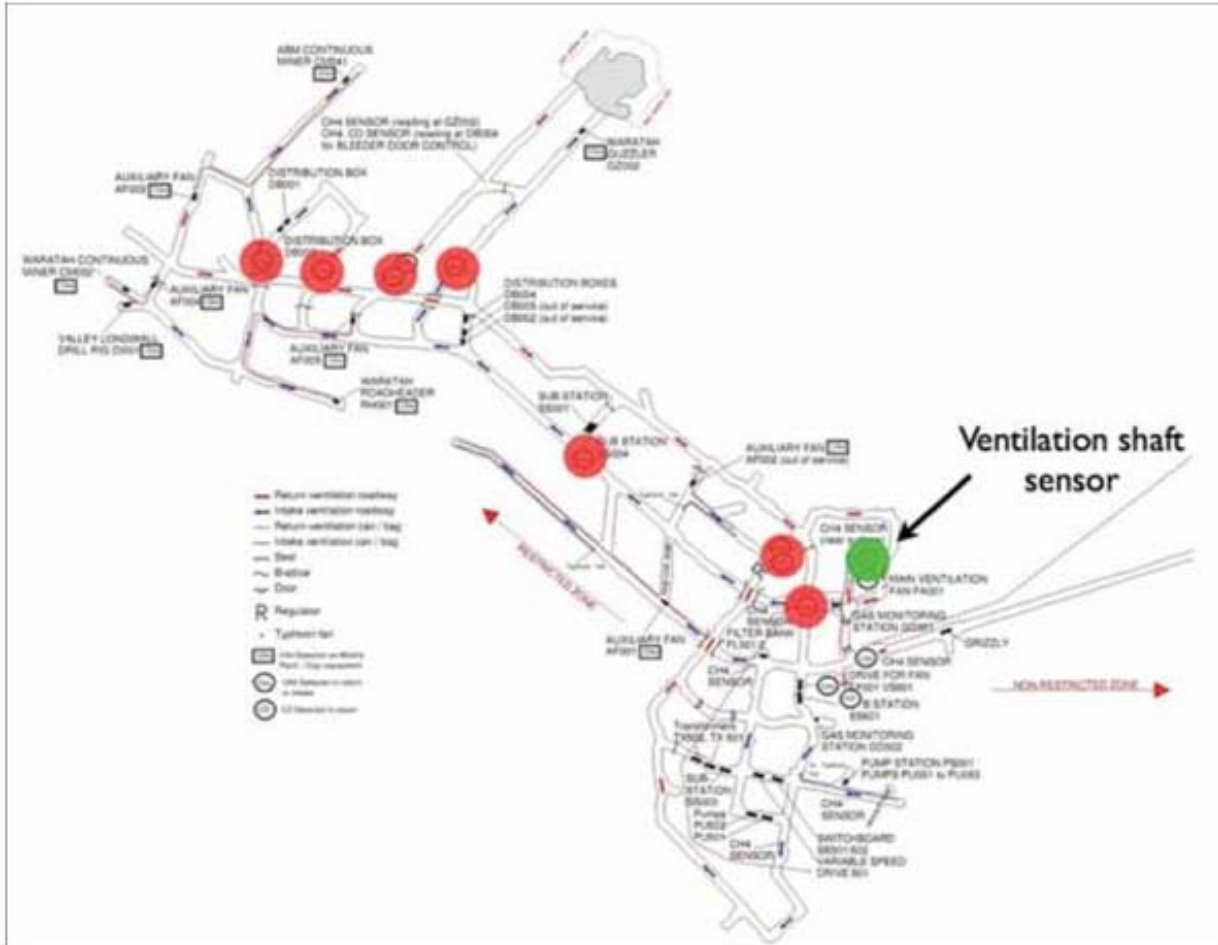
Figure 10.2: Plan of required gas sensors at Pike River under Queensland legislation<sup>27</sup>

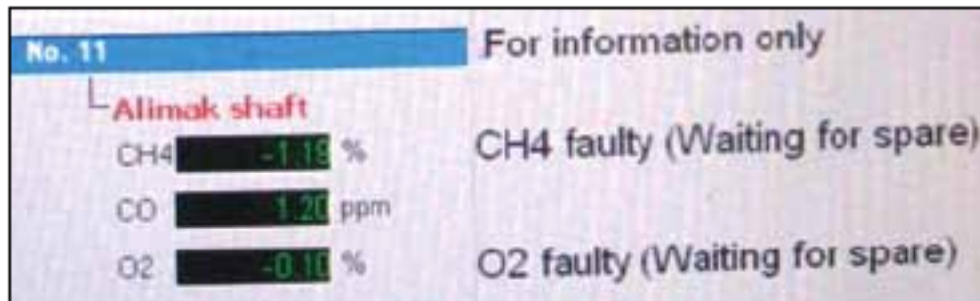
19. There were several problems with the gas sensors in the ventilation shaft. First, the sensor at the bottom of the ventilation shaft stopped working on 4 September 2010, nearly 11 weeks before the explosion, and was never repaired or replaced.<sup>31</sup> Indeed, the control room operator's screen on the Safegas system was permanently annotated to say the sensor was 'faulty' and 'waiting for spare'.

Figure 10.4: Control room operator's screen on the Safegas system<sup>32</sup>

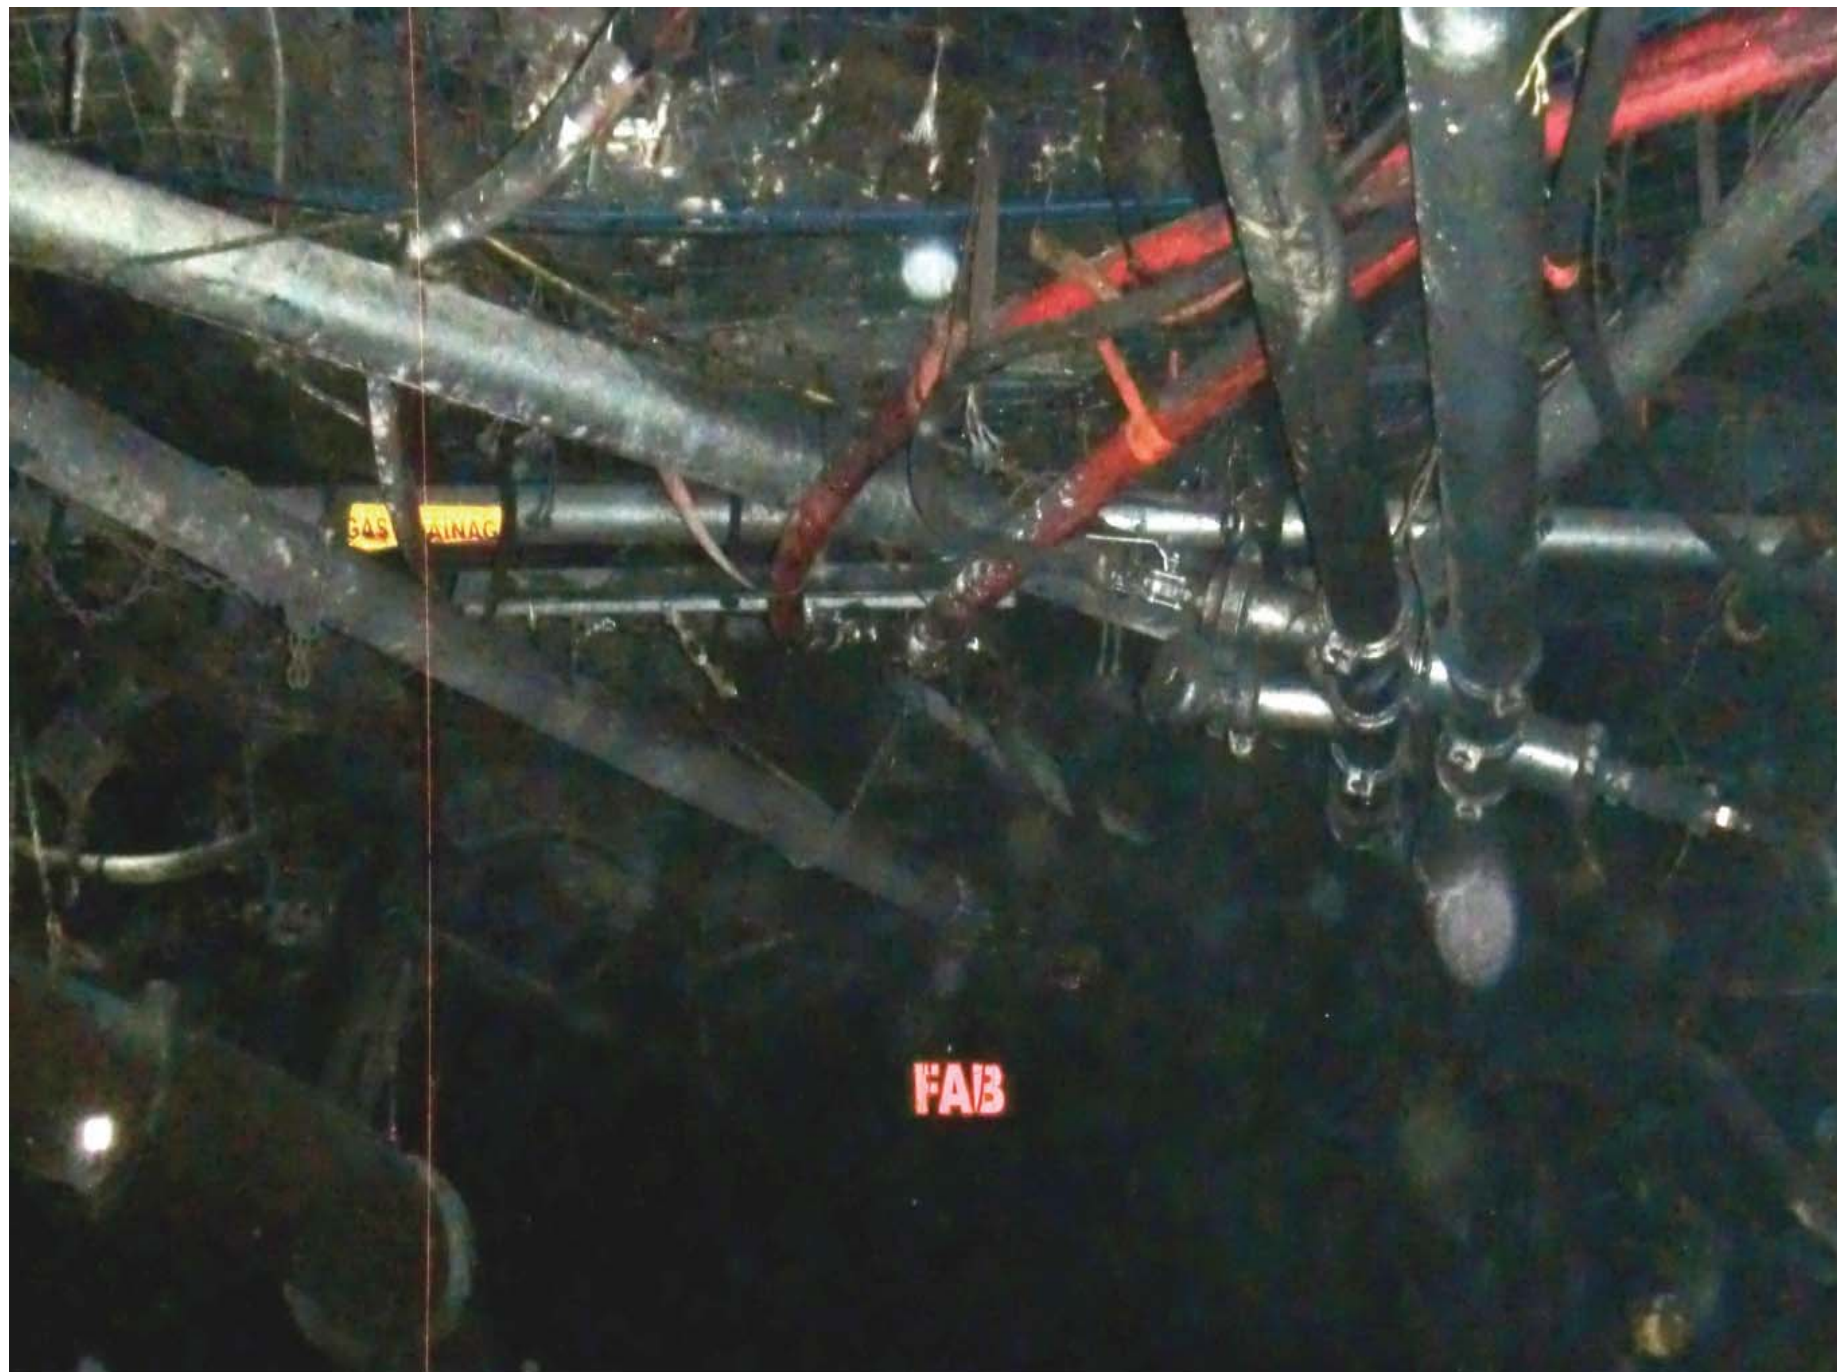
# POORLY INSTALLED SYSTEMS
