Holing Underground – An Example of the Swiss-Cheese Model

Name of Presenters Organisation: Rio Tinto – Kestrel Mine

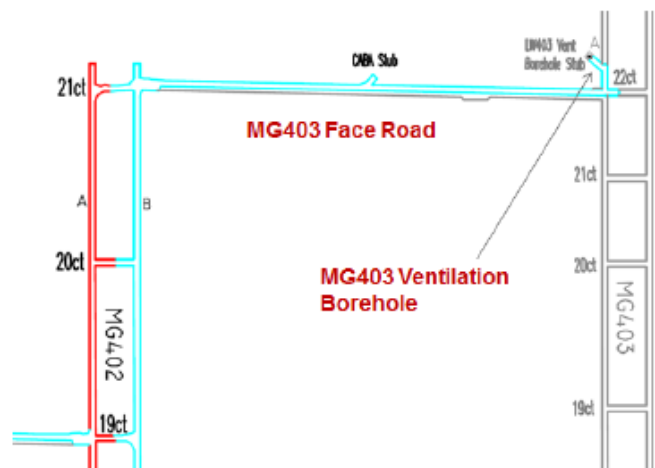
Figure 3 Borehole and stub location

During the nightshift of the 3rd February 2014 the stub was driven to distance, intercepting the grouted hole.

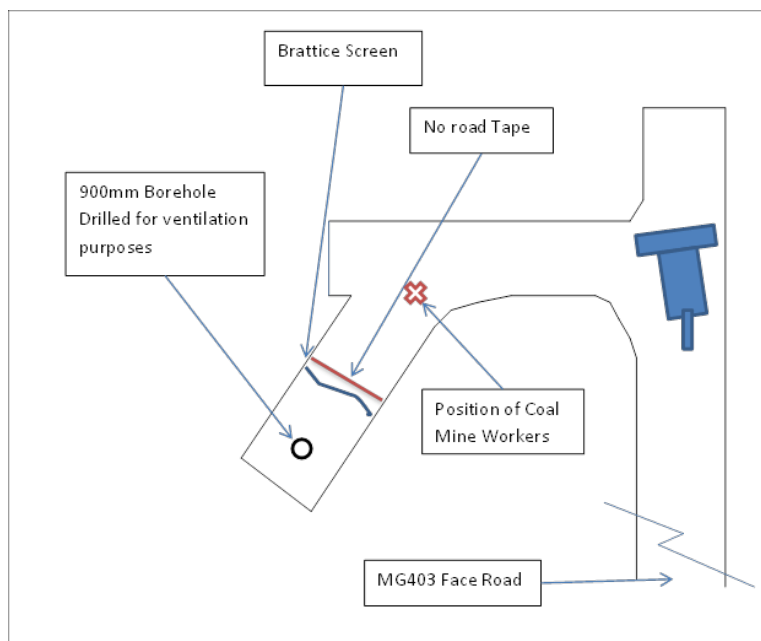
Figure 4 Detail of stub and features

It was now time to coordinate the hole through procedure. The job was being coordinated through the ventilation officer who briefed the control room operator (CRO) on the procedure specifically for this job. The Explosive Risk Zone Controller (ERZC) for the panel was informed the plan was to hole through; he was tasked with cutting the mesh off the roof section where the hole-through would occur and installing preparatory brattice ventilation stopping just out-by of the hole. A length of no-road tape was installed on the out-by side of the stopping. At this time it was still believed that the hole would be empty, no other barricading or protection was installed to prevent entry to this area.

At 12:02pm, the ERZC notified the CRO the panel was clear as per the procedure and the drillers were informed they could commence drilling, which they did. Then at 12:49pm the drillers called to inform their drill string was blocked and they would need to clear it out. As a result the hole-through was not expected to occur on that day. During the following nightshift there was some incidental mining activity in the area and the continuous miner was moved out of the heading back to the face road.

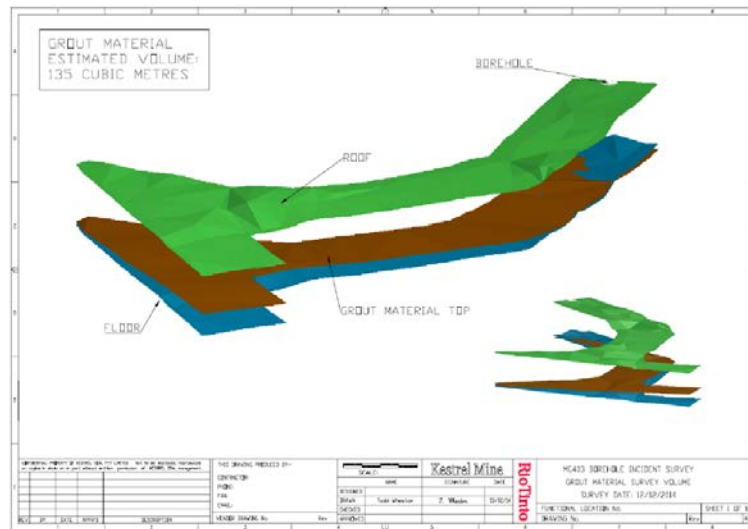
Figure 5 Survey detail of material volume

A subsequent survey of the area determined as much as 135 cubic metres of material might have discharged in the release. Considering a margin of error due to potential changes in the floor profile during the mining activity, it is estimated that there could be a variation of +/-44 cubic metres on this volume. In addition the volume of the drill

string in the hole has to be accounted so it is believed the volume of the material in the hole to be approximately 75 cubic metres.

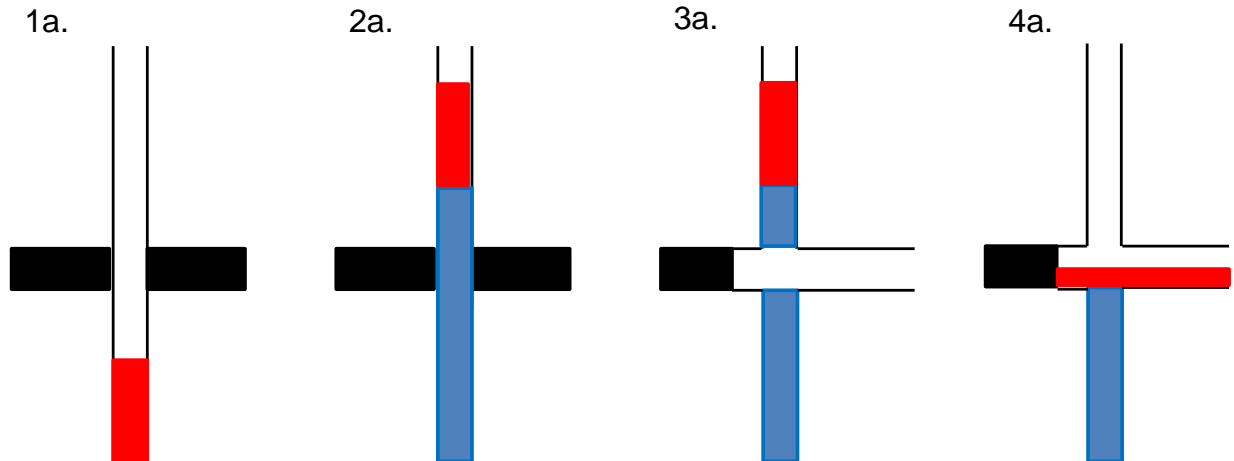
Figure 6 Representation of borehole contents

An increased hole diameter means the volume of the hole, any residual material in it and any associated hydrostatic head, will increase exponentially. The bailing pressure to remove cuttings and fluids also has to increase proportionately and reduced bailing efficiency experienced over the larger diameter makes it harder to completely clean out the hole. Missing the full implication of this aspect meant there was insufficient appreciation of energies associated with the discharge and release at the hole-through moment. Notwithstanding this, barriers were identified as a control in the risk assessment, however there was no specific detail provided on their construction, location and distance from the bottom of the hole.

The bore hole was drilled without incident other than it missed its target depth to intercept the top of coal at 230m resulting in the hole being drilled to 259m. This increased depth opened up more open-hole section than was intended and resulted in more work for the bailing pressure to clear the hole. This increased the likelihood that fluid and cuttings were not flushed out and still in the hole.

It was apparent now that the holing methodology looked more like that show in figure 6, steps 1a to 4a, with the red indicating the residual fluidised material in the hole.

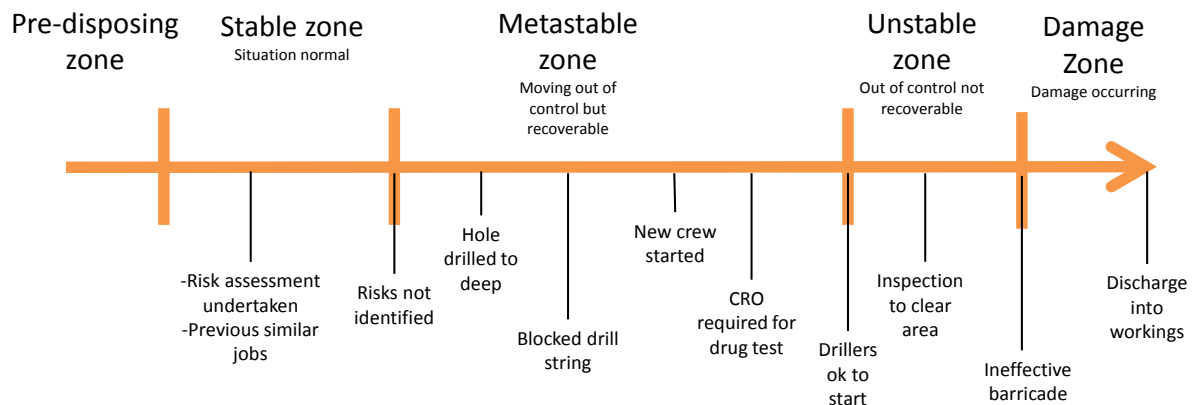
Figure 7 Changing time zones and incident factors

The increasingly unstable nature of the events as the incident moment approaches can also be represented in terms of the phase changes as per McDonald's time zone diagram. It shows that with each event a further defence is eroded, the opportunity to re-stabilise the changing situation diminishes and the situation changes from stable, where the situation is normal, to unstable, where things are now out of control and cannot be recovered.

The investigation carried out post this incident prescribed a number of actions concerned with addressing weaknesses in the risk management approach at for this task at Kestrel. Representing the key factors in a manner such as the "changing time zones" helps to "run the ruler" across the prescribed actions to gauge whether their implementation will prevent recurrence. Only one action preventing one of the factors is necessary to prevent recurrence.

- A formal Management of Change process has been established for one-off or new jobs, which involve concurrent activities (surface/UG, Cat 2, 3 Contractor groups). This process is applied, reviewed and signed-off, to ensure that the hazards and risks are understood and managed.
- A permit process has been established for activities involving interaction between a surface drilling operation and the underground workings. This requires formal sign-off by, as a minimum, the driller, CRO, Deputy responsible for the shift and a Dept. Leader.
