David Bond – GM Health, Safety & Security Thiess Global Mining

The purpose of this session is to create a greater understanding of potential hazards associated with heavy vehicle tyres and rims, with particular focus on the 49" EV style rim assembly.

49" EV Style Rims – Technical Review

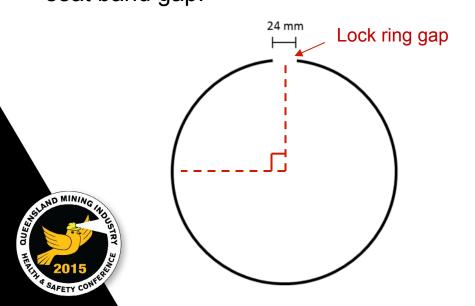
The lock ring was held out of it's landed position by the bead seat band 'hood' at a position approximately 90 degrees from the lock ring gap. This is where the failure mode commences. The application of pressure subsequently results in a rotating/ extruding type of expulsion of the lock ring from the groove / bead seat band gap.

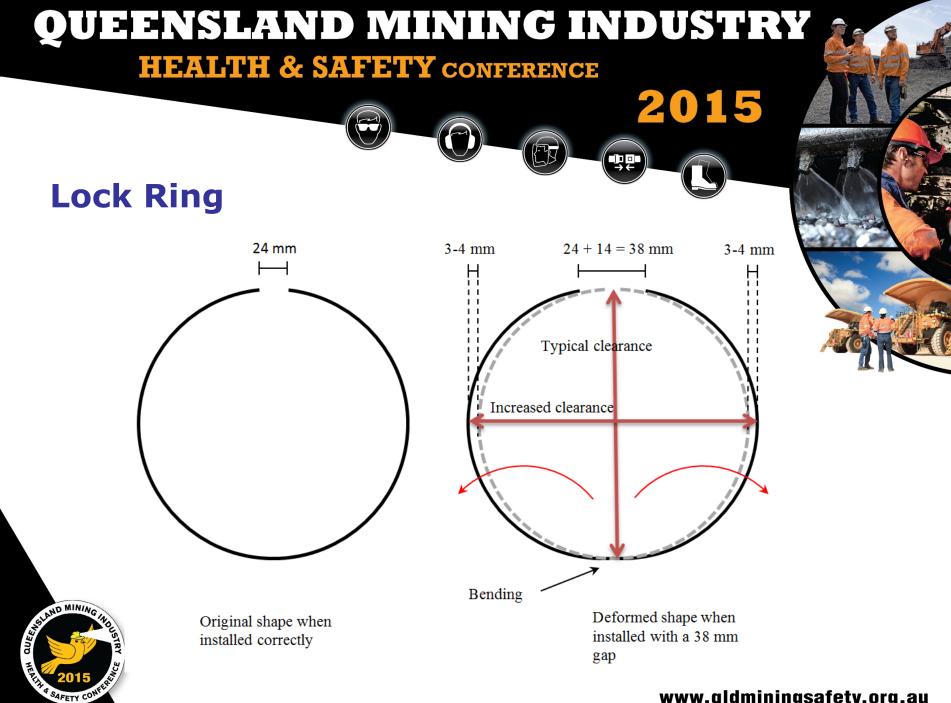
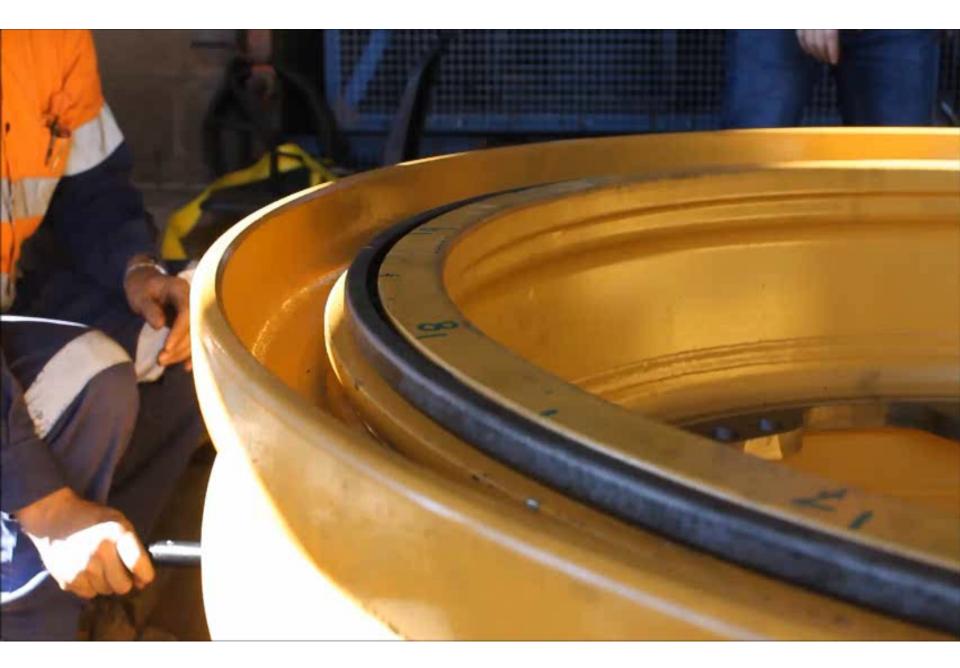
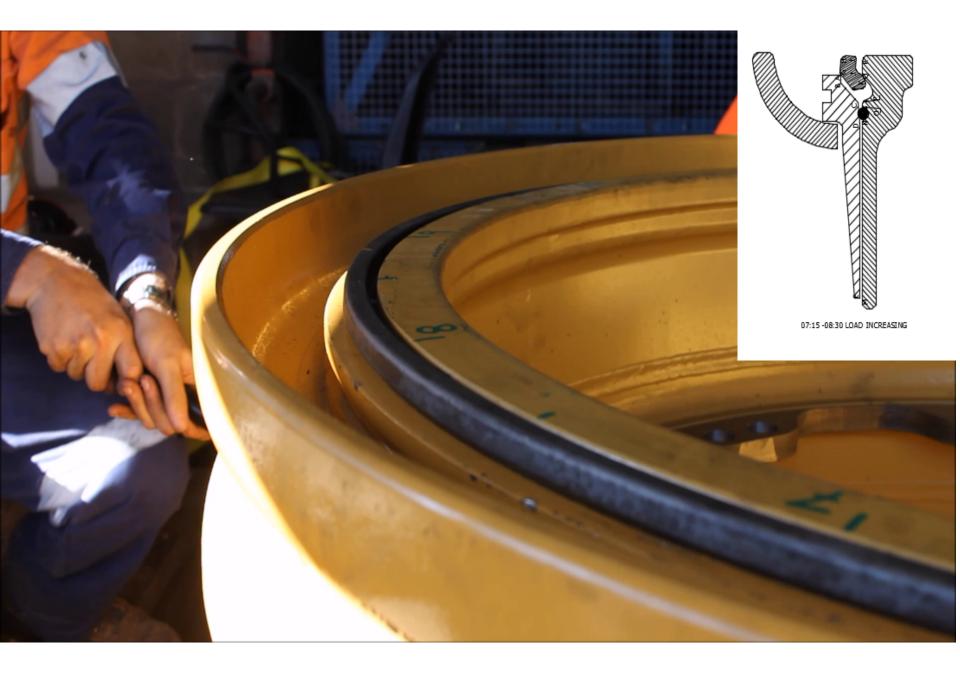
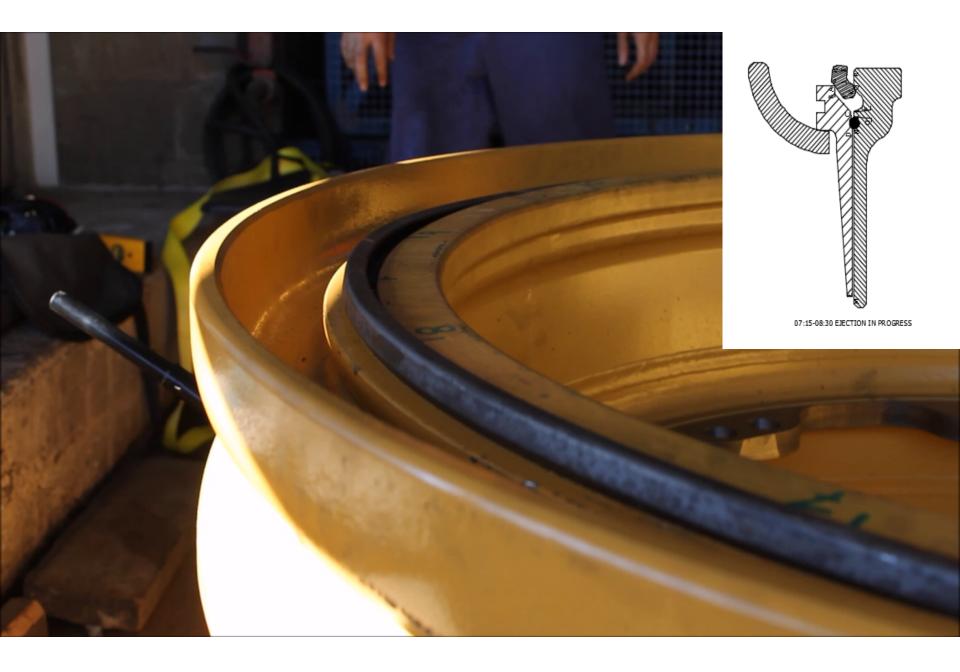
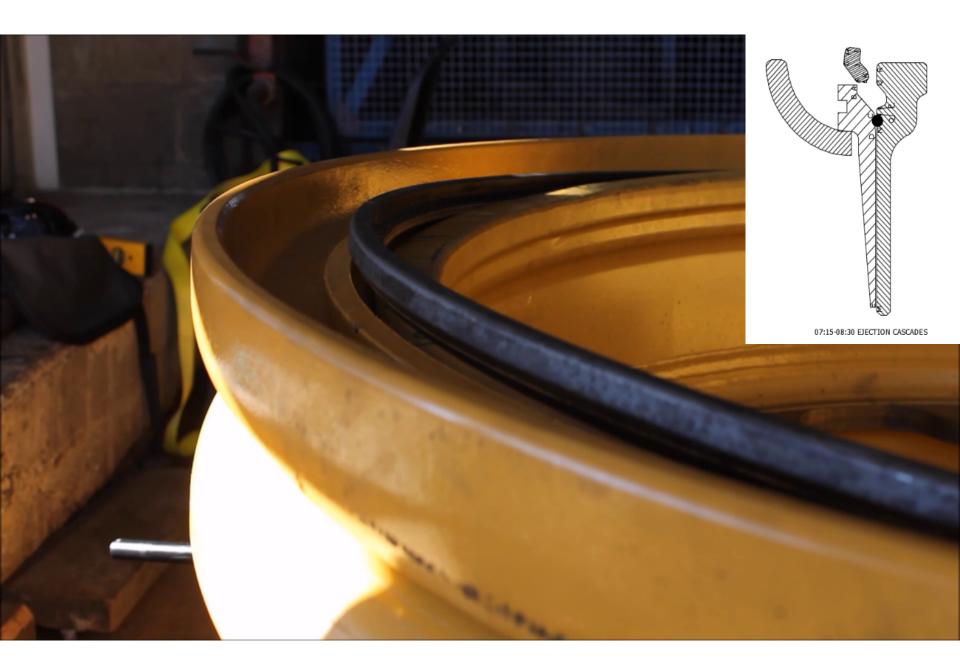
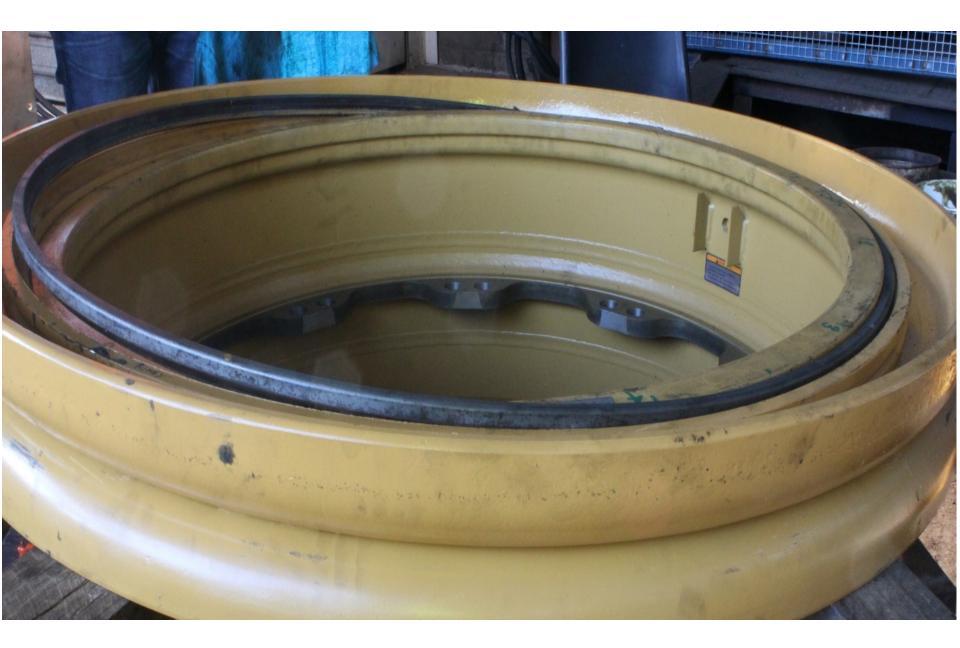
The damage on components involved in a past disassembly events were compared with the components used in the simulation.

- Strong similarities in the location and types of witness marks on each rim base and bead seat band (simulation and a past known disassembly)
- Both the simulation and past disassembly event components had the same <u>lack</u> of damage 90 degrees from the lock ring gap (the failure initiation point)
- Both lock rings (simulation and past known disassembly) were no longer planar. Both had a bend in a similar location.

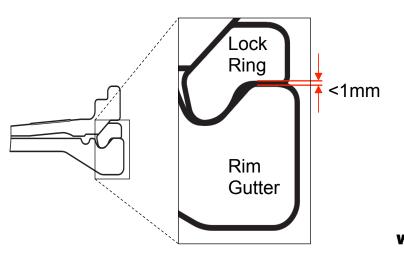
- Even when misplaced, simulations indicate that structural capacity is maintained provided the lock ring remains under the bead seat band hood. See Figure 1.
- When the lock ring is caught by the bead seat band hood, if a Shur-Lok is fitted, the O-ring is not engaged. This prevents the build up of hazardous energy, i.e. the design fails in a safe mode. See figure 2.

Figure 1 – Shur-Lok with lock ring misplaced but captured under bead seat band hood.
