ACARP Project C23005

Use of plastic metal for temporary repair
of flamepath on flameproof equipment
used in underground coal mines

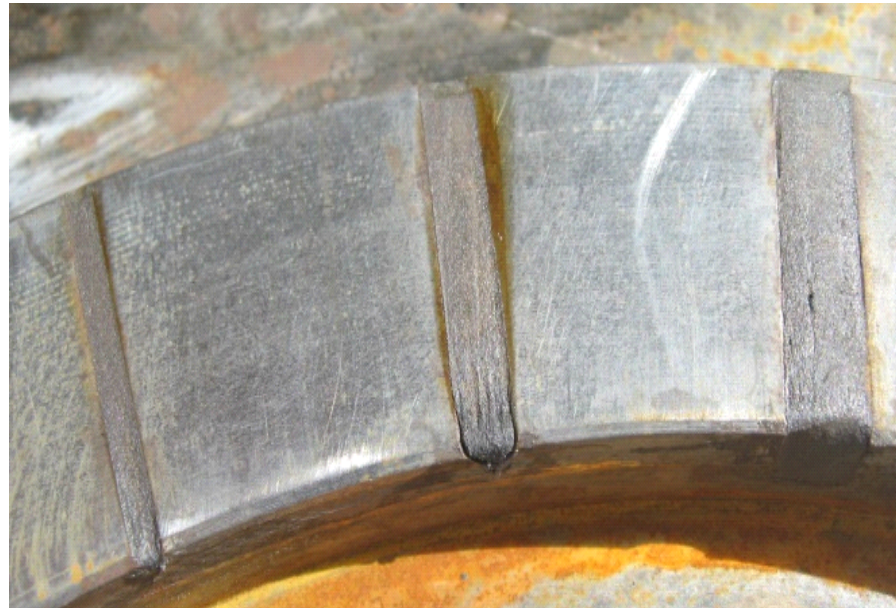
- Flame non-transmission tests
 - 5 test conducted using hydrogen methane mix
 - No transmission, however minor erosion of material

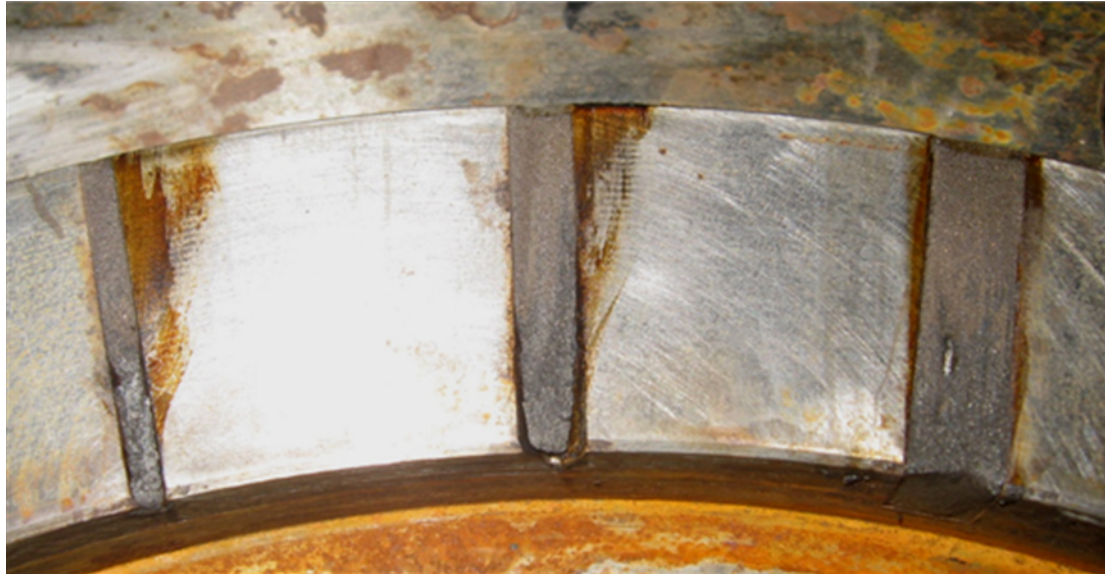
- Flame erosion tests
 - 50 tests conducted using 9.8% methane in air mix

- No transmission

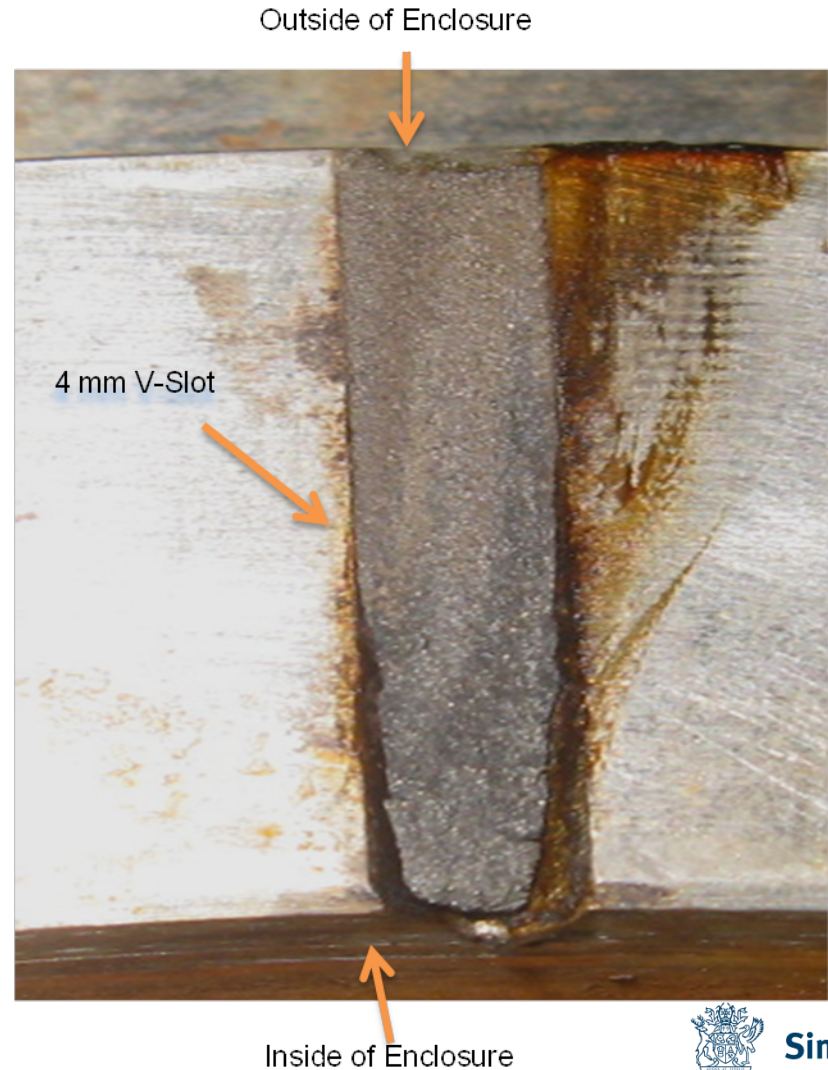
- Flame erosion tests
 - Closer inspection

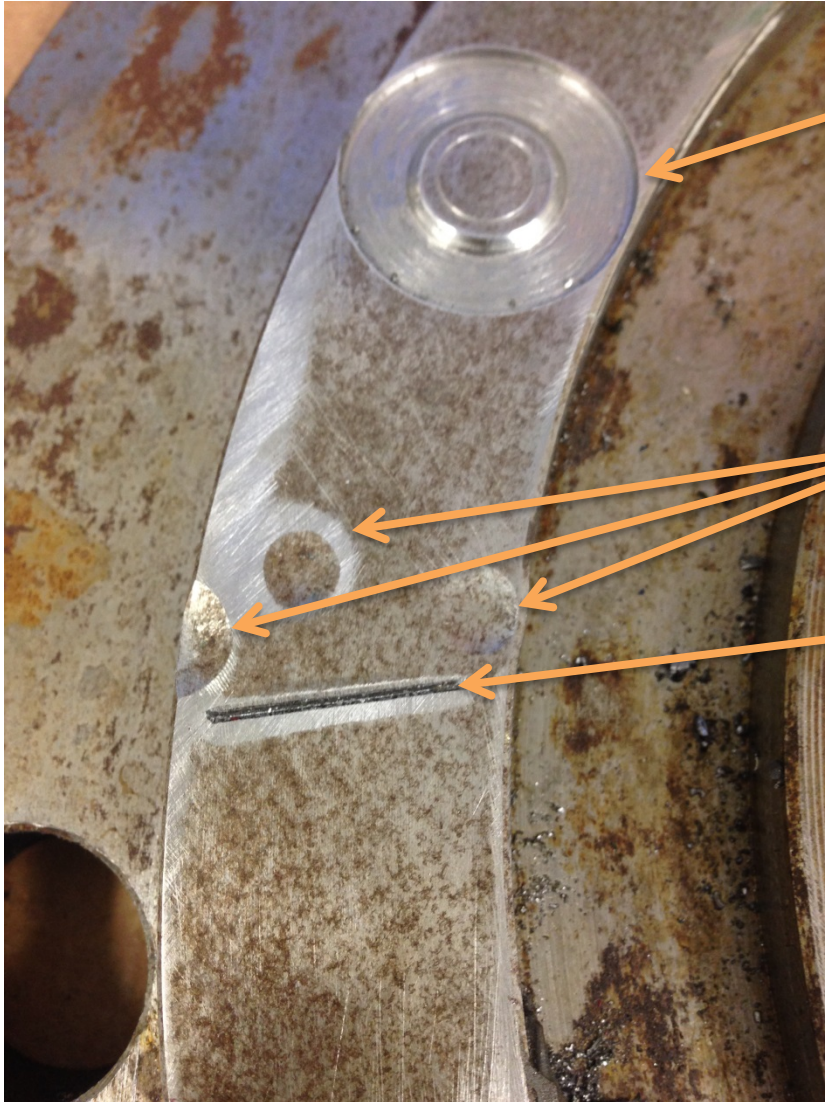
Indentations

Washer imprint across
the flamepath

Impact damage across
the flamepath

Deep stretch across
the flamepath

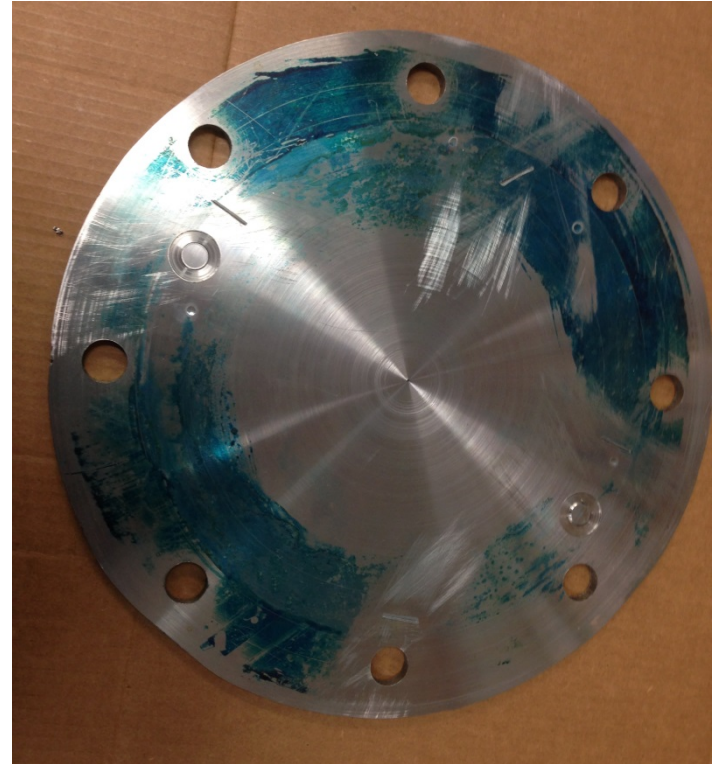
Back view with indentations

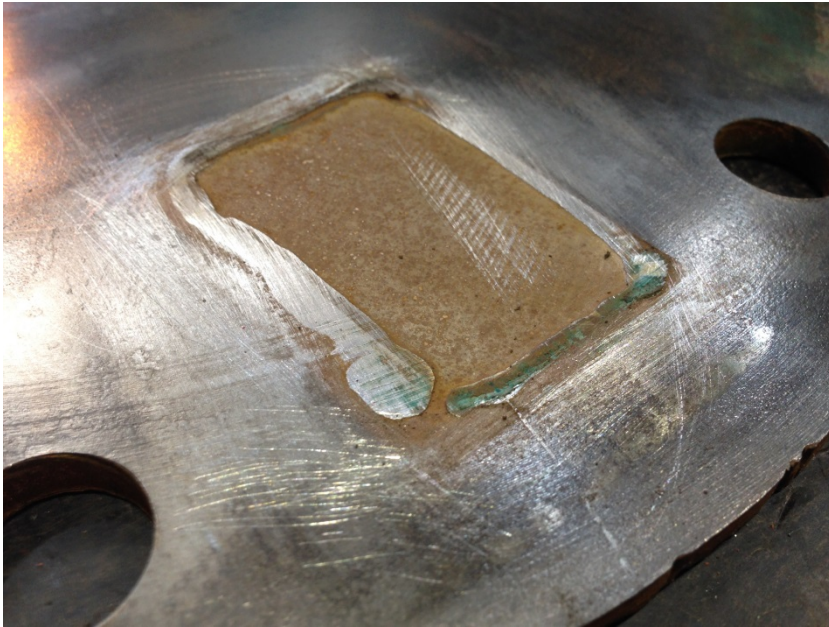
Flamepath damaged by corrosion

Flamepath etched with acid
on 8 mm thick cover plate

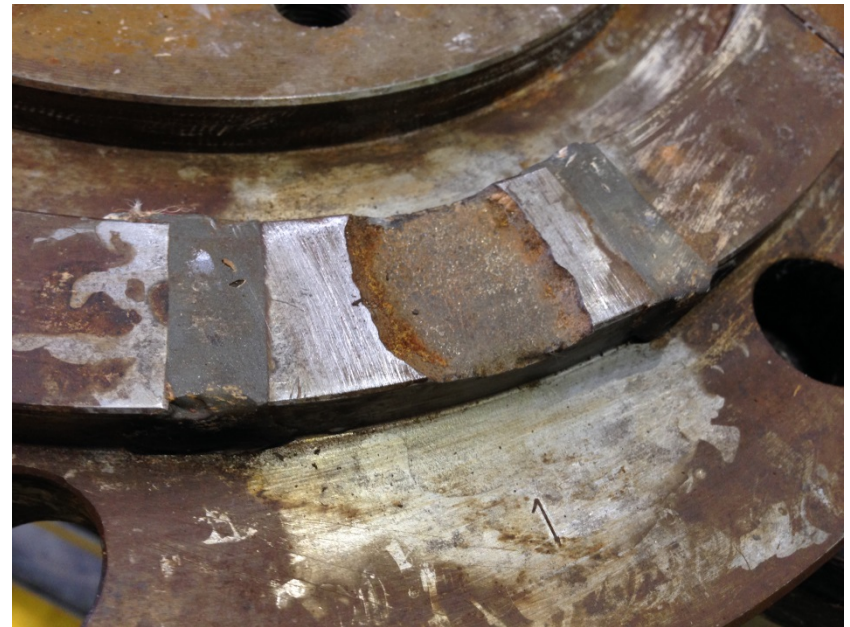
Flamepath etched with acid on
thick cover plate
