QUEENSLAND MINING INDUSTRY

Anglo American Moranbah North Mine

- Anglo American - Moranbah North Mine
- Underground Coal Mine – Longwall Operation
- Bowen Basin, Central Queensland
- Pulley String Catcher

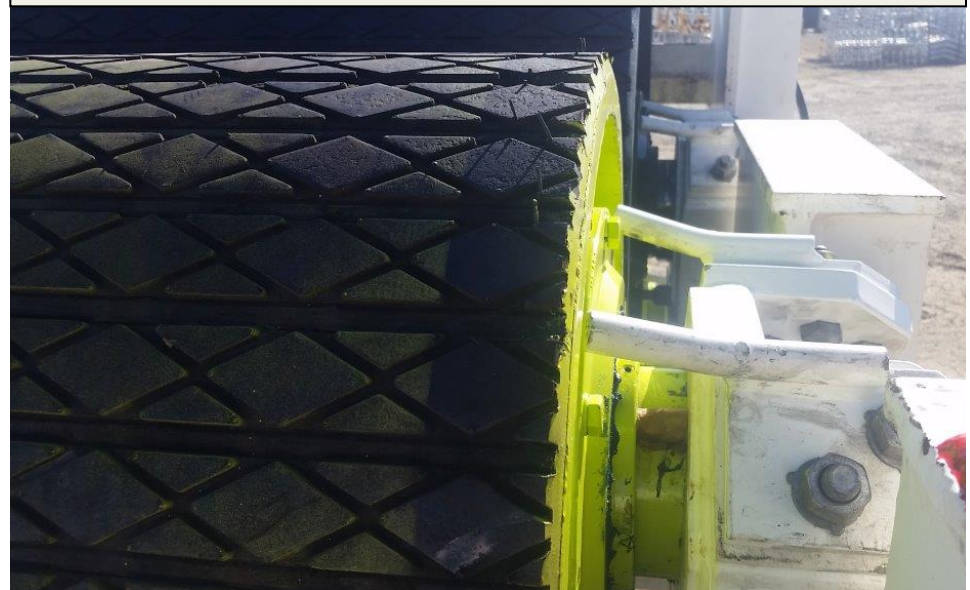
Pulley String Catcher installed on loop take up pulley before installation

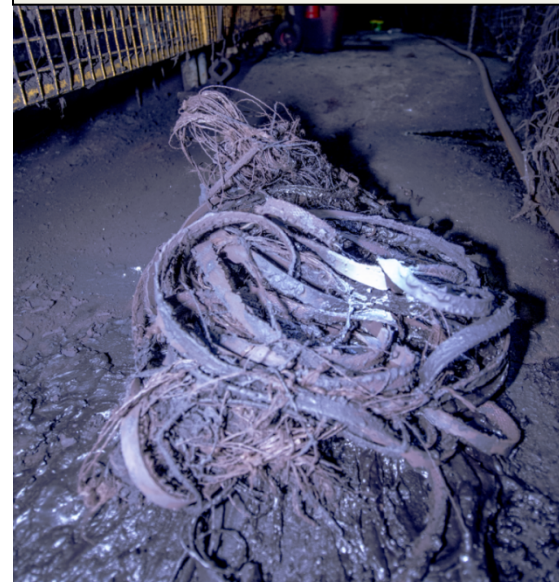
- String ingress to the pulley labyrinth seals
- Conveyor belt string from damaged edges of belt
- Edges damaged due to tracking
- Caused by idler failures, bootend pushes, mechanical or vulcanised joints
- Age of conveyor belt and retraction process

String and rubber removed from pulley seals underground

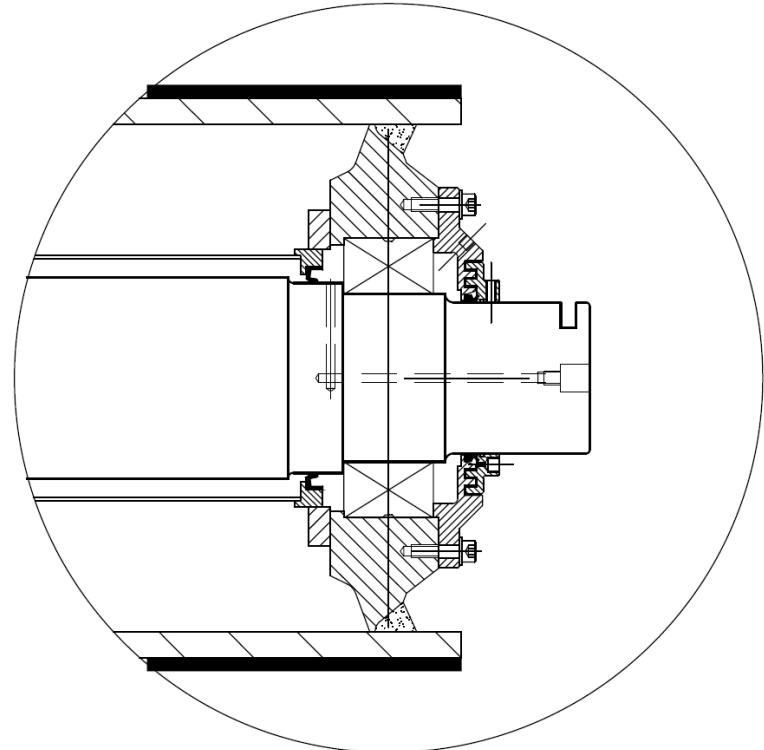
- Risk to coal mine workers with potential for underground fires
- Seal failure due to ingress of string
- Allows ingress of dirt and water to the bearing
- Causes bearing failure
- Friction with combustible materials present, grease and string fibres

Labyrinth Seal breakdown

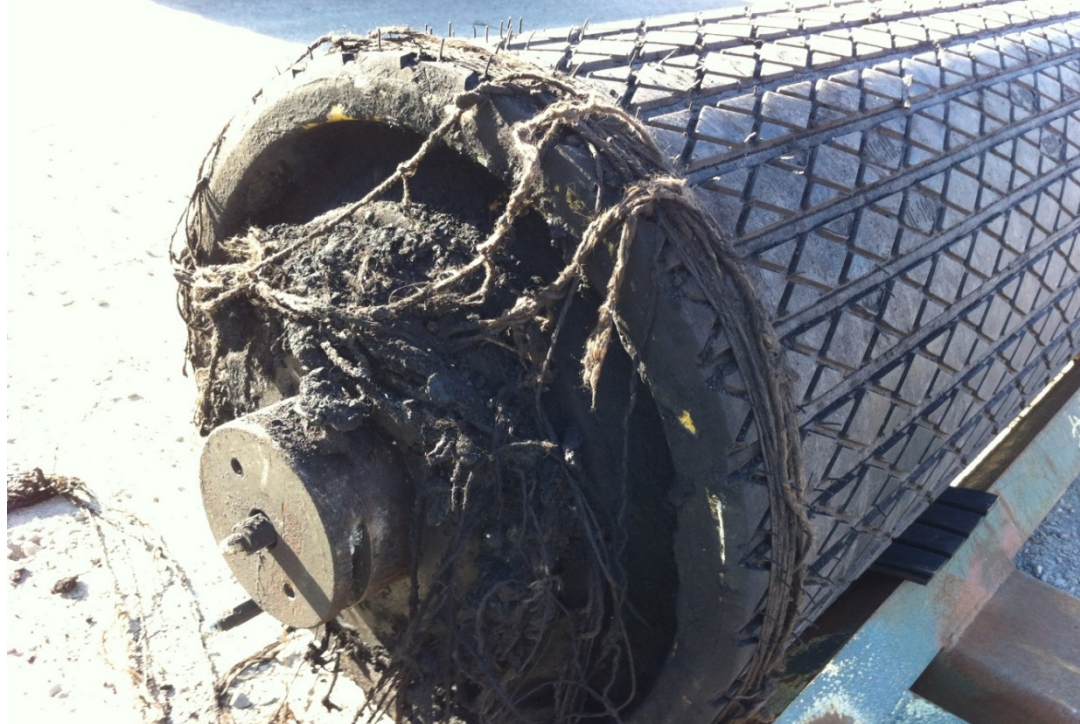
- This mode of failure has been seen on 7 pulleys at Moranbah North Mine

Failed Moranbah North Pulley due to string ingress

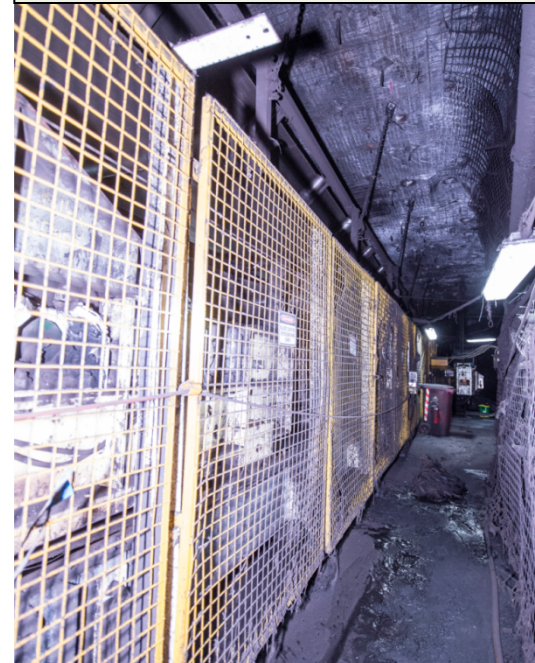
- Risks to coal mine workers regarding pulley changeout activities
- Weight of the pulley being between 1.5 to 3 tonne
- Narrow walkways and low headroom
- Process in which pulleys have to be re-slung
- Need to reduce the risk to coal mine workers by reducing the requirements for pulleys to be changed out

Confined work environment

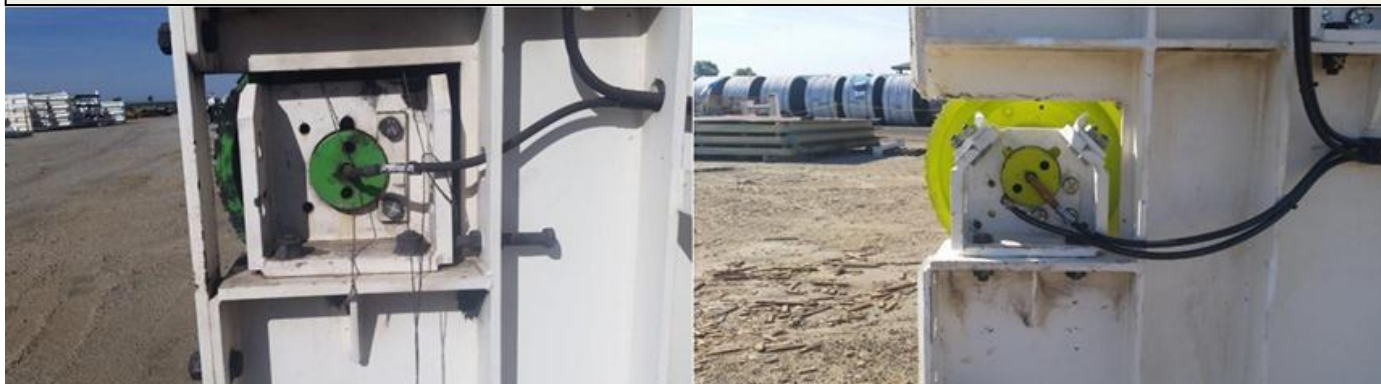
Comparison of old conveyor pulley blocks to the new style with the string catcher installed allowing more of the pulley to be seen

- Modification of the currently used pulley blocks
- Robust bars added to the pulley blocks
- Redesign of the pulley blocks allowing greater ability for visual inspection
- Allows for grease to be seen purging and whether string is building up around the seals

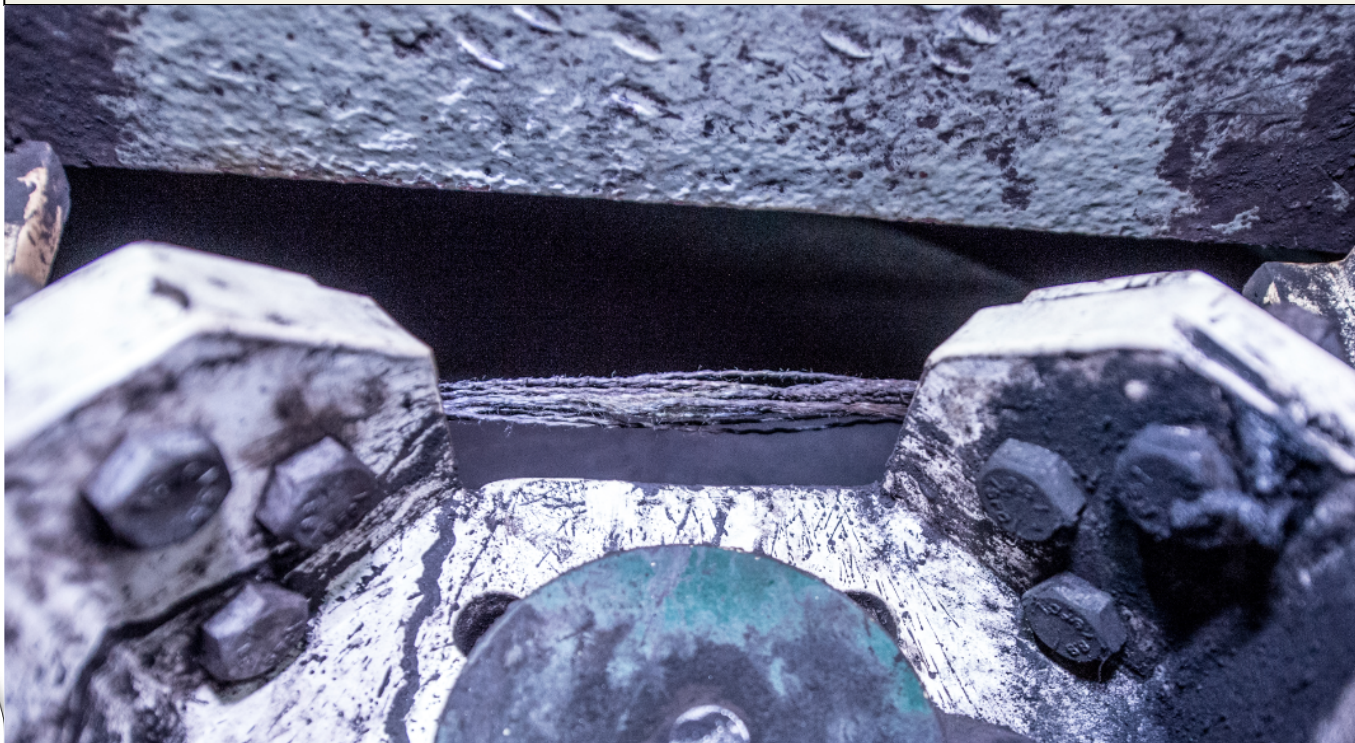
- Trial installed on pulley in LW110 conveyor loop take up
- Significant amounts of string built up around the pulley string catcher
- Labyrinth seals have been left clear
- Easier to cut clear of the string catcher rather than clean out of pulleys
- All of these factors have reduced the risk to coal mine workers through reducing bearing failures and higher risk activities

Pulley string catcher installed underground removing string from the belt

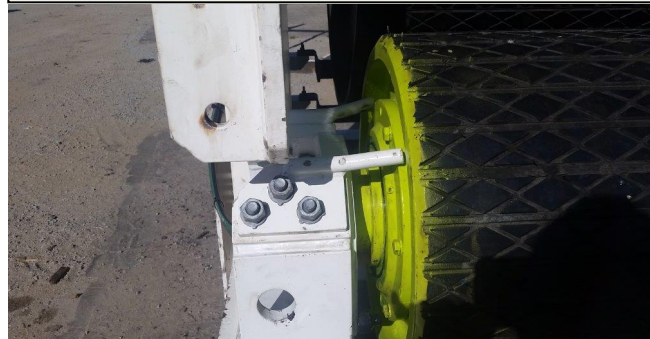
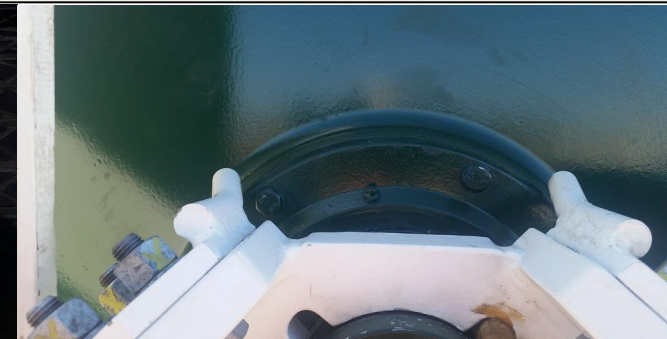
Pulley String Catcher installed on the loop take up pulleys before installation underground

- Reduction in risks associated with potential underground fires
- Reduction in exposure for coal mine workers to manual handling and pinch point activities
- 7 pulley failures prior to installation, no failures have been seen since due to a strict regime of cleaning the seals and the work of the string catcher
- New standard for the Loop Takeup of the longwall block and form part of the panel belt installation standard
- To be reviewed for all conveyors at Moranbah North Mine for at least the improvements to visibility of the seal
