Dozer Blade Lift Cylinder Light Bracket Modification

BMA – Goonyella Riverside Mine

2008 QUEENSLAND MINING INDUSTRY HEALTH AND SAFETY INNOVATION AWARDS

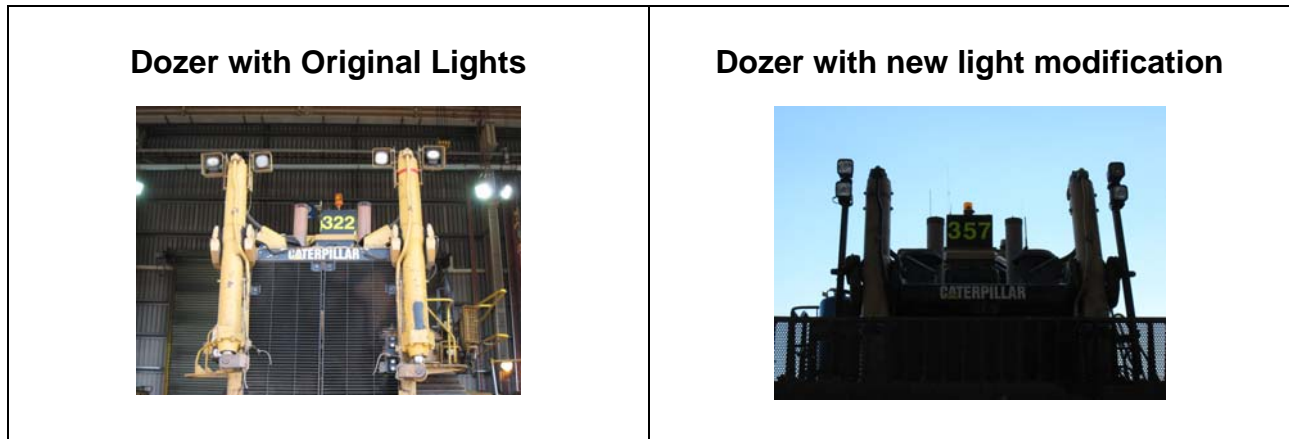
Fold down light brackets were designed which can be accessed from the dozer track. This eliminates the need to work at heights and brings the repair work down to a safe work environment. A handrail system has also been fabricated to be placed on the

tracks to eliminate falling from this lower height and reduce the risk even further. The frame is made of aluminium so is light and easy to lift into place when required.

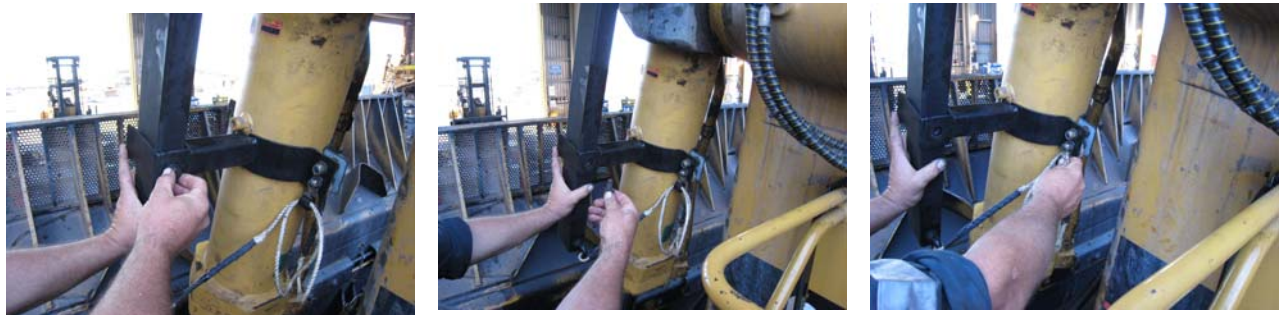
Once the machine is isolated, the retainer bolt located on the bottom of the saddle clamp is removed and the lowering rope is released from its locator.

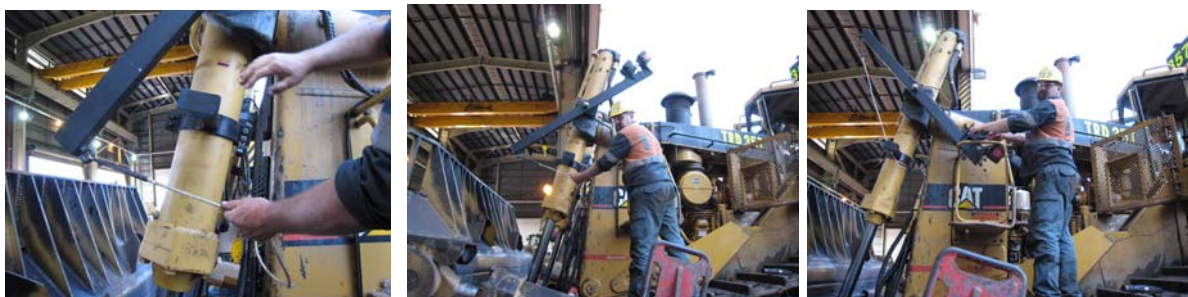
The light bracket is then lowered using the rope until it comes to rest on the step handrail allowing for maintenance work to be undertaken.

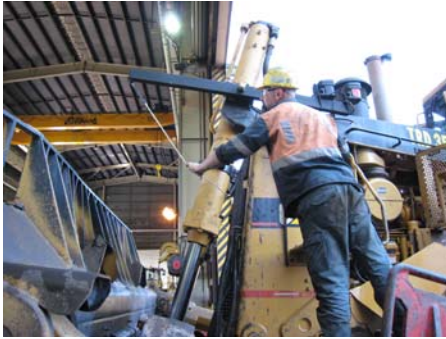
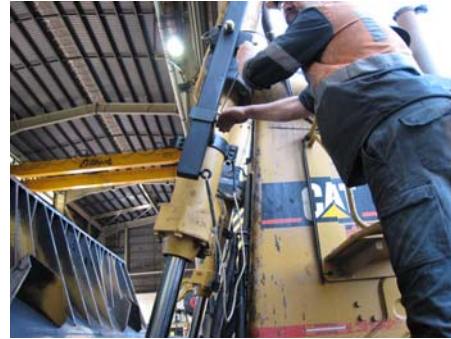
Once the lights are repaired, the light bracket is raised by the rope, the retainer bolt refitted and the lowering rope placed back in the locator.
