**TITLE: Burton Highwall Challenge**

**OPERATION: Burton Coal Mine, owned by Peabody and operated by Thiess**

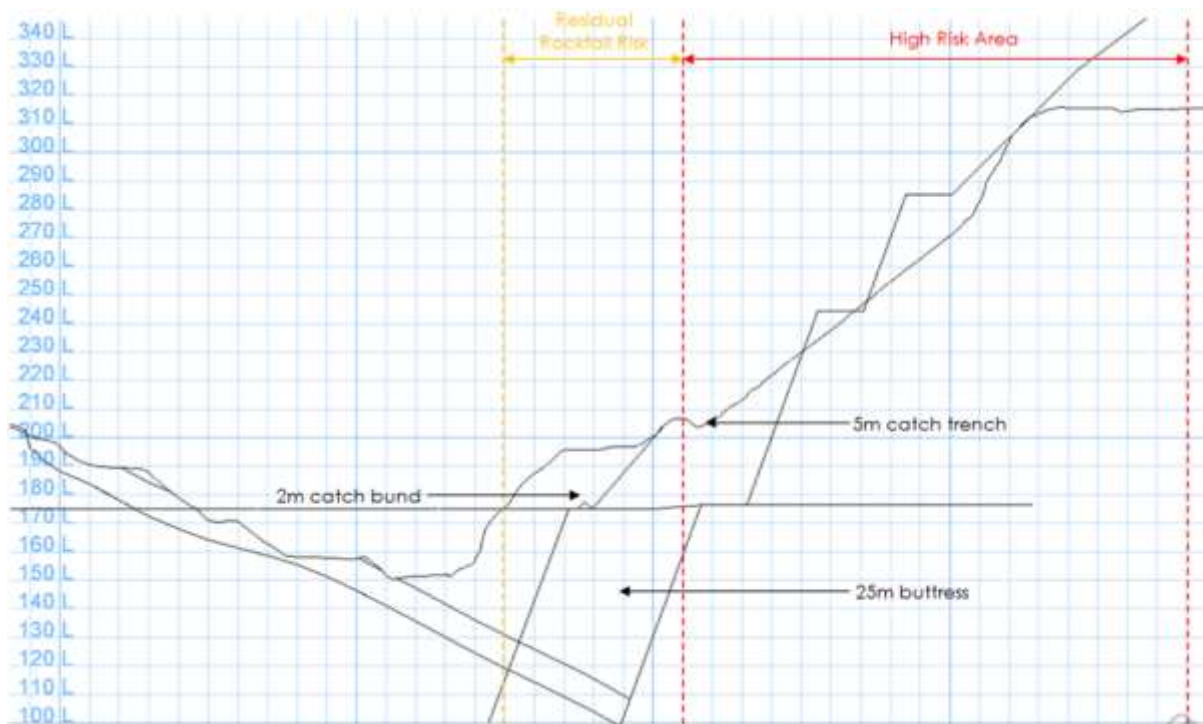
Figure 6 A representative cross-section showing the final design for the Burton Widening Highwall Buttress

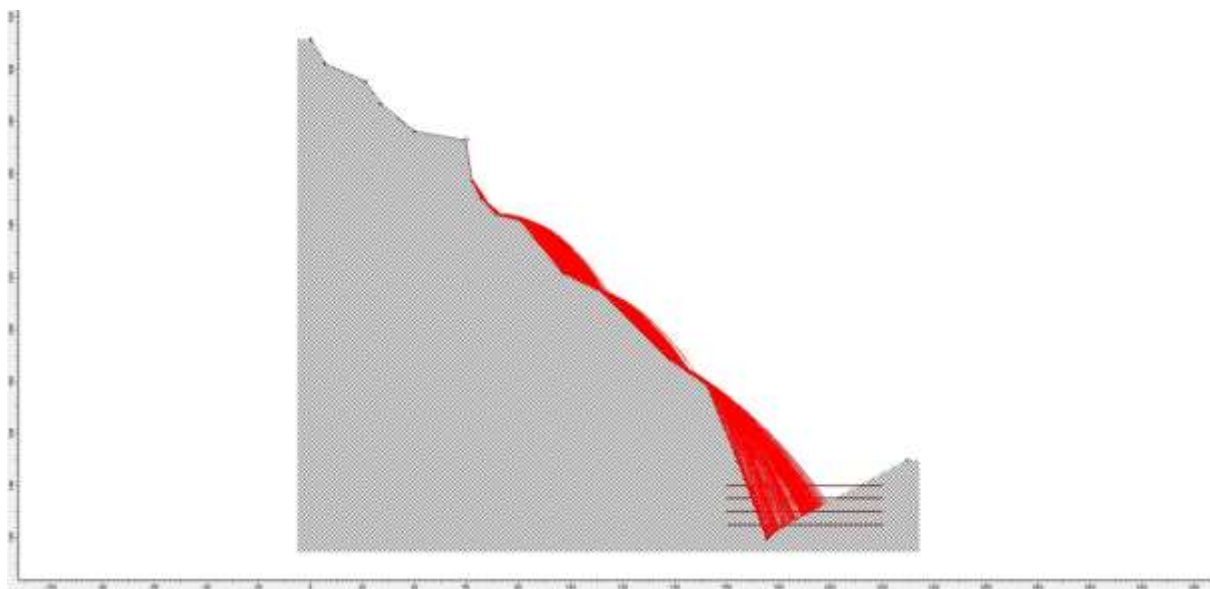
Figure 8 Results of rockfall analysis carried out to establish limits of rockfall standoff zone below deteriorating Block 1 Wedge

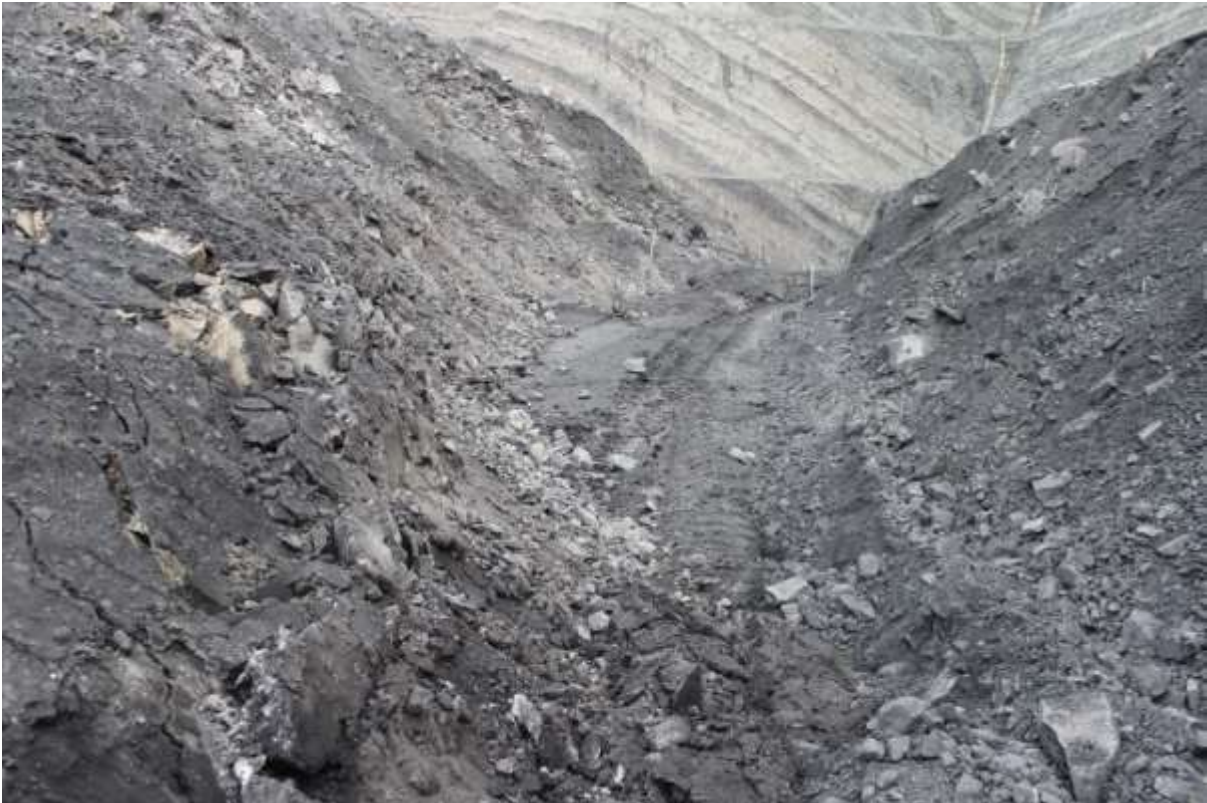
Figure 9 Photograph taken 11 March 2014 looking north after a floor heave event of up to 3m height that had resulted in the loss of up to 10m working width
