Caterpillar 24H Motor Grader Rear Window Access System

New Acland Coal

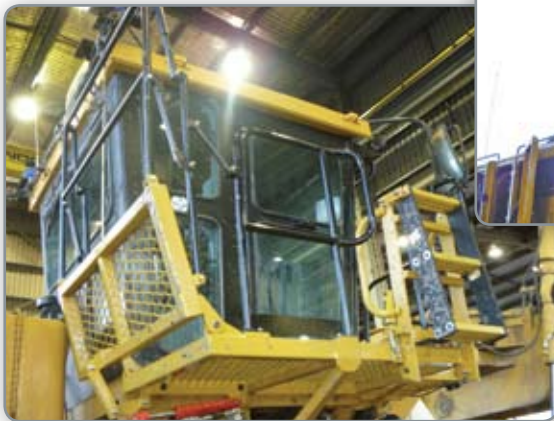
Picture 1
Rear access platform in the 'raised' position.

The initial design drawings incorporated a fold-down platform design but was deemed not acceptable due to the fact that the platform's default position meant that it was not a fail-safe system for the operator. Through the risk evaluation process, it was noted that should an operator be standing on the access platform and a mechanical failure occur, the platform would fold down to its default position, trapping or dislodging the operator. The second attempt at design proposed a design in which the platform defaulted to a lowered position in the case of mechanical failure. While this new design presented a limited amount of risk of platform damage if the platform was to lower while in operation, warning systems from the existing hydraulic access systems already incorporated in the operator cab meant that this risk was minimal and adequately controlled when considering potential outcomes. As such, this design was approved for construction and trial. In conclusion, the final design incorporated the platform in a fold-up state when actuated by the existing stairs hydraulic circuitry with a fail safe to the deployed position. Additionally, a set of emergency egress steps were incorporated into the design for redundancy. This unit has now been operational in trial for more than 12 months, with positive feedback from all operators on safety, operation and visibility. There has been no case of mechanical failure of the platform or operating systems.

The platform system has allowed the operators to clean all the windows on the Caterpillar 24H by safely folding up, and interlocking with the existing stairs without additional control panels or switches.

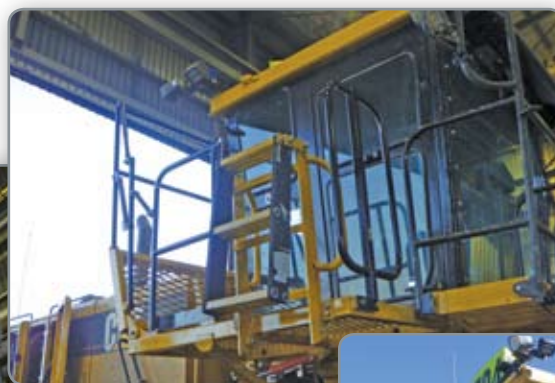
Picture 2
Rear access platform and emergency egress steps in raised position.

This access system has allowed unfettered access to safely clean rear windows on the right hand side of the 24H Motor Grader with minimal reach to clean all rear window areas of the machine. Emergency egress stairs are manually folded up with sufficient clearance for full functionality of the blade and all other operations of the motor grader. These stairs are easily deployed with a foot lever – further reducing the likelihood of manual handling related incidents. The platform is automated as it raises to the 'hold' position as soon as the hydraulic steps are powered and raises. As soon as this function is actuated, the rear access platform folds up allowing full articulation and use of grader functions. Until the existing hydraulic stairs are fully retracted and the machine handbrake released, the machine is safe guarded and will not move.

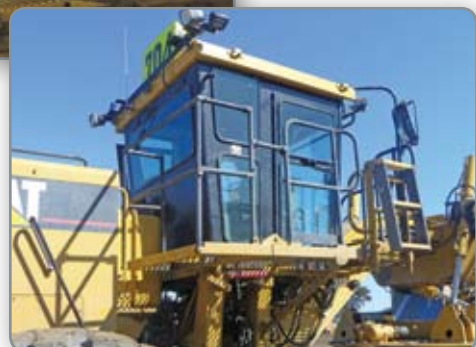
Picture 3
Access platform in the deployed position.
