## Pajingo Gold Mine

### Innovation Submission

**Accidental  
Locking of  
Isolator in “ON”  
position.**

**“Team based risk  
solving”**

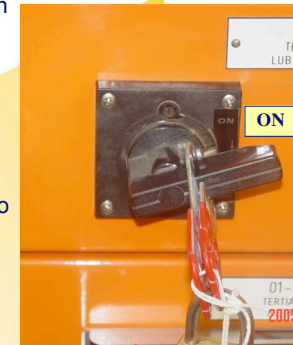
- During a crusher shutdown, an isolator in a MCC was accidentally locked in the “ON” position.
- The original design of the isolators as fitted in the 1980’s allowed these circuit breakers to be locked in the “ON” position
- ✓ We needed to prevent an occurrence of an electrical isolation incident.

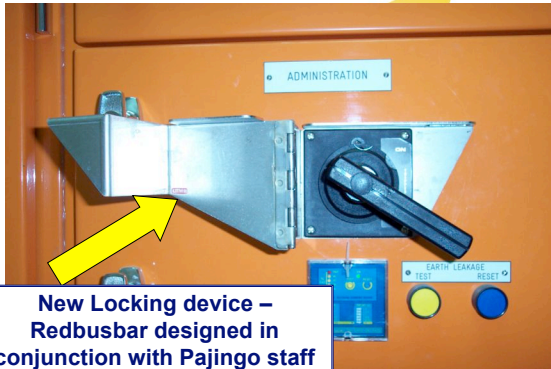
**New Locking device – Redbusbar designed in conjunction with Pajingo staff**

- Plate gate locking system fitted
- Removal of existing pin latch mechanism

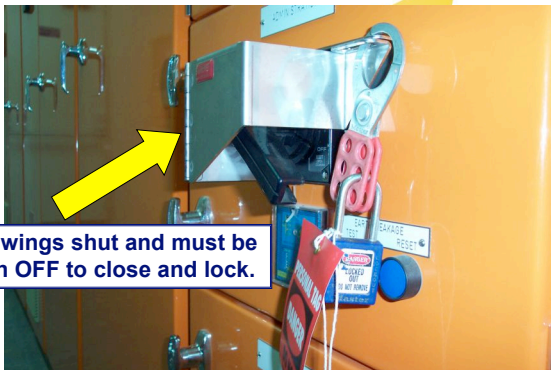
## Now safe – Can only be locked in OFF position!

**Swings shut and must be in OFF to close and lock.**

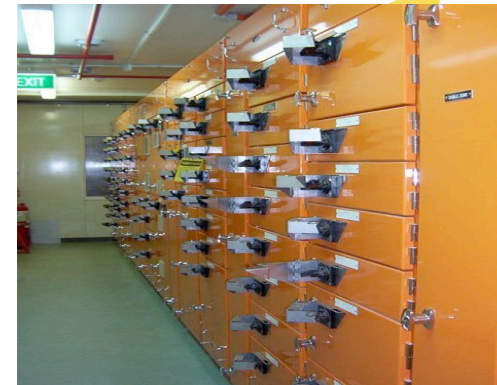
## Each Isolation switch has been upgraded. Over 200 switches have been retro-fitted!

**“CIRCUIT BREAKER”  
POSITIVE EQUIPMENT ISOLATION**
