## QUEENSLAND MINING INDUSTRY HEALTH AND SAFETY INNOVATION AWARDS 2008

### 9020 Intermediate Assembly Upgrade Rio Tinto Coal Australia ~ Hail Creek Mine

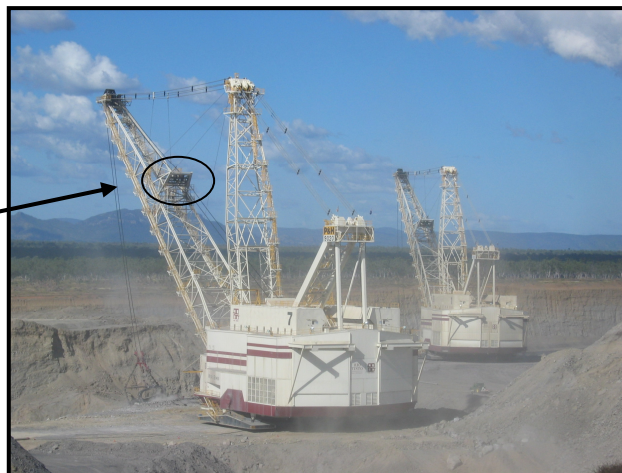
Intermediate  
Hoist Rope  
Sheave  
Assembly

One of the key operating components of the 9020 dragline is the intermediate hoist rope sheave assembly. The assembly component is located half way up the dragline boom, which is almost 100 metres in length. This sheave houses a 'cassette', which guides and controls the hoist ropes towards the end of the dragline boom.

The original cassette, which was designed and applied for use on 9020 draglines, lacked strength and reliability, which regularly resulted in severe cracking around the centre shaft support transition. Additionally, bobbin rollers frequently failed due to inherent design problems leading to rope wear and flange cracking.

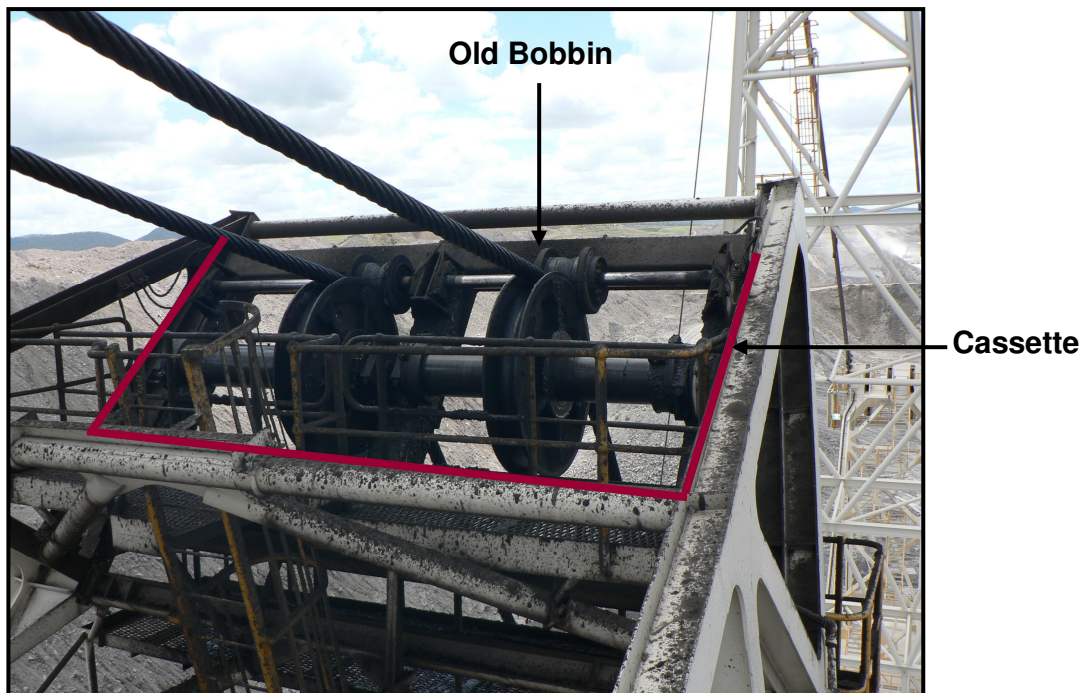
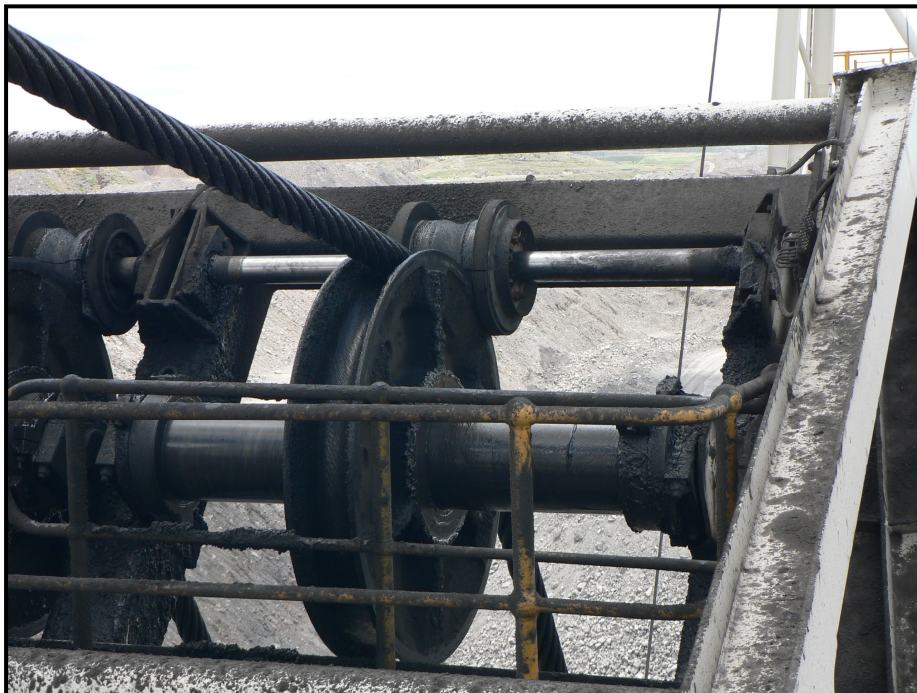
*Previous cassette and bobbin roller arrangement above and below*

The photos below show both the previous cassette and bobbin roller, as well as the replacement cassette and new poly sleeved cylindrical roller.

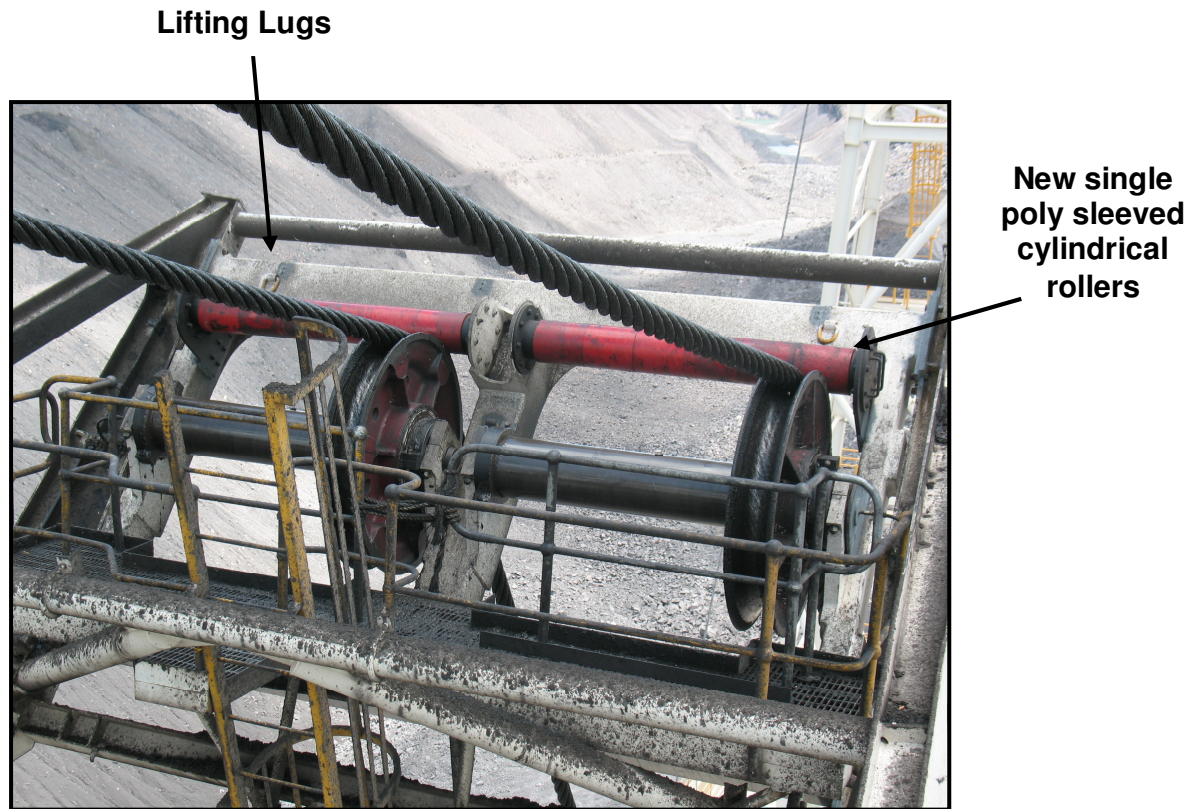
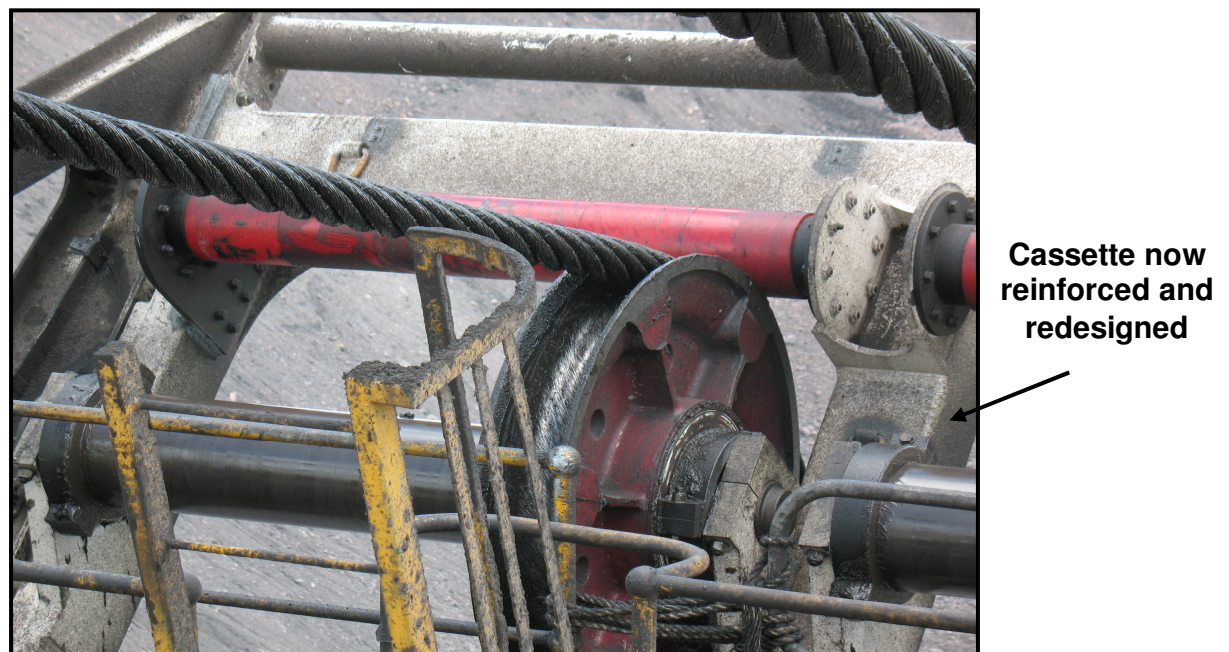
***New cassette and poly sleeved roller arrangement above and below***

The project involved designing a cassette that increased the material thickness and supported the intermediate sheave, as well as replacing the bobbins by using a single poly sleeved cylindrical roller to prevent wear and tear.
