Joystick Test Module

OZ Century

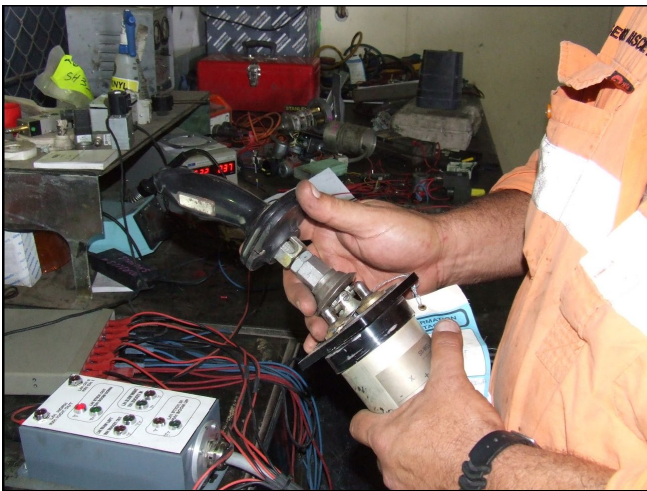
Photo 2: Once the electrician has repaired the joystick, it is connected to the system via deutsche plugs. The joystick is then manoeuvred in each direction, with LED lights illuminating in the appropriate direction if the joystick is functioning correctly.

3. The electrician connects the shovel joystick to the Joystick Test Module for testing via deutsche plug (Appendix 1, Photo 1).
4. The electrician moves the joystick in each direction. Flashing lights illuminate as the joystick is manoeuvred in each direction if it is functioning correctly (Appendix 1, Photo 2).

- As the system is easy to use – operators determine if a joystick is functioning correctly by manoeuvring the joystick in each direction and monitoring LED lights – very little training is required before the Joystick Test Module can be used in the workplace. This improves its transferability across the industry by further reducing initial outlay costs.

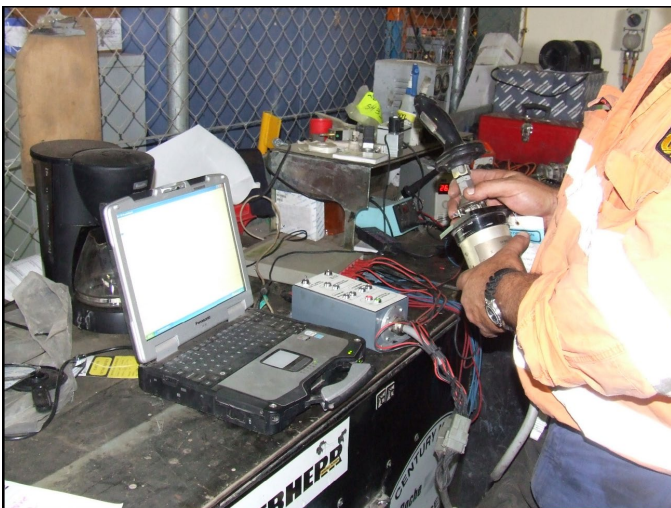
Photo 3: The electrician then connects the Joystick Test Module to a laptop to measure the voltage the joystick is operating at. This allows the electrician to use existing datalogging software to confirm that the joystick is running within appropriate voltage parameters and safe for use.

The test module can be connected to data logging software, enabling the electrician to ensure that the joystick is operating within stringent electrical parameters and is completely safe for use. The joysticks and test module have been standardised by deutsche plugs, thus enabling joysticks to be tested without any modification or alteration.

6. If all lights illuminate, the electrician plugs the Joystick Test Module into a laptop computer and connects it to a data-logging program.
7. Using the data-logging program, the joystick is tested again to ensure that it is operating within appropriate parameters (Appendix 1, Photo 3).
