# **Pneumatic Controlled Deflector Plate Sedgman Coal Wash Plant Rio Tinto Coal Australia - Blair Athol Mine**

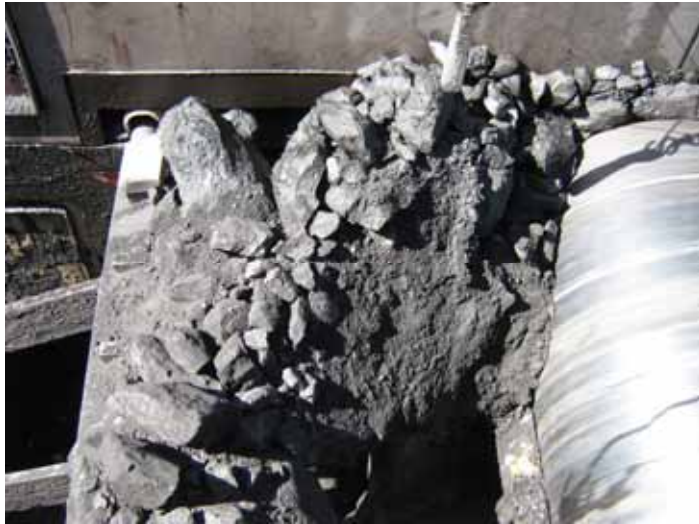
When large lumps of coal became stuck in the head chute of the plant feed conveyor, operators were required to use a platform ladder to access the top of the head chute. They then used a crow bar to assist in the removal of the wedged coal between the deflector plate and the head drum of the conveyor.

Figure 1: Large lumps of coal stuck in the head chute of the plant feed conveyor

The solution proposed was to install pneumatic rams which were designed to move the deflector plate approximately 150mm away from the head drum of the conveyor when activated. This allowed enough clearance between the deflector plate and the head drum for any blockage to clear without intervention.

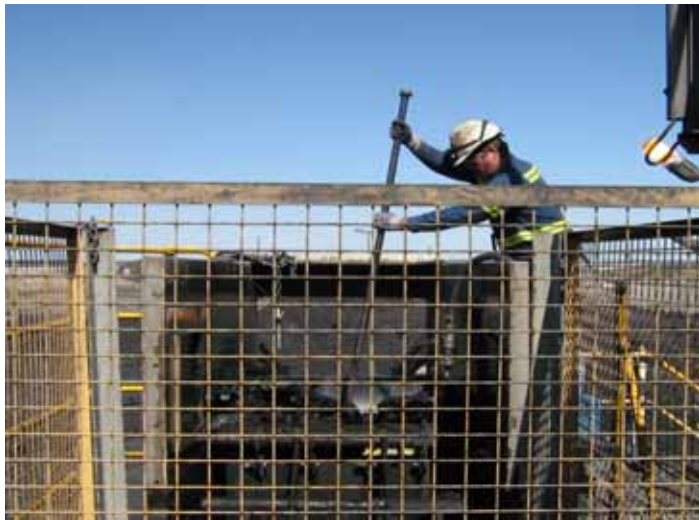
This practice had the potential to result in an injury to an employee due to the manual handling task and working in an awkward position. It could have also lead to equipment damage if the crow bar was dropped into the crushers below, causing them to jam.

Figure 2: A crow bar being used to assist in the removal of the wedged coal between the deflector plate and the head drum of the conveyor.

Using the Hierarchy of Controls, the highest level of control was chosen - elimination. This could be achieved by eliminating the need for the operators to stand on a platform ladder leaning over the head chute to remove the blockage.

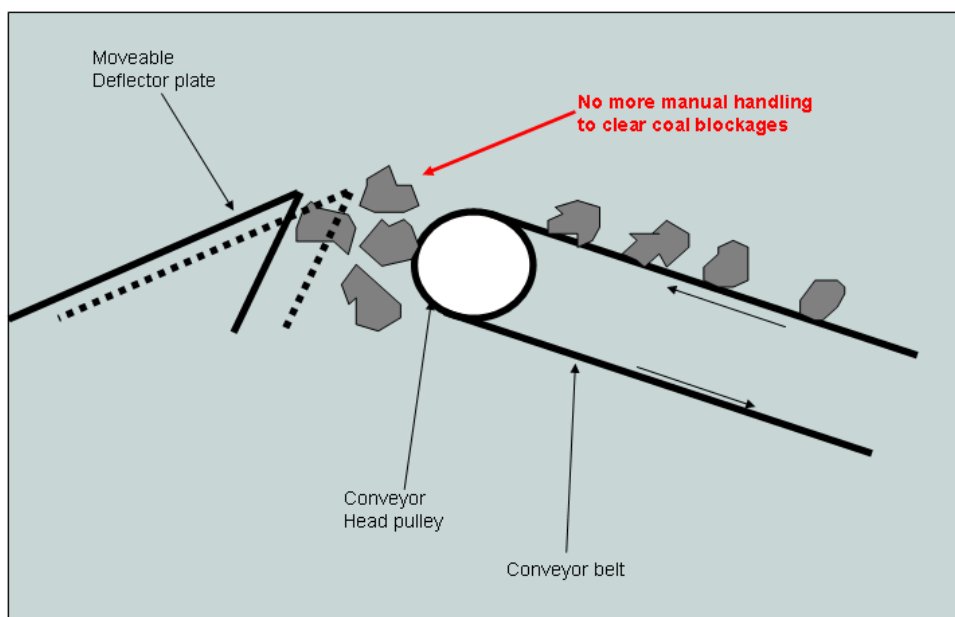
The deflector plate is used to direct the coal over the teeth of the crusher. This assists in spreading the coal across the teeth to ensure even wear.

Figure 3: A diagram of the role of the deflector plate

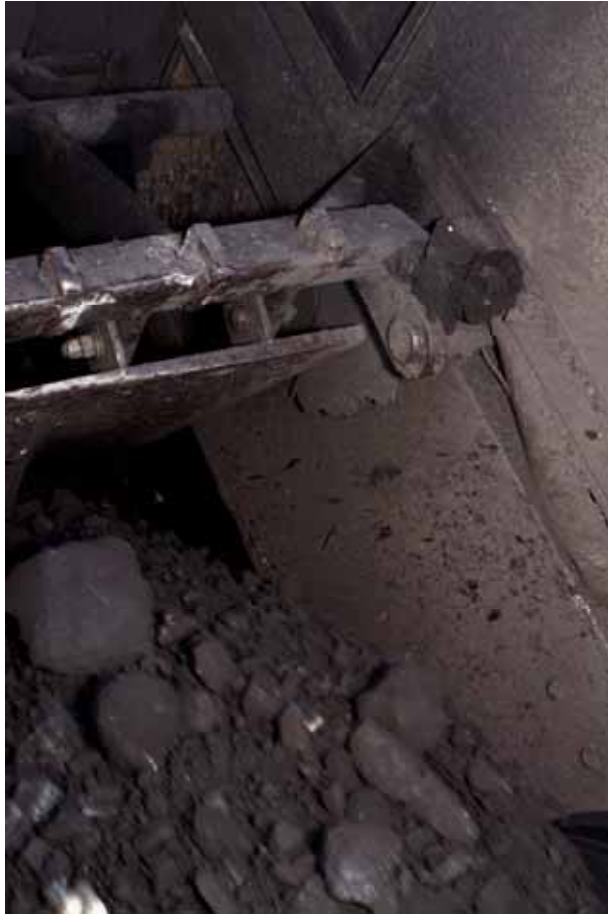
Figure 4: Deflector plate movable mounting arm.

The design team met a couple of times to brainstorm the finer points of how the moving deflector plate was going to work. Once the team agreed, the parts were ordered for the job. The fabrication took place in site during a shutdown and only took 12 hours to install. Once installed the deflector plate worked successfully with no issues from start up.

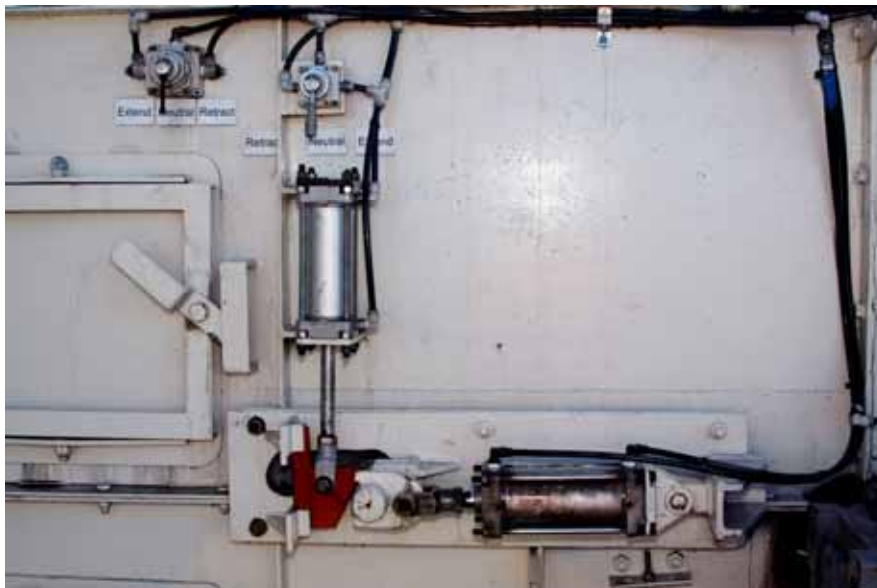
Figure 5: Locking arm and actuation arm for the deflector plate

Since the moving deflector plate has been installed, a number of improvements have been made which help in the locking and unlocking of the deflector plate. This was done by installing two pneumatic cylinders to lock the shafts in place which took the place to two manual locking clamps.
