Avoiding collisions in underground mines

Robin Burgess-Limerick PhD CPE

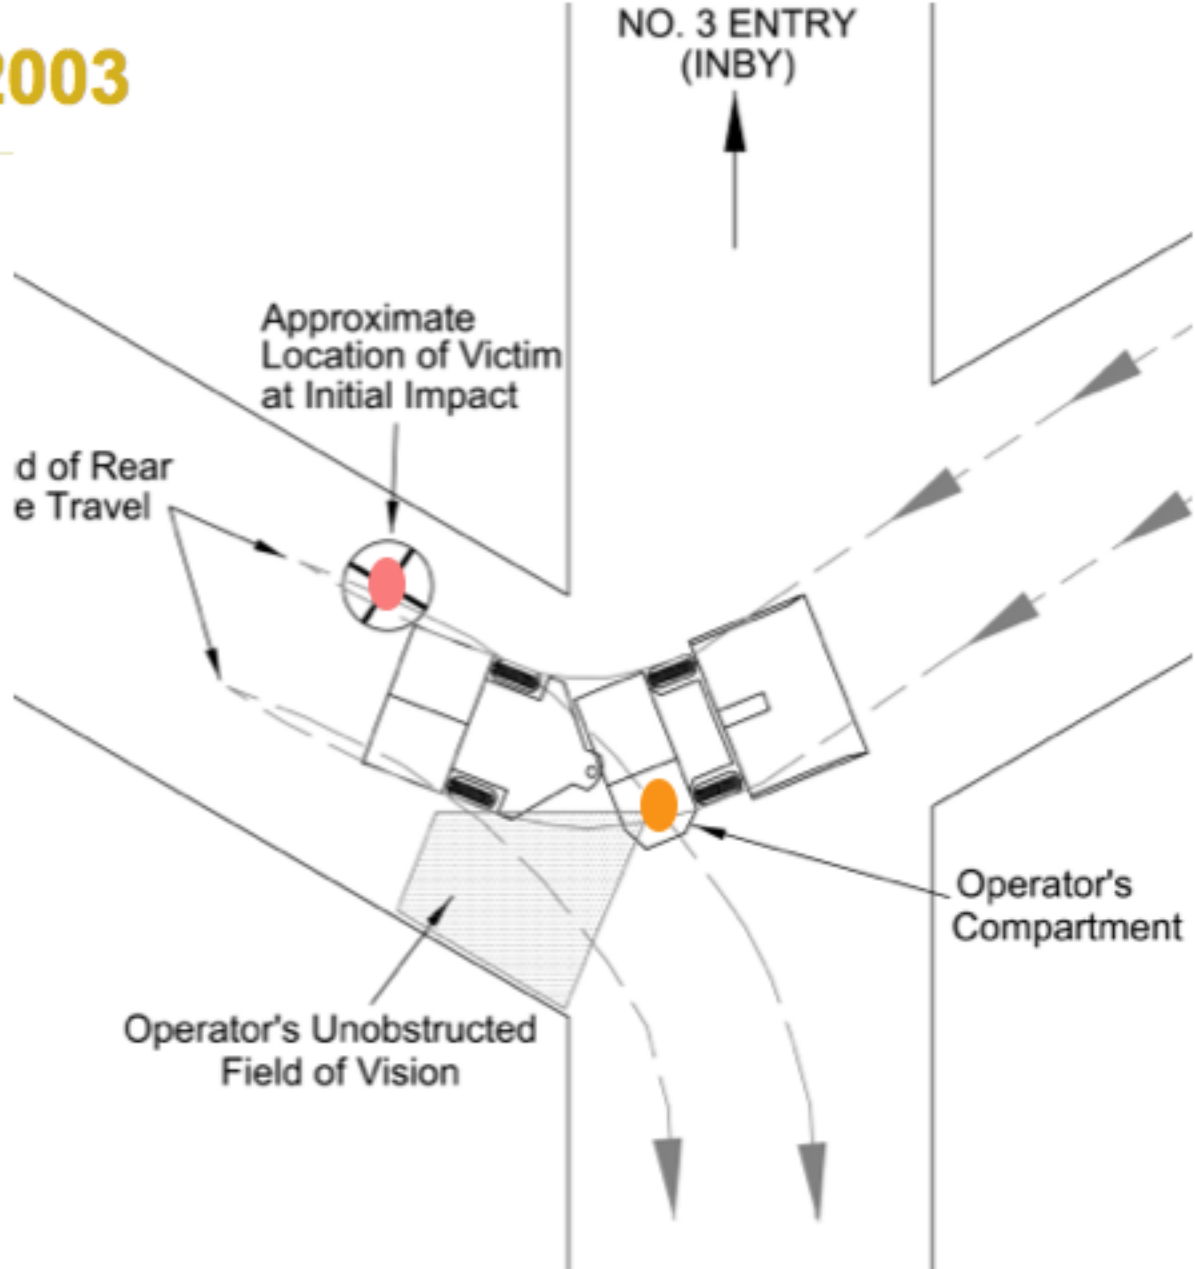
Case 2 - June 20, 2003

Scoop collided
with pedestrian

Operator visibility
restricted - video
camera or
proximity detection
are potential
controls

Video cameras (cases 1 & 2) or proximity detection linked to warning may have been effective.

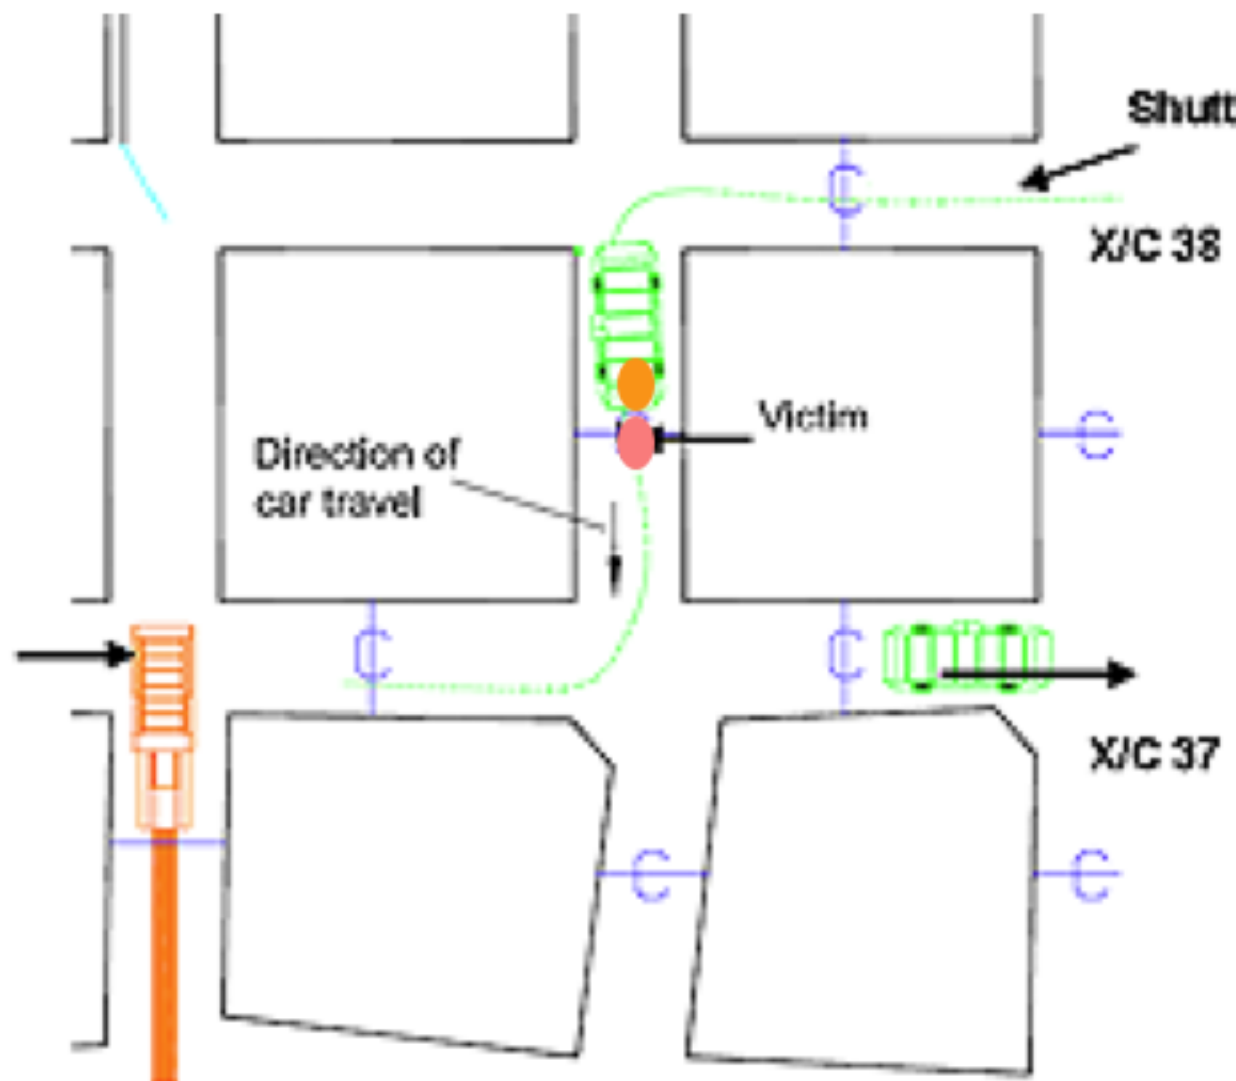
Case 3 - Oct 27, 2010

Loaded shuttle car
travelling outbye
collided with miner
repairing
ventilation curtain

Visibility restricted
by curtain -
proximity
detection is
potential control

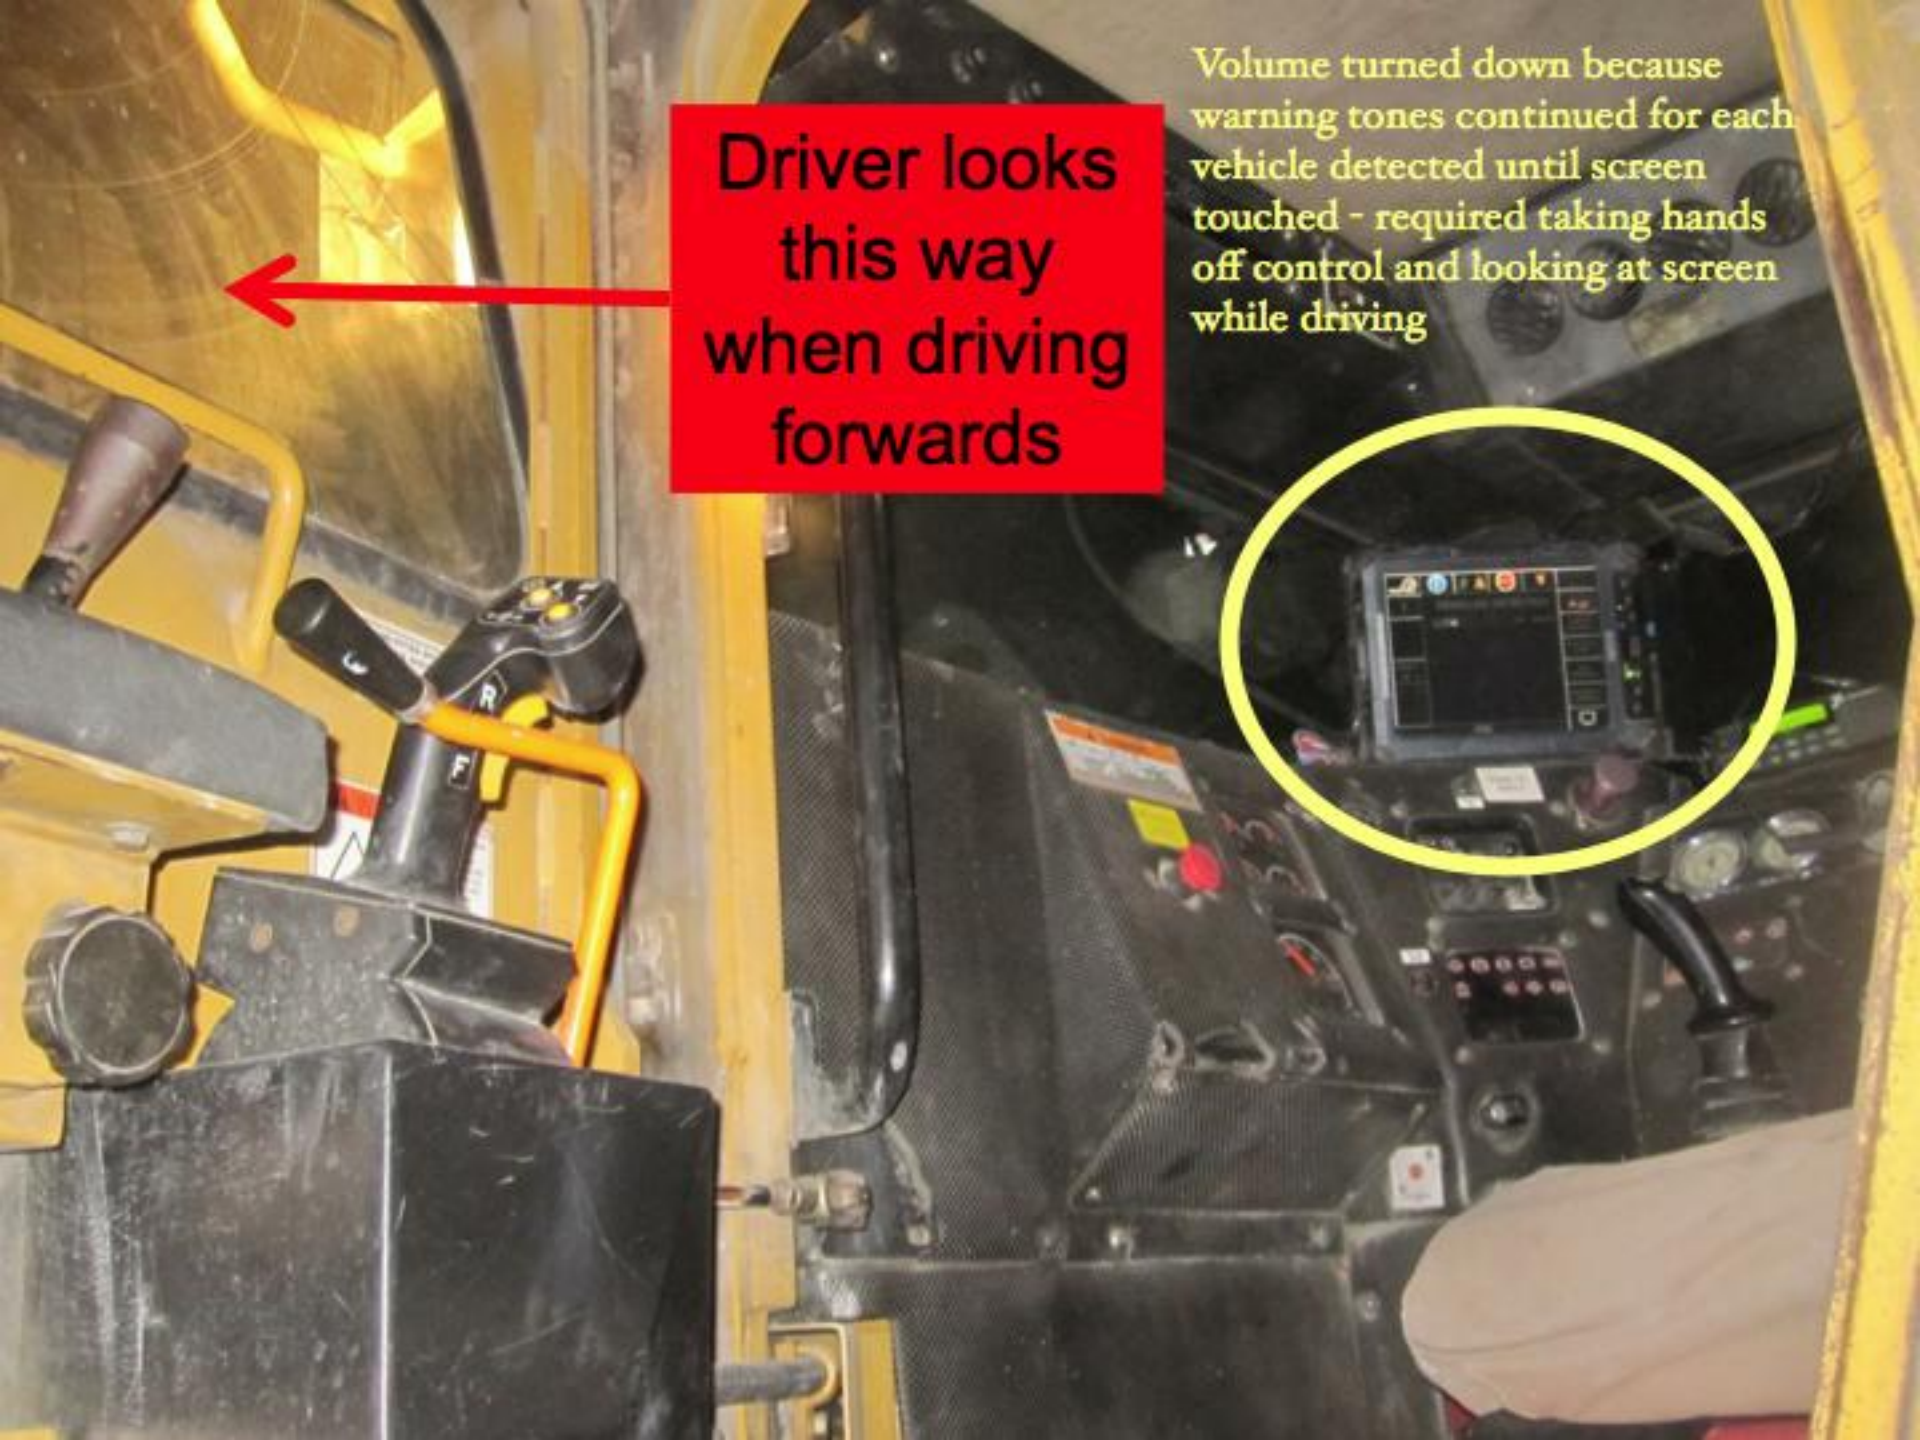
**Driver looks
this way
when driving
forwards**

Volume turned down because
warning tones continued for each
vehicle detected until screen
touched - required taking hands
off control and looking at screen
while driving

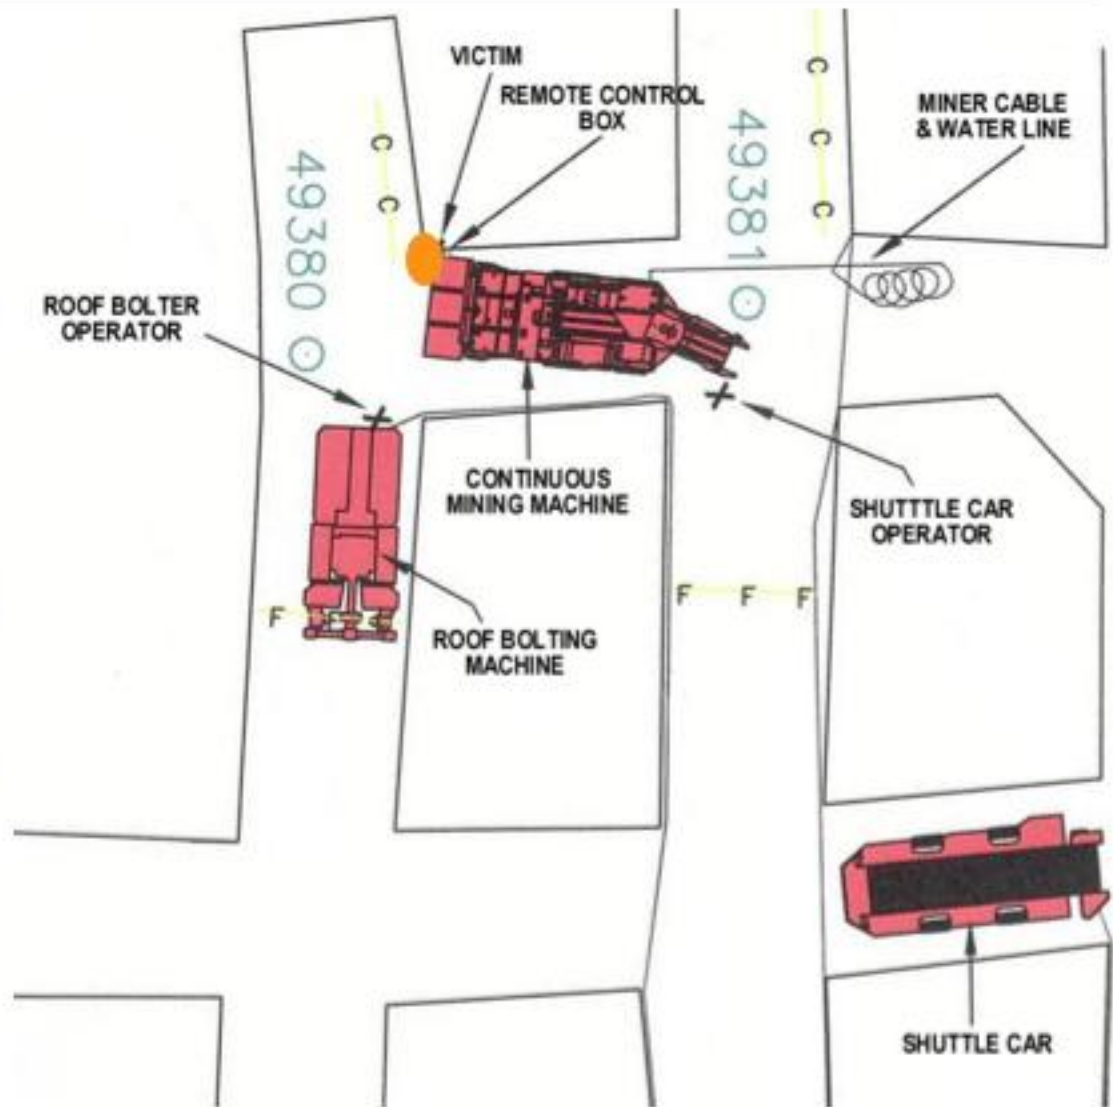
Case 4 - April 3, 2004

CM operator
crushed between
head and rib while
tramming.

Directional control
incompatibility
likely involved, but
not restricted
visibility

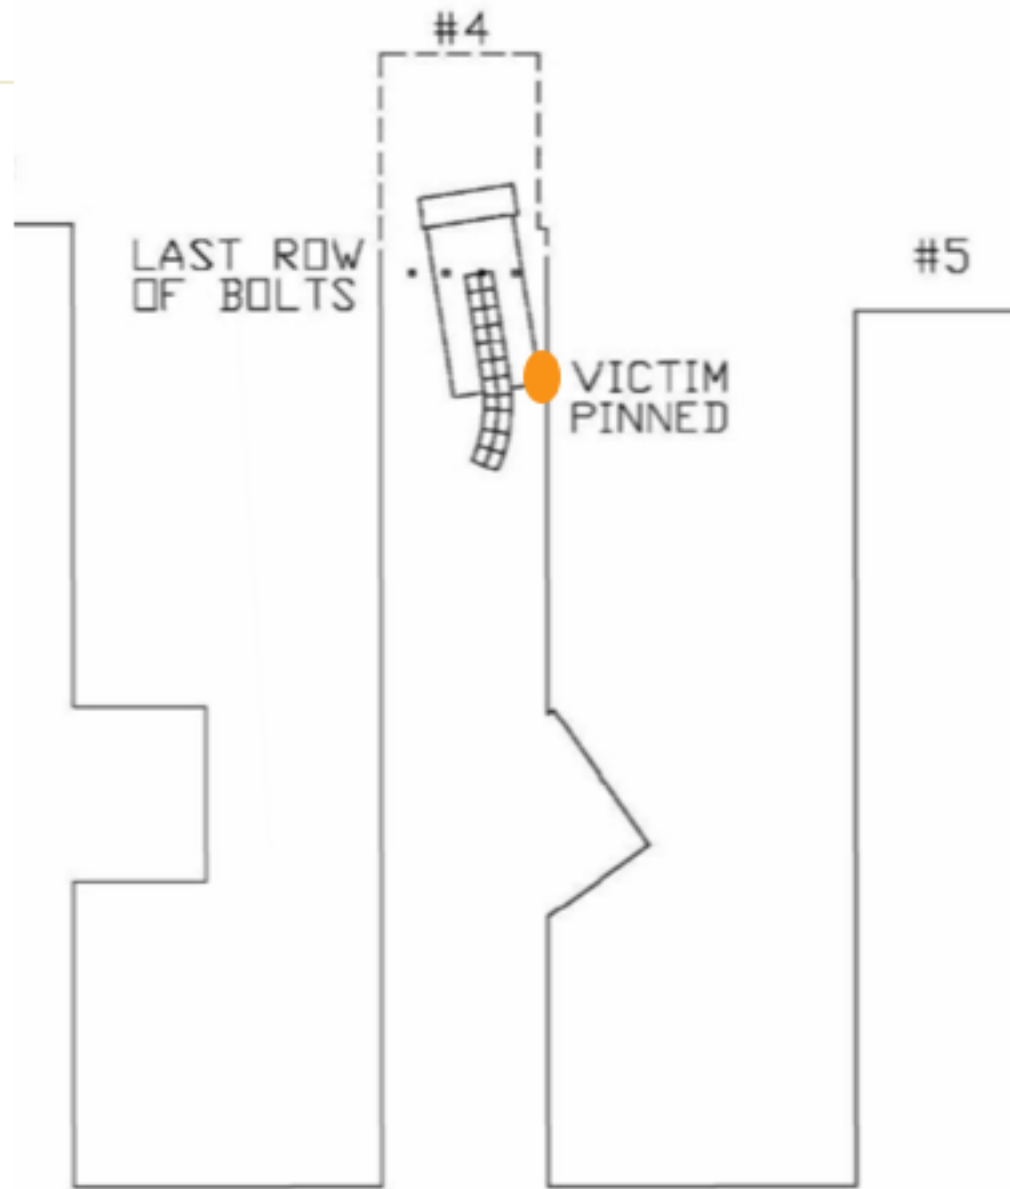
Case 5 - June 4, 2010

CM operator
crushed between
rear of CM and rib
while cleaning
floor.

Restricted visibility
was not a causal
factor.

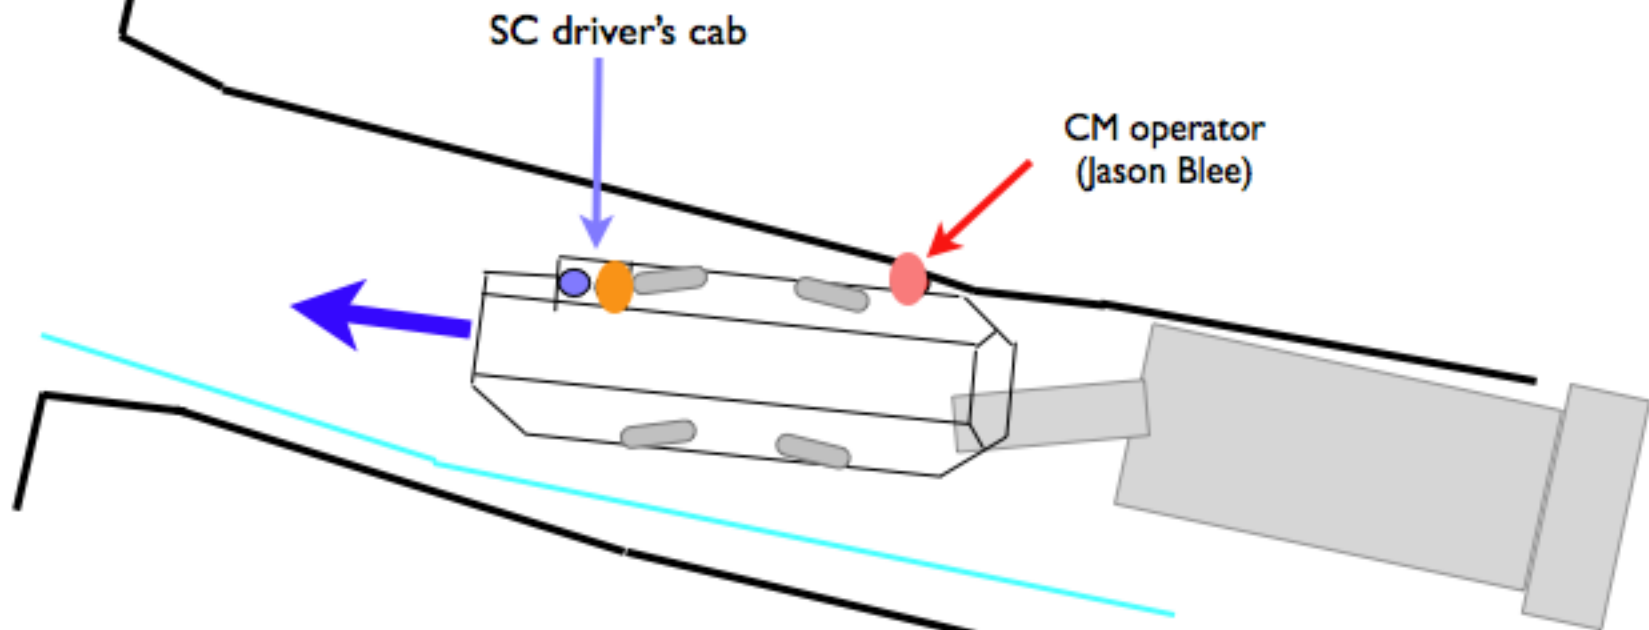
April 9, 2007 - Moranbah North

Following a mechanical fault on the continuous miner, Mr Blee walked to the shuttle car drivers cab and instructed the shuttle car driver to take the car to the boot end. Mr Blee was subsequently crushed between shuttle car and rib.

That coal mining operations and the Department (as the approval body) move quickly with manufacturers and other appropriate bodies to have developed, tested and approved proximity detection devices for use in underground coal mines to detect the presence of pedestrians in and around mobile equipment including shuttle cars.
