Light Vehicle Penetration Protection System

BHP Billiton – Cannington Mine

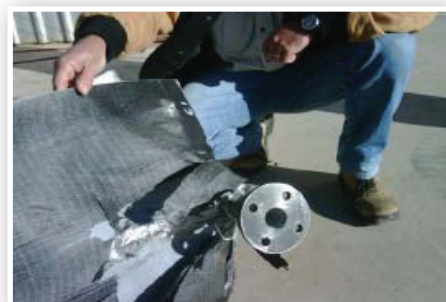
Figure 3: Post testing photos of the Kevlar panel still intact and the bent Split Set

Testing was completed on a combination of Kevlar sheets up to 8 millimetres thick. The test piece was held horizontally while a short length of rock bolt attached to a 200 kilogram weight was raised approximately 5 metres up inside a casing and released (see figures 2 and 3). This produced an impact speed in excess of 35 kilometres per hour, which is slightly faster than the speed underground vehicles are allowed to travel.

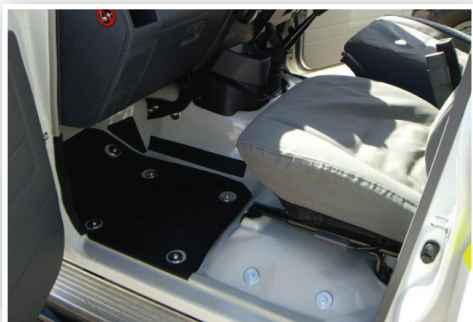
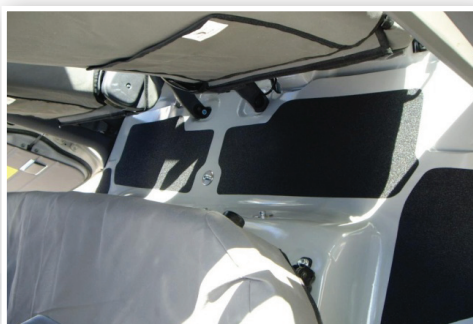
Figure 4: Completed wagon cut down

This engineering and installation project, initiated in response to penetration hazards, has resulted in the world-first floor penetration protection system being implemented at Cannington (see figure 4).
