## High-Voltage Electrical Flashover Prevention

### Downer EDI Mining

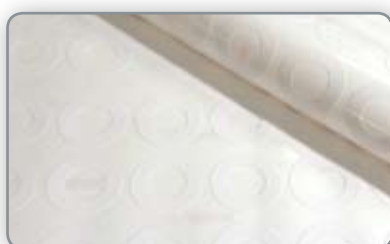
Image 1: Sheet of insulating vinyl stickers.

Elton approached electronic, electrical and mechanical suppliers, and even the manufacturer of the decals for Downer Mining vehicles for stickers, which were then tested by placing a high-voltage charge each side of them. Ultimately, it was the product from the provider of the decals that proved to have the ideal qualities.

The supplier was provided with a template of what was required, and the stickers were manufactured and trialled on a truck. When there was no flashover event on that particular truck following the next wet-weather event, the stickers were applied to all the diesel-electric trucks that had the potential for flashover events.

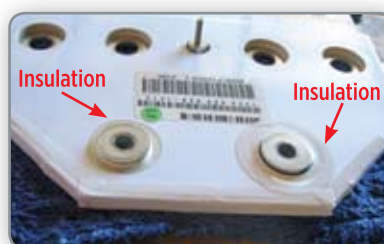
Image 2: Busbar showing insulating vinyl stickers in place.

- The initial response was to thoroughly clean all the busbars, and then use smoke bombs to ascertain where dust may be entering the cabinet. Damaged gaskets were replaced, and Silastic2F3 was used to seal any leaking seams.
- Secondly, silicone desiccant gel bags were placed inside the inverter cabinets to absorb any moisture inside the cabinet.
- When neither of these proved effective in preventing the flashover events, attention was turned to the area of the busbars on which the dust was accumulating. Through research and some very innovative thinking, Downer Mining Electrical Superintendent, Elton Cousins, formulated a solution using insulating vinyl stickers. This is illustrated in Figure 1.

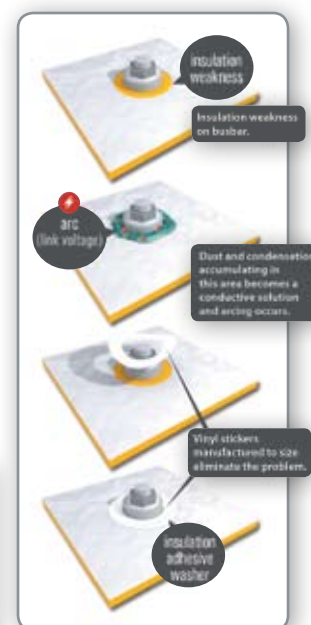
Figure 1: Eliminating the insulation weakness on the busbars.

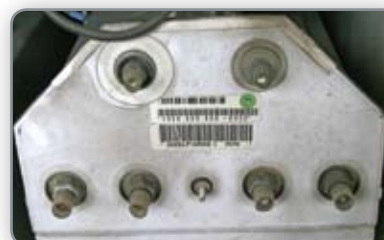
Image 3: Busbar with Downer Mining insulating vinyl stickers.

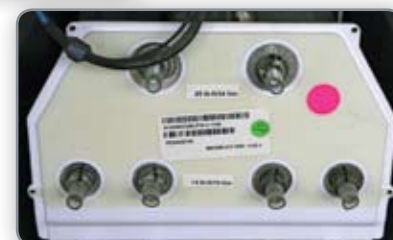
Image 4: New busbar produced by manufacturer with modified design.

The transferability of this innovation has been proven by the fact that the manufacturer of the busbars has now modified its design, incorporating the insulating vinyl stickers, (see below) and is trialling them across other sites.
