## Caterpillar 24H Motor Grader Rear Window Access System

### New Acland Coal

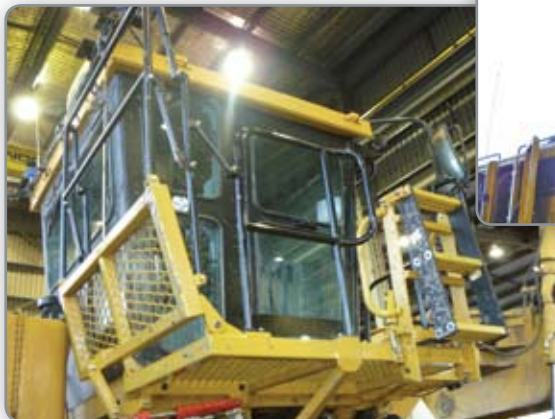
Picture 1  
Rear access platform in the 'raised' position.

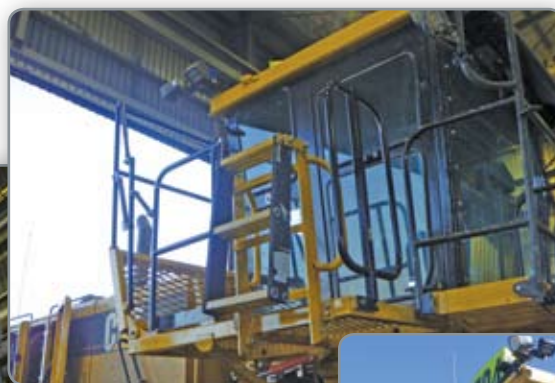
Picture 2  
Rear access platform and emergency egress steps in raised position.

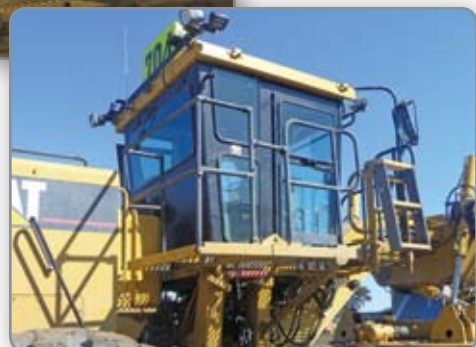
Picture 3  
Access platform in the deployed position.
