Carbon Fibre Shuttle Car Collars

Xstrata Coal Queensland – Newlands Northern Underground

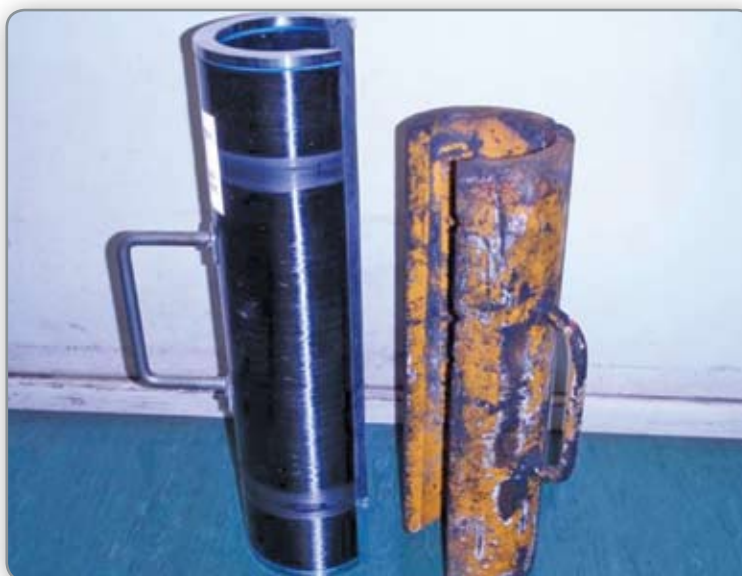
- The project team had a carbon fibre version designed and manufactured.
- The new collar weighs approximately 3kg and is rated to 12.5 tonnes as per the current steel collar.
- This rating is in accordance with half the weight of the shuttle car.
- End users of the innovation were consulted in the design and testing of the collar, with positive feedback received throughout the design and implementation process.

- Extensive trials were conducted on the collars, which involved destructive testing.
- In the initial trials, the collars didn't fail, however the layers began to separate (and this has since been rectified).
- The collars are rated to 12.5 tonnes, however the destructive testing was taken to 75.0 tonnes without complete failure.

- The carbon fibre collars are approximately 3kg (an 11kg reduction from the original version) and greatly reduce manual handling issues.
- As a result, the risk of strain and sprain injuries is minimised.
- The carbon fibre collars are easier and more efficient to apply and reduce the time that fitters will be in a hazardous zone underneath the shuttle car.
- This reduces the risk of a crush injury.
