# The One Constant: HEALTH & SAFETY

# **REDUCING THE RISK OF UNCONTROLLED MOVEMENTS FOR ROAD GOING VEHICLES USED IN MINING OPERATIONS**

## SPRING APPLIED HYDRAULIC RELEASE

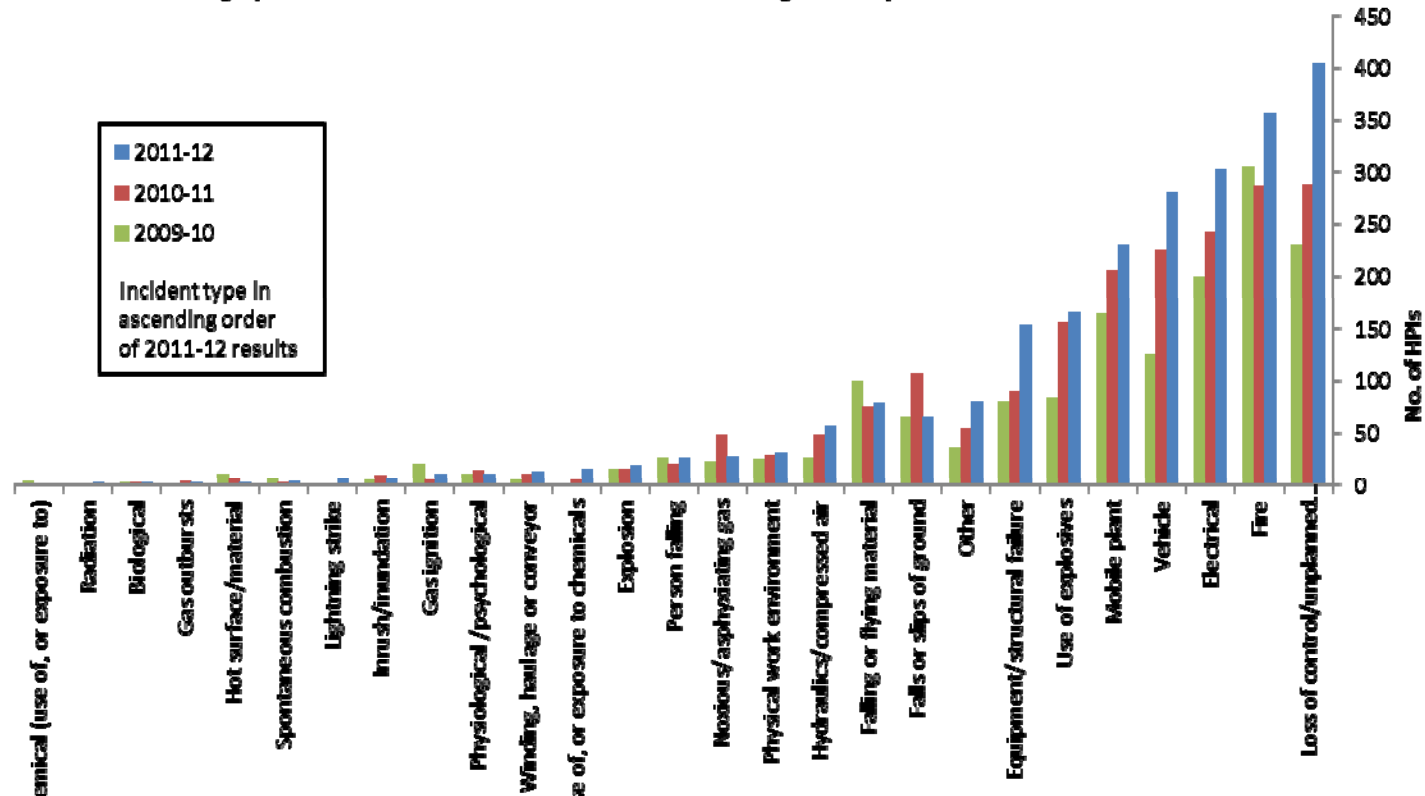
High potential incidents in the Queensland mining industry 2009-12

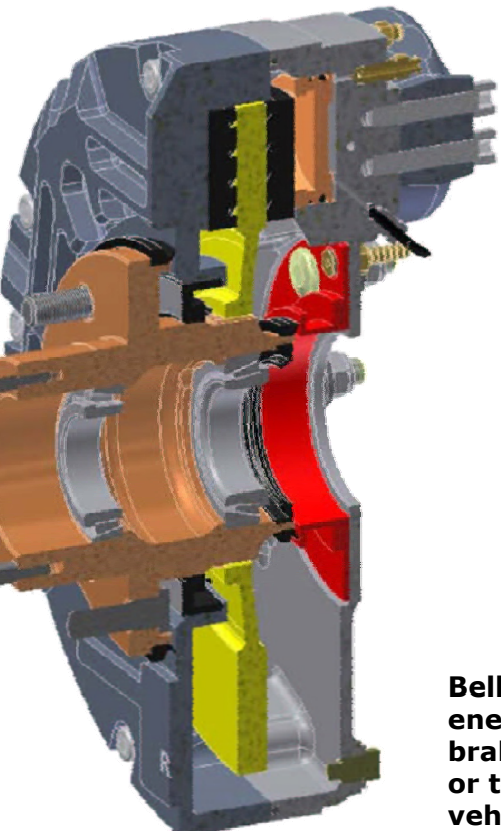
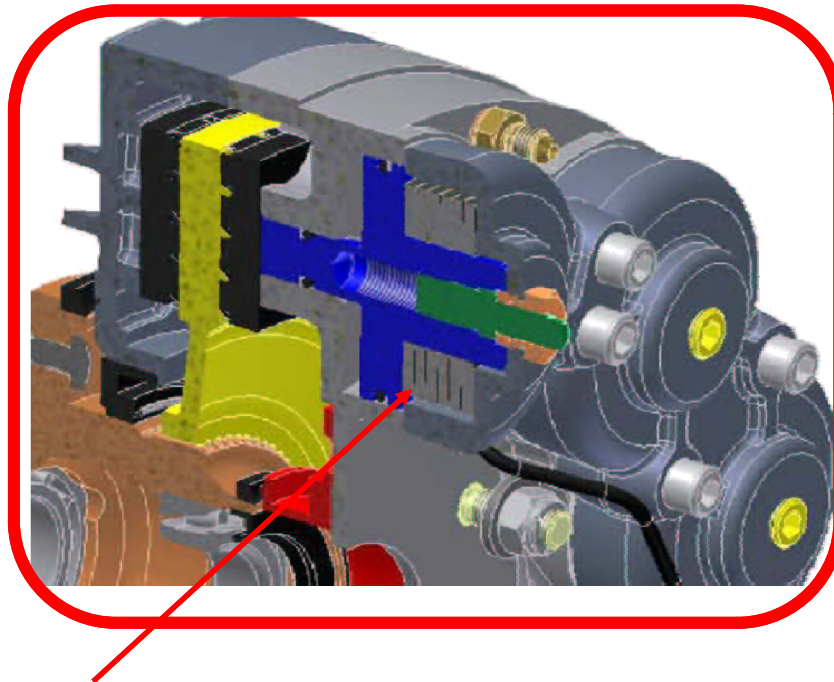
**Bellville Springs provide an autonomous energy source to mechanically apply brake either in an emergency situation or to park the vehicle ensuring the vehicle is always fundamentally stable**

1. Automatic fail safe spring applied hydraulic release (SAHR) brake
2. Operator applied emergency brake
3. Integrated park brake to ensure full and automatic brake application through selected interlocks
4. Reliable braking in all conditions

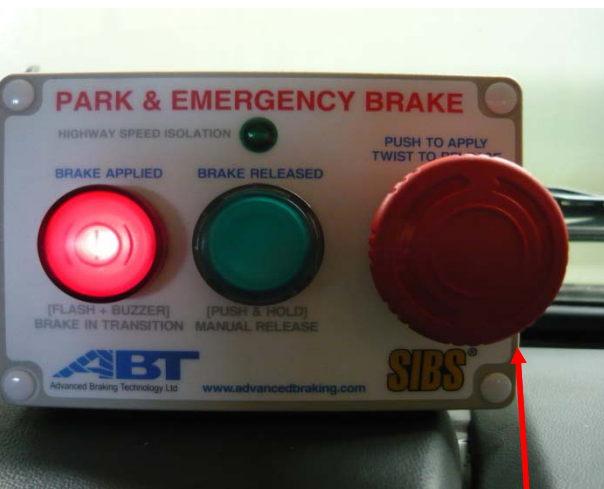
**Operator Applied  
Emergency Brake**

### Operator Interface

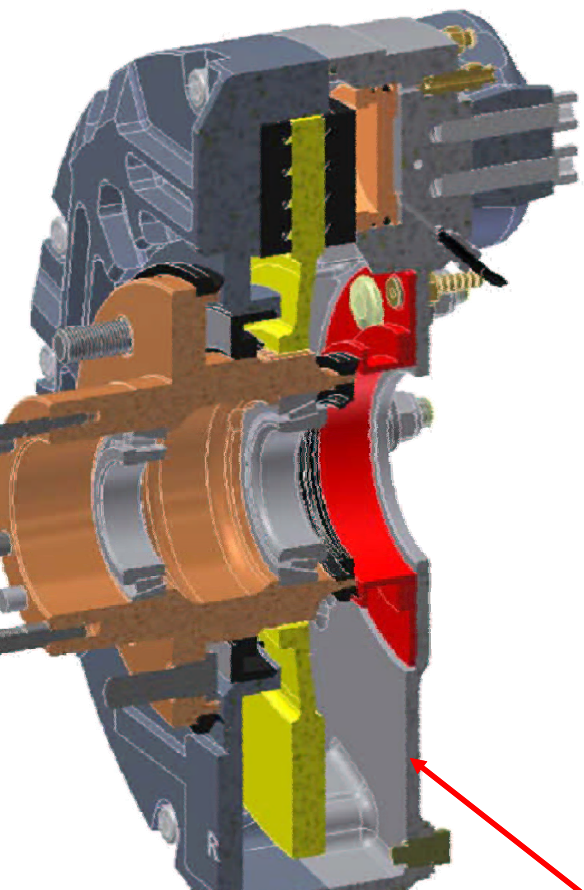
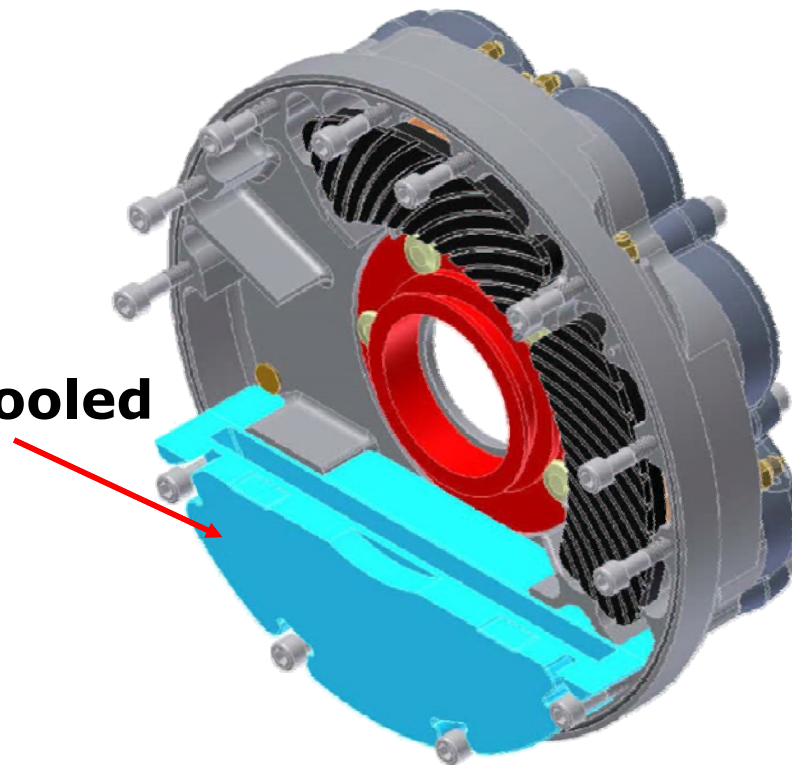
**Oil Cooled**

## RELIABLE BRAKING
