DRAGLINE TUB MAINTENANCE CAPSULE

Steve Kovac – GM Operations & SSE
Laurie Stanton – Maintenance

Dragline Tub Maintenance Capsule

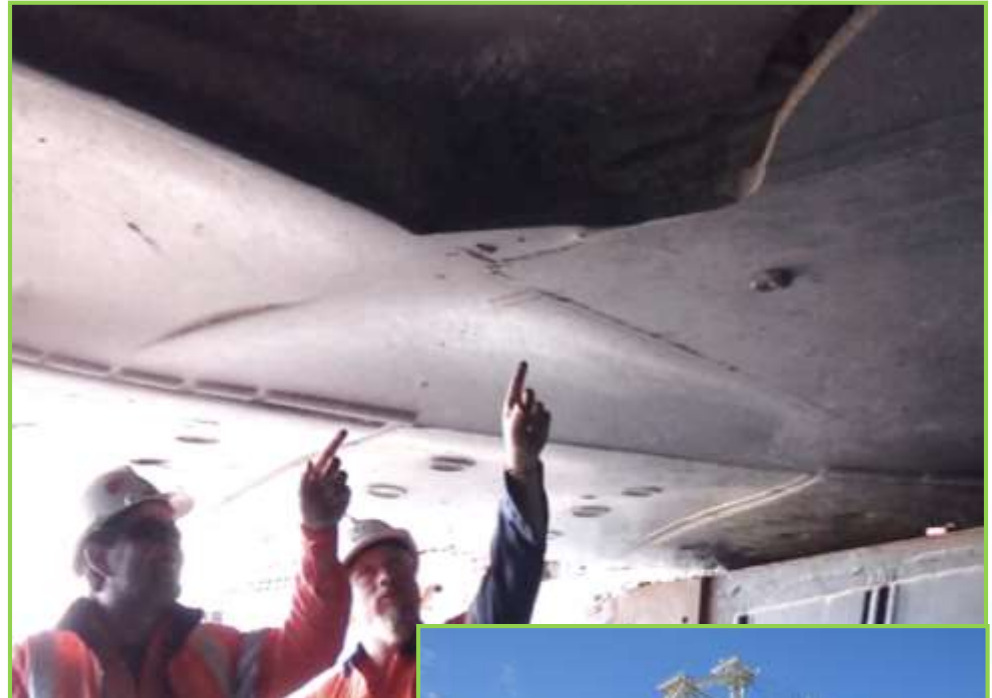
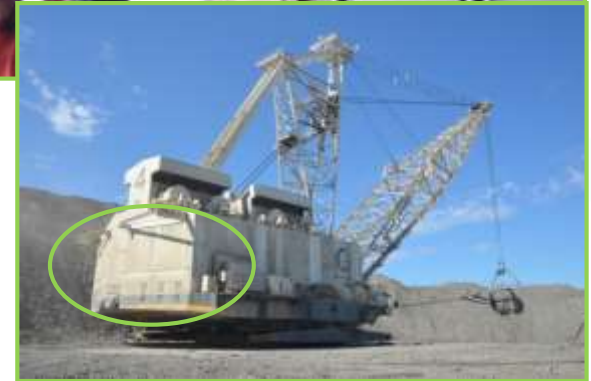
Inspections identified a number of tub floor plates failing due to wear on Dragline 1.

Image of damage to tub plates

Repairs would need to be undertaken over a number of small shutdowns to minimize production delays.

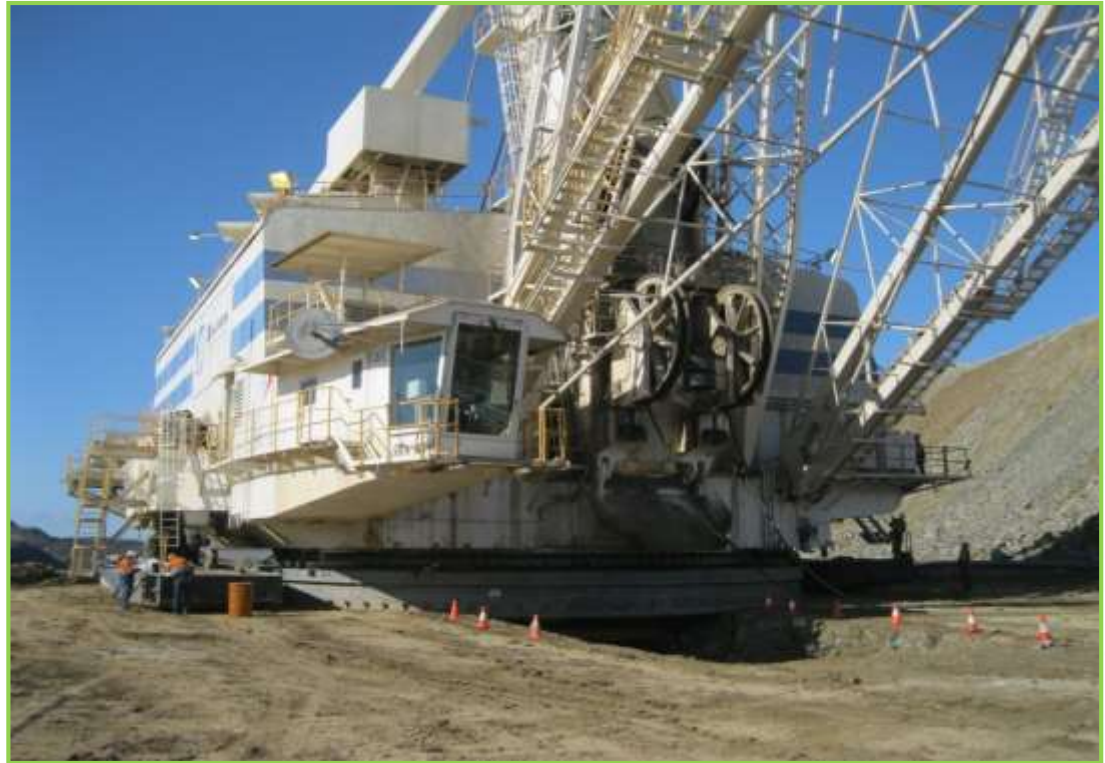
Potential for trench wall collapse in unstable strata areas.

Image showing trench relative to the size/position of the dragline.

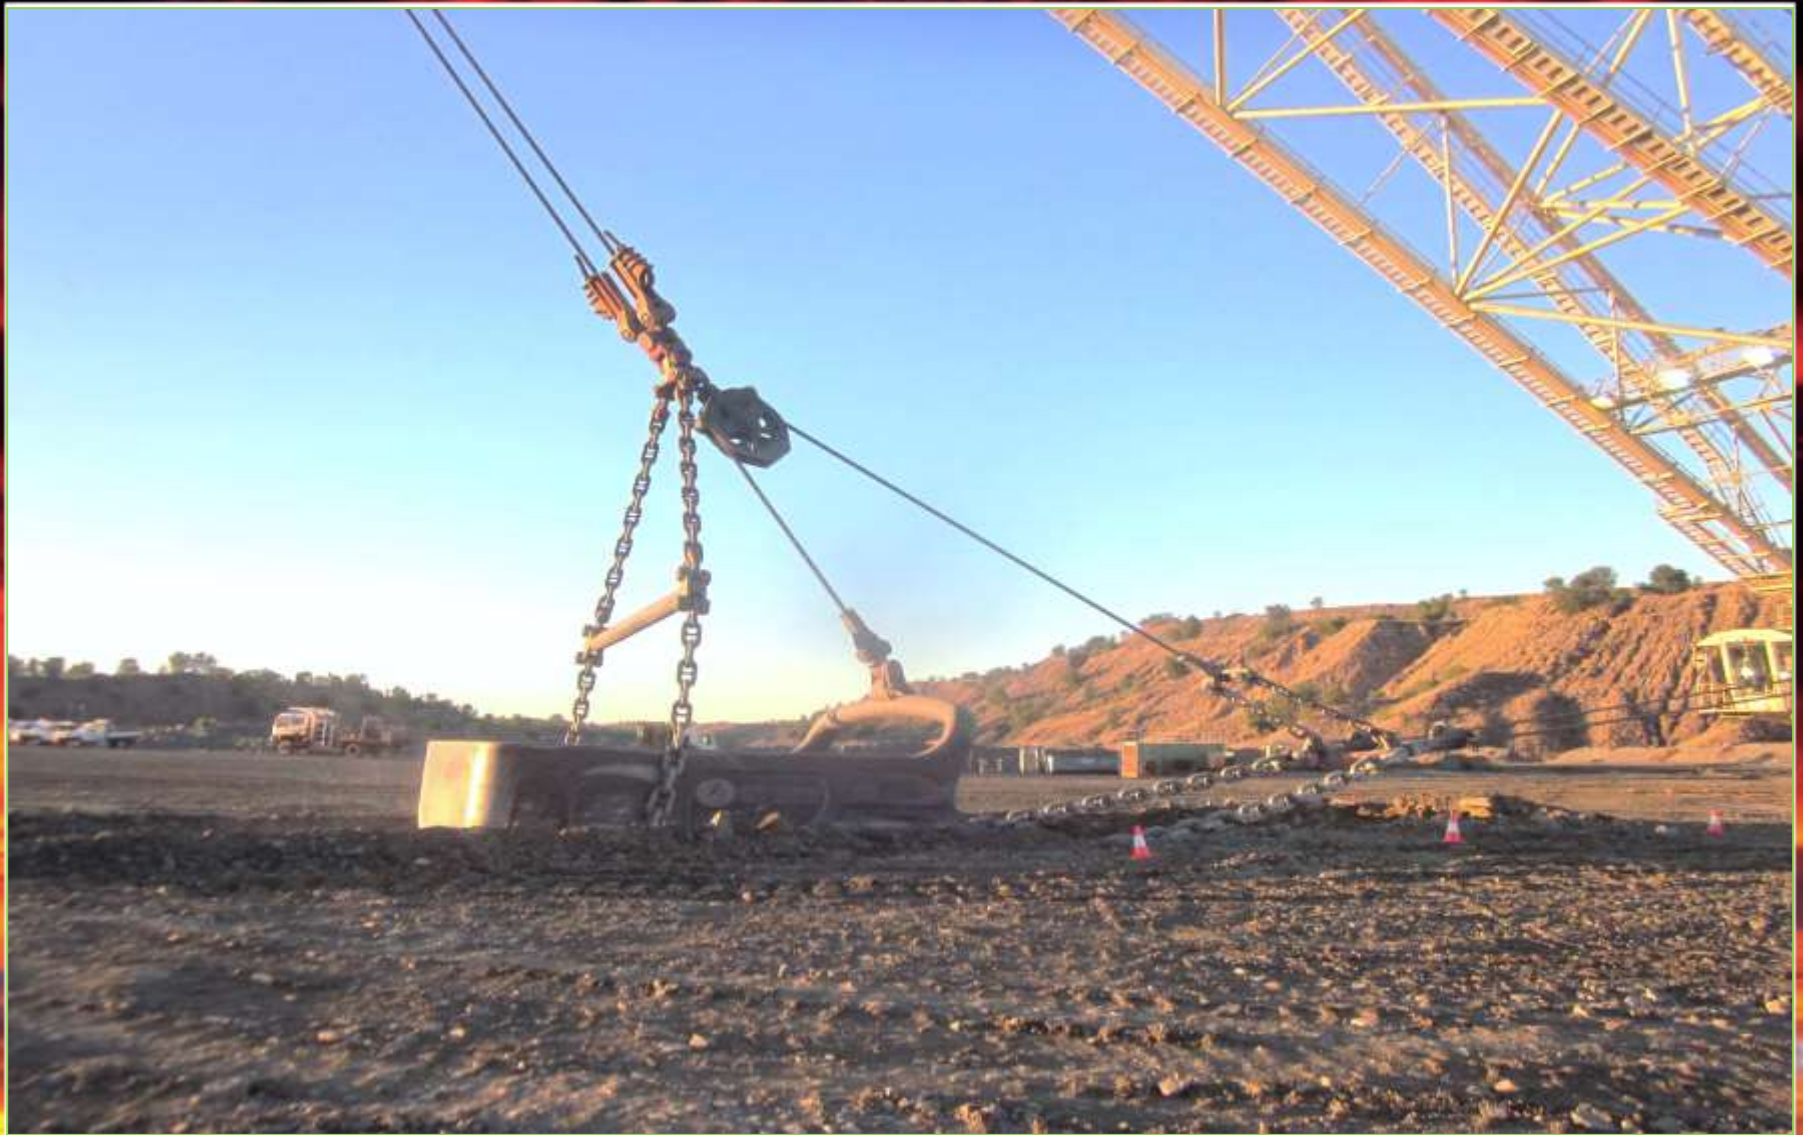
Dragline preparing trench

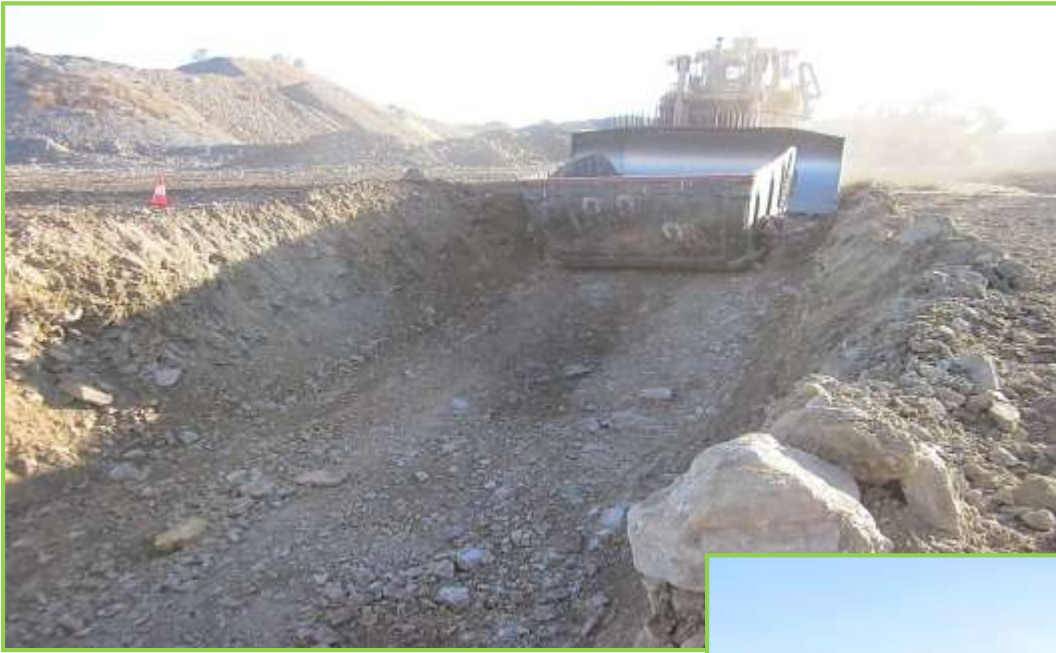
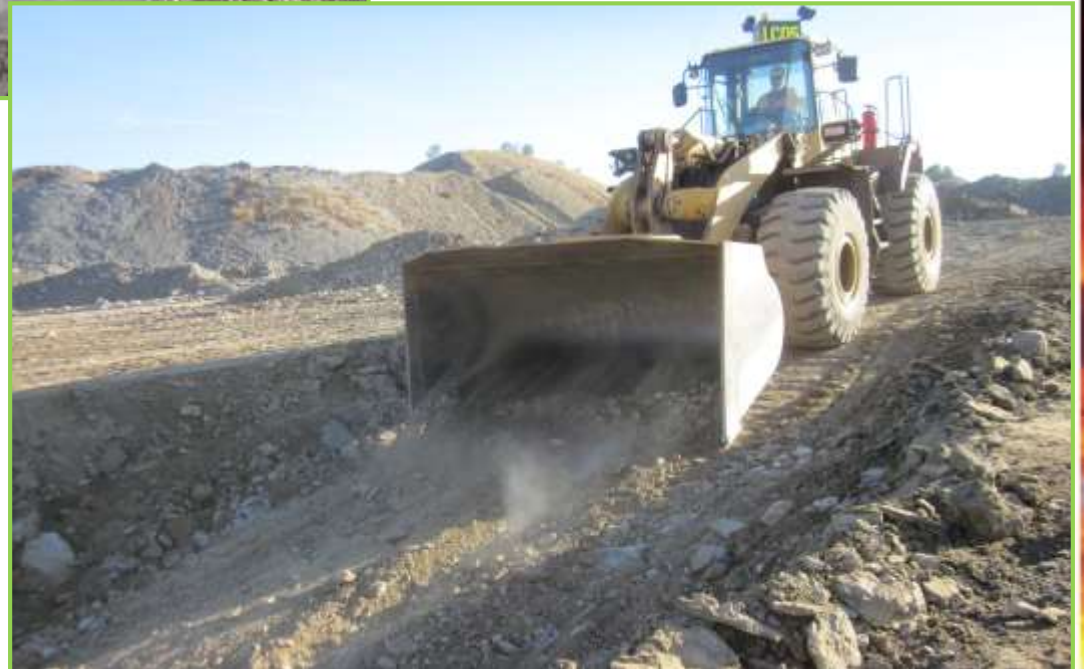
Positioning capsule

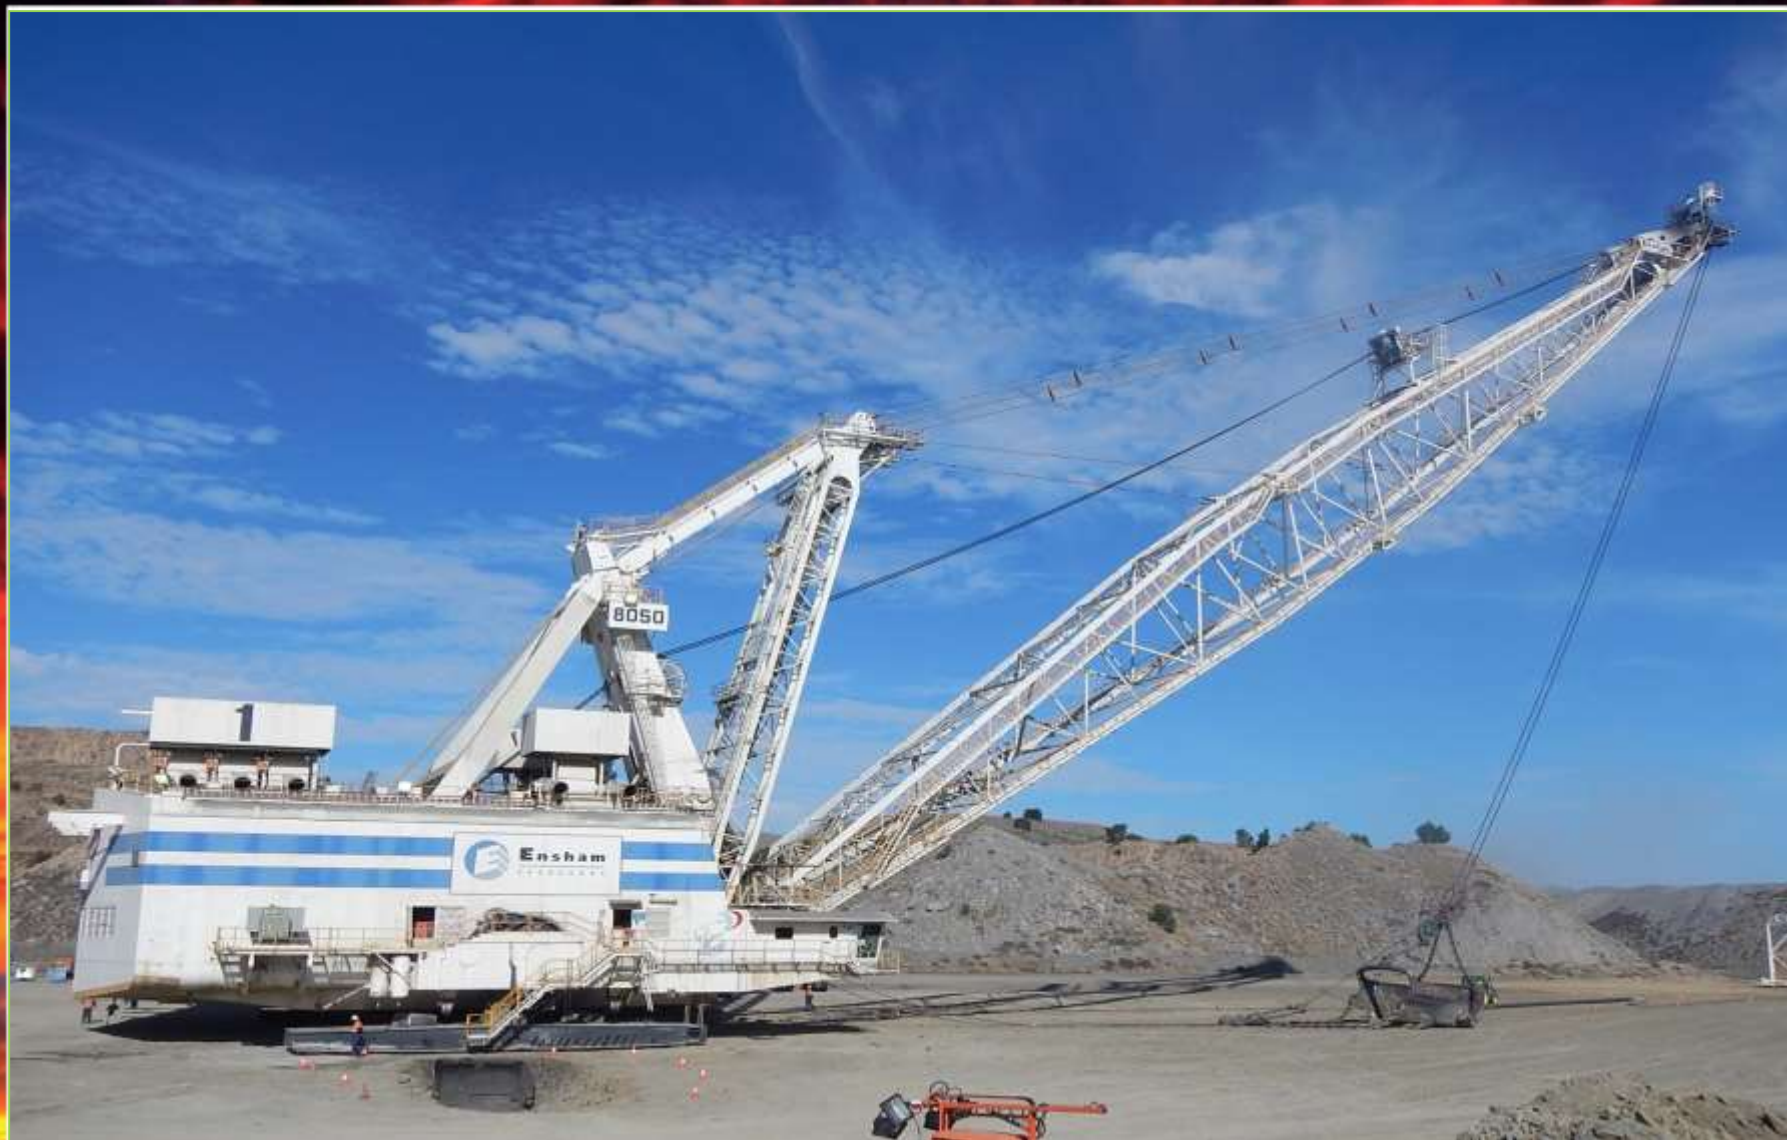
Dragline Positioning

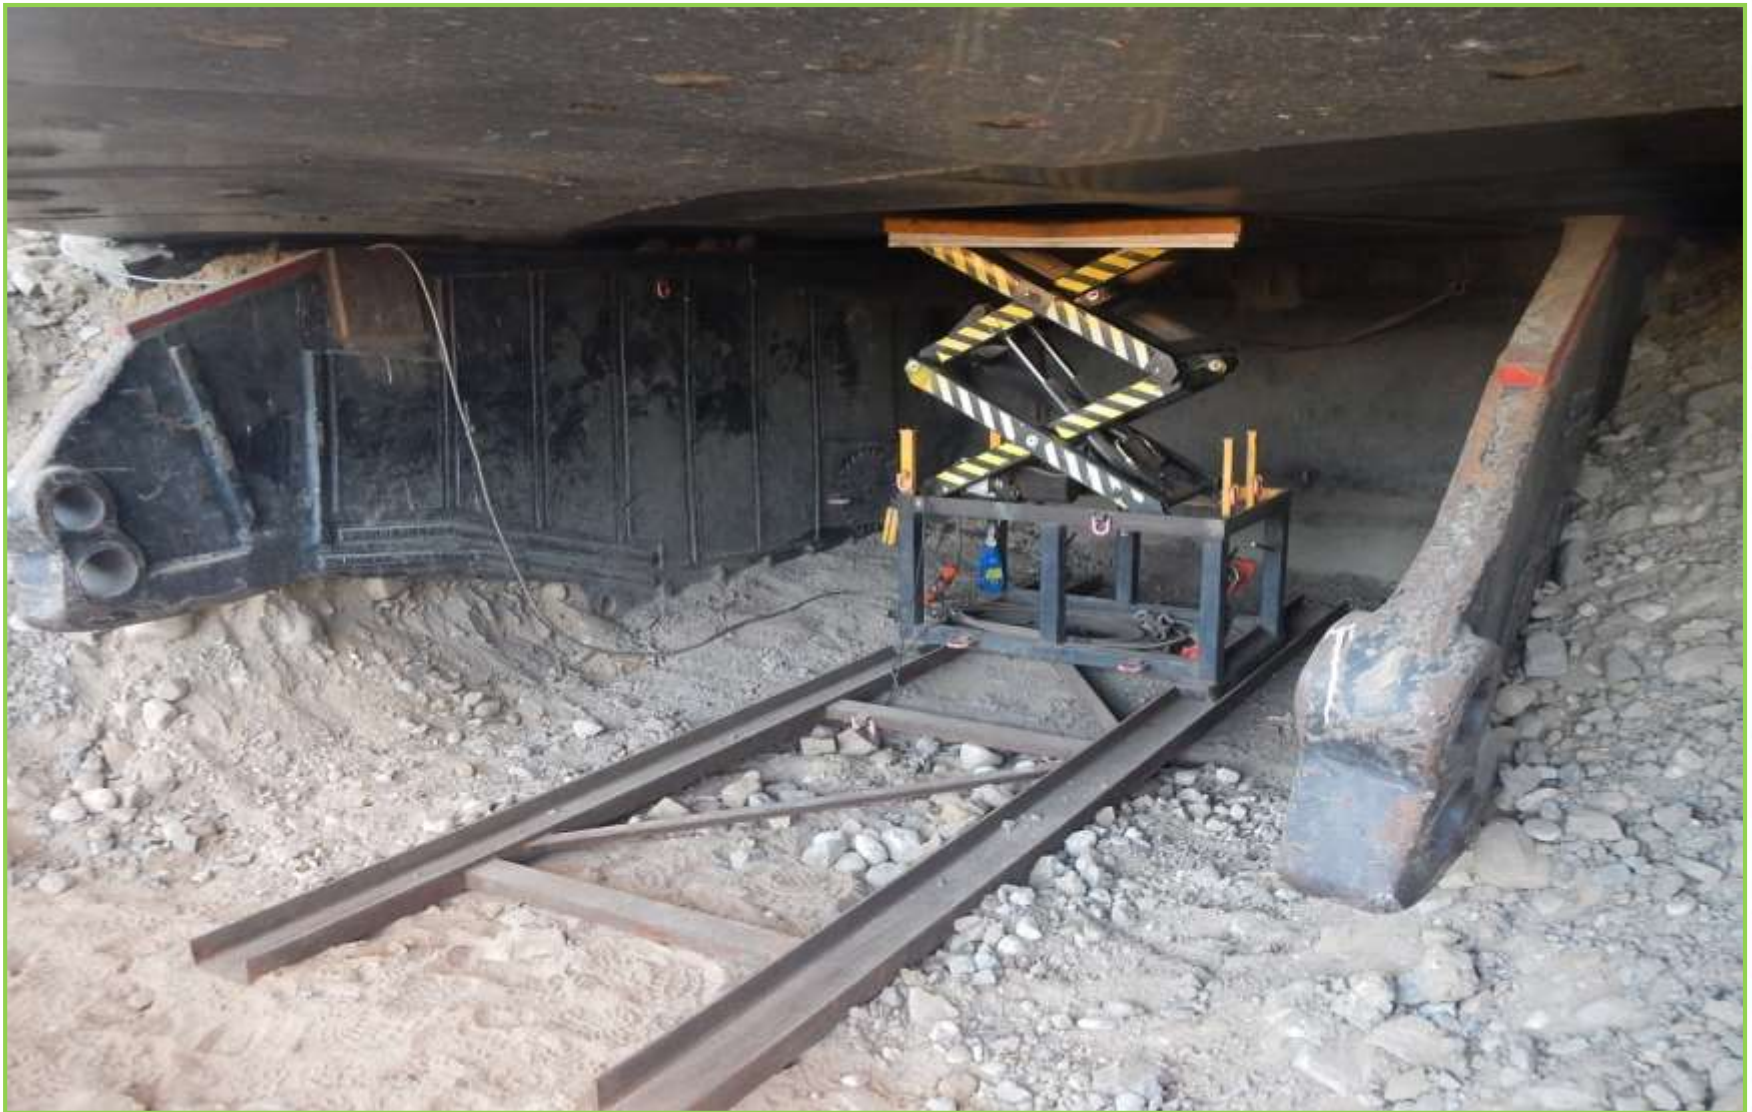
Capsule in place with mechanical aids

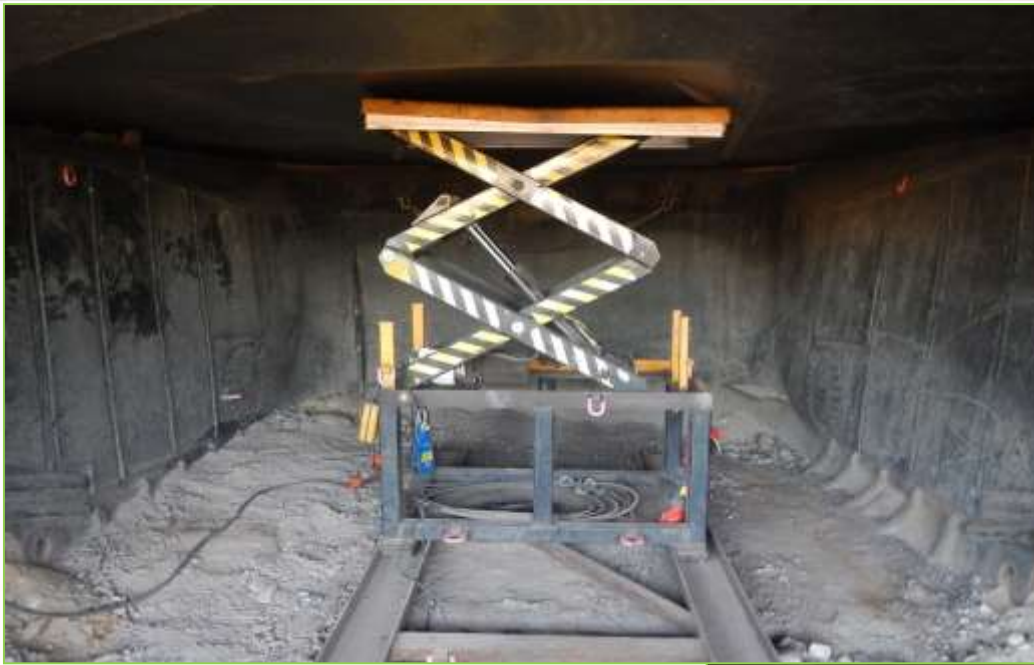
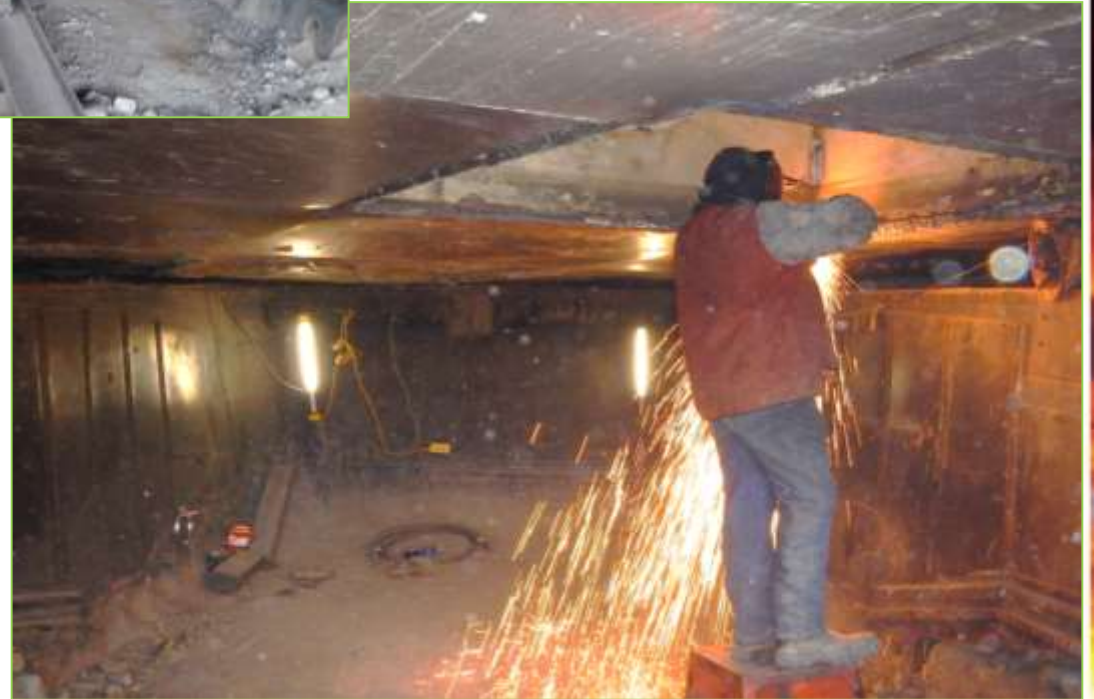
*In position
protecting workers*

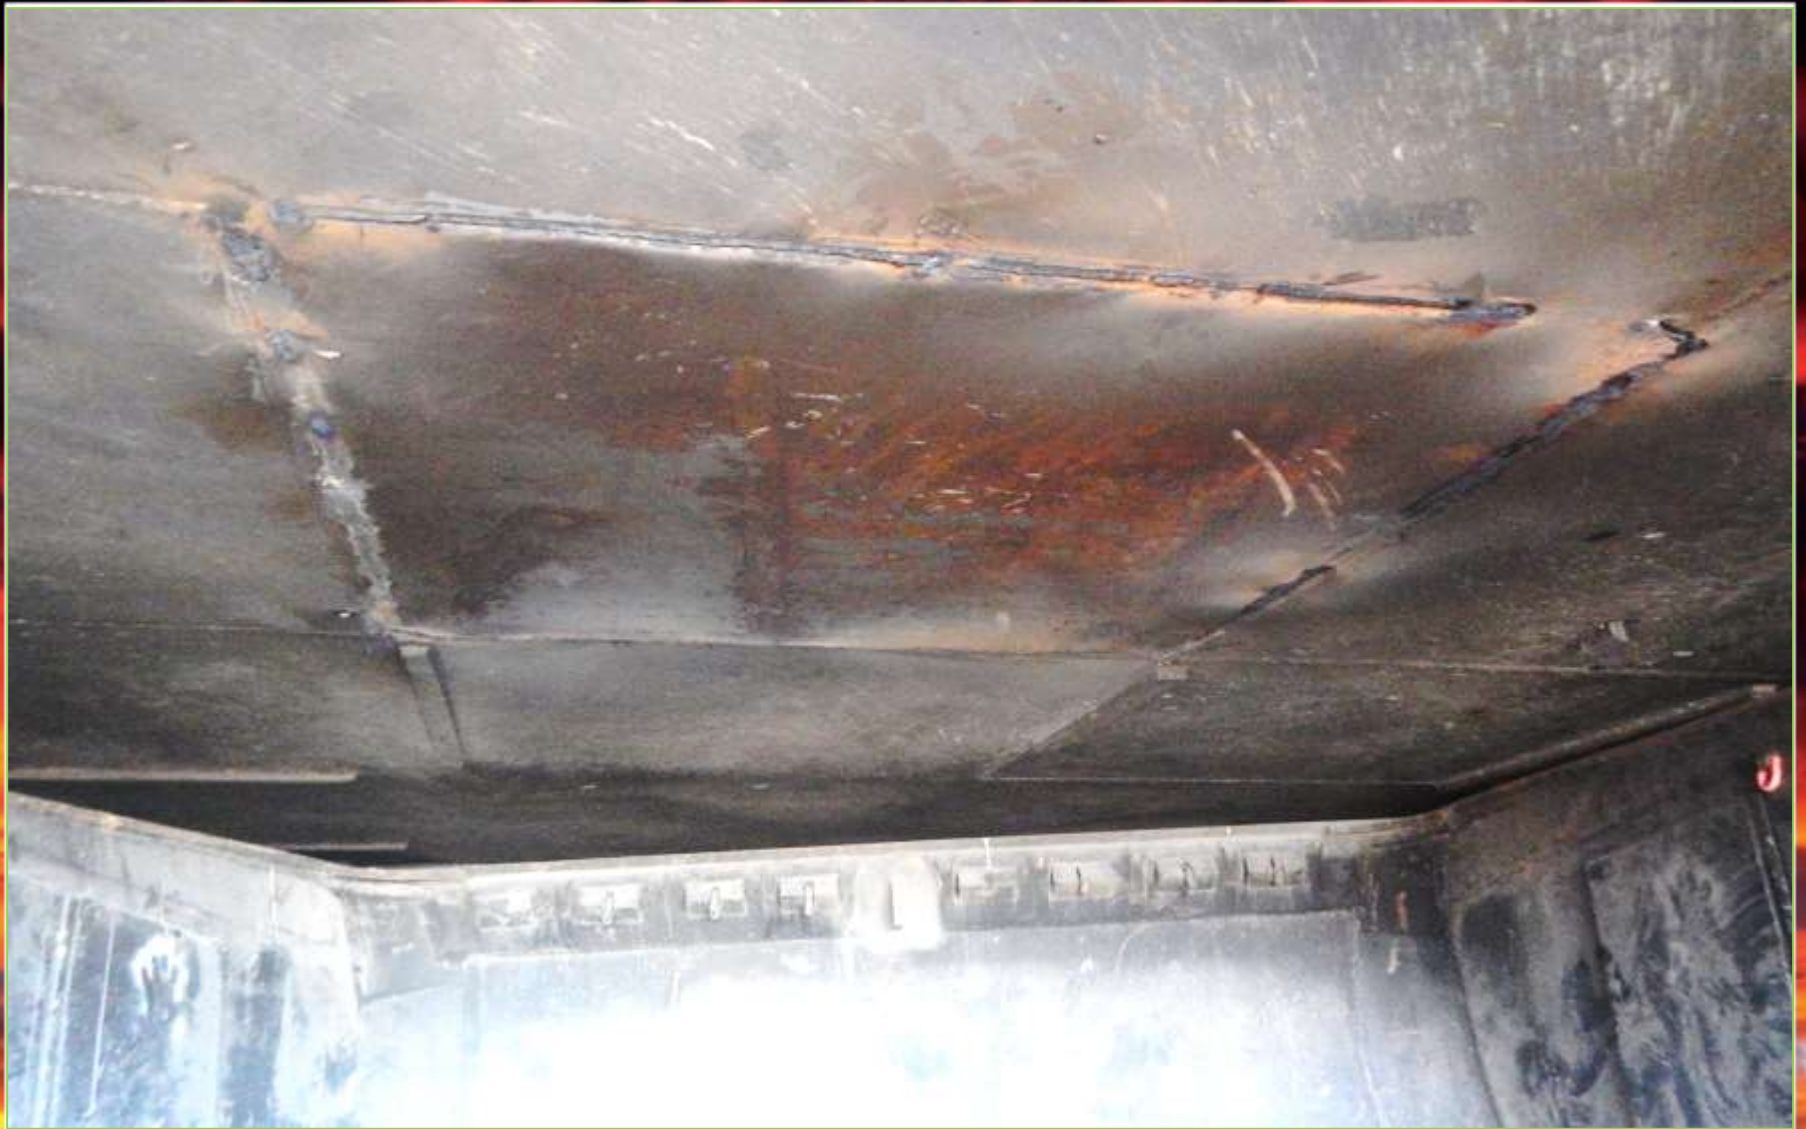
Completed repairs

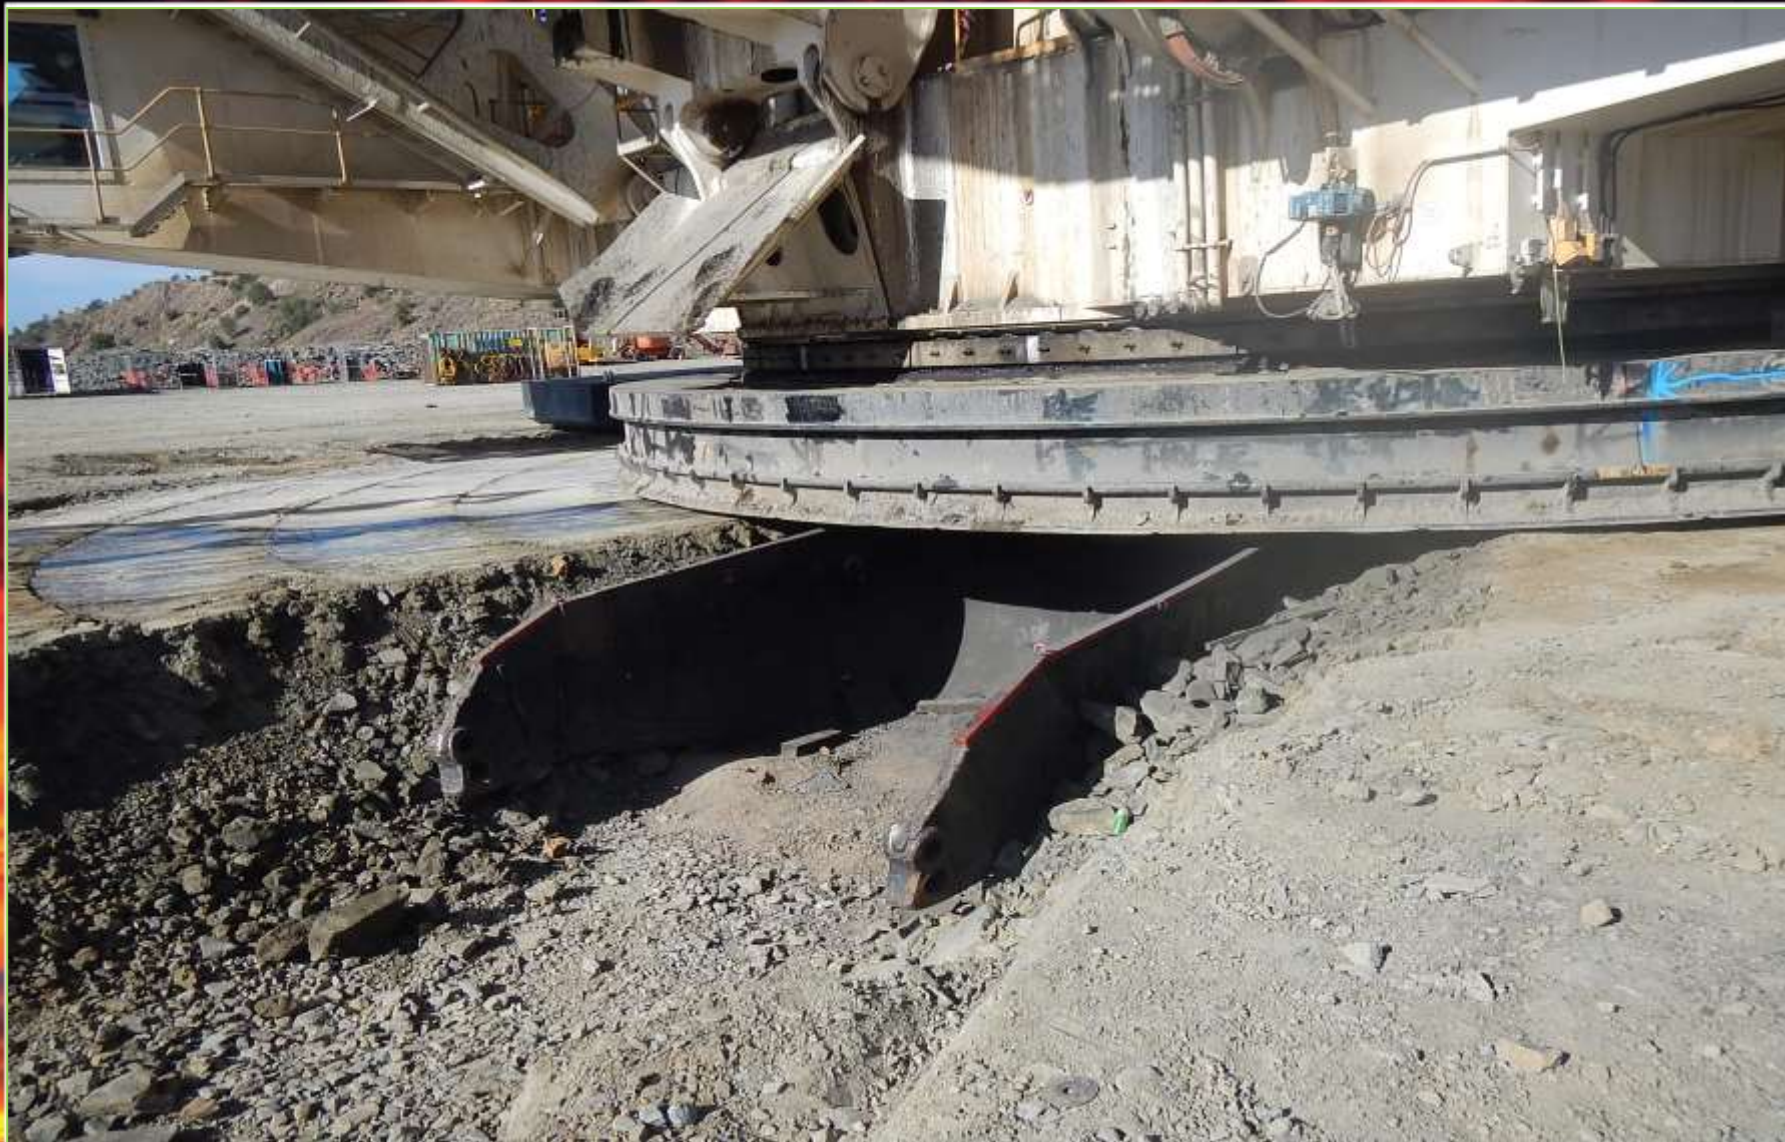
***Dragline walking off after repairs
(note ground compression)***

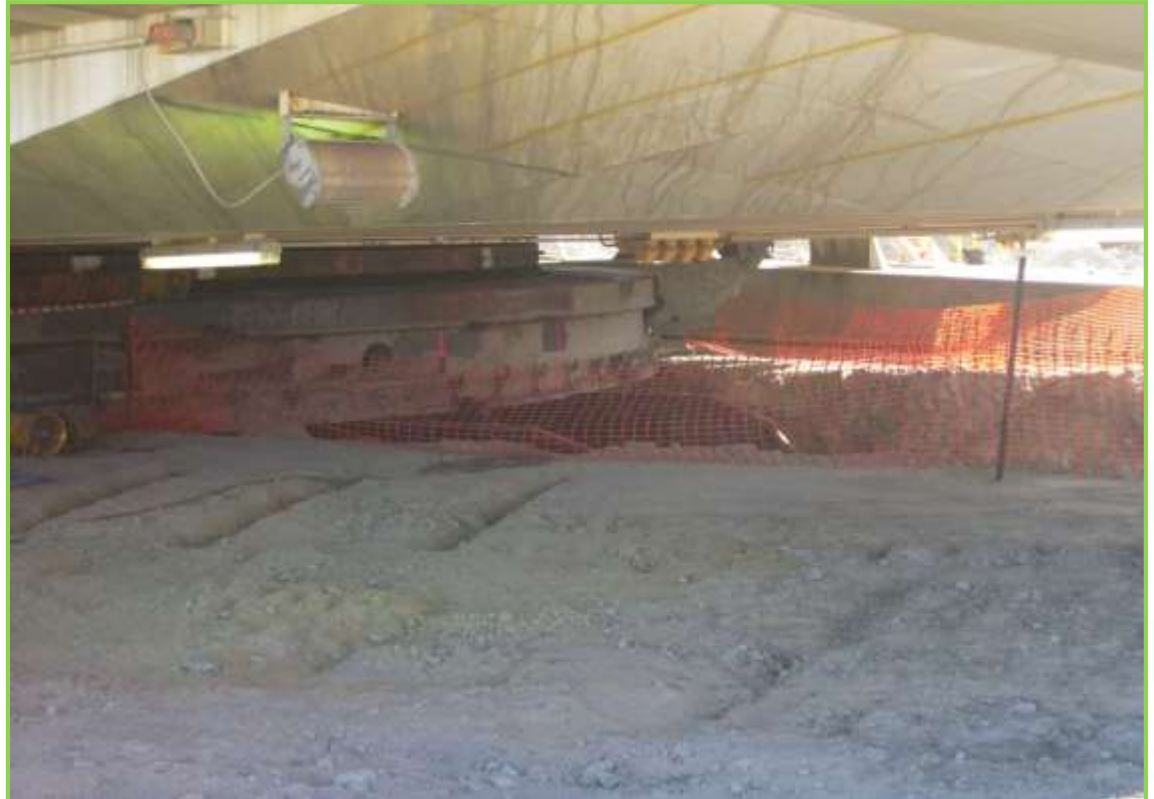
*Image of maintenance day in progress.
Capsule in position.*

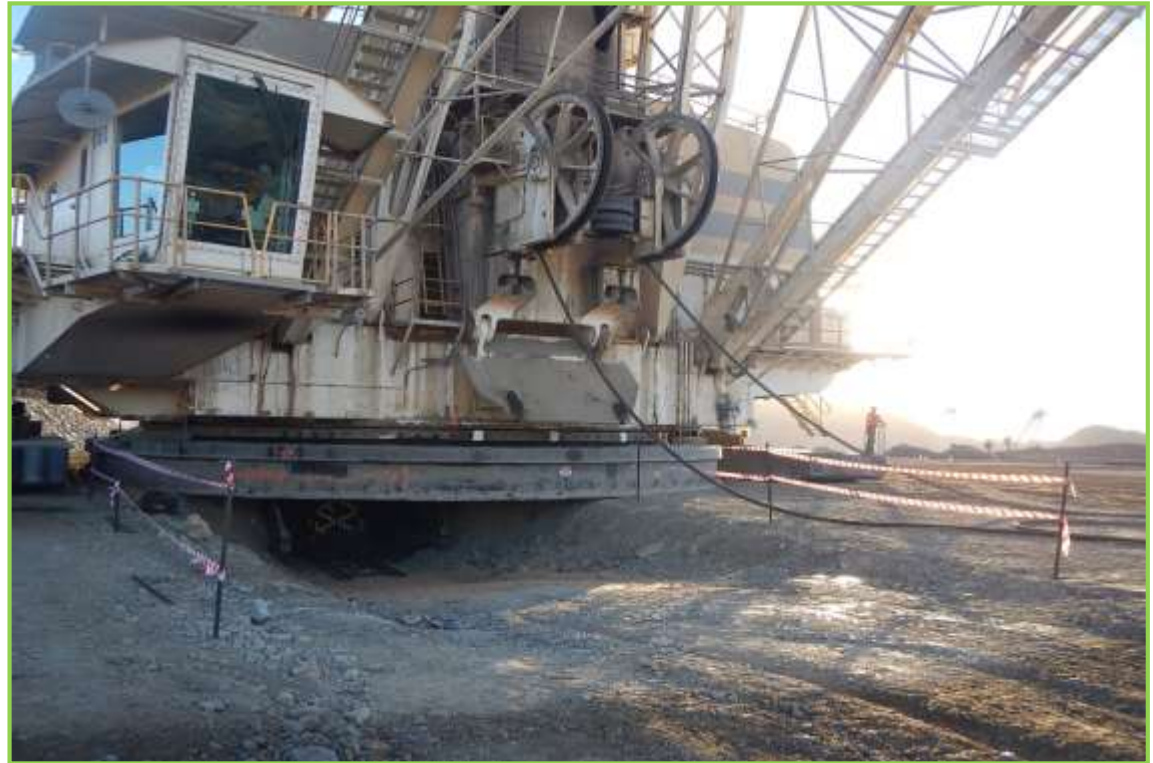
Image of capsule in place under dragline during set up

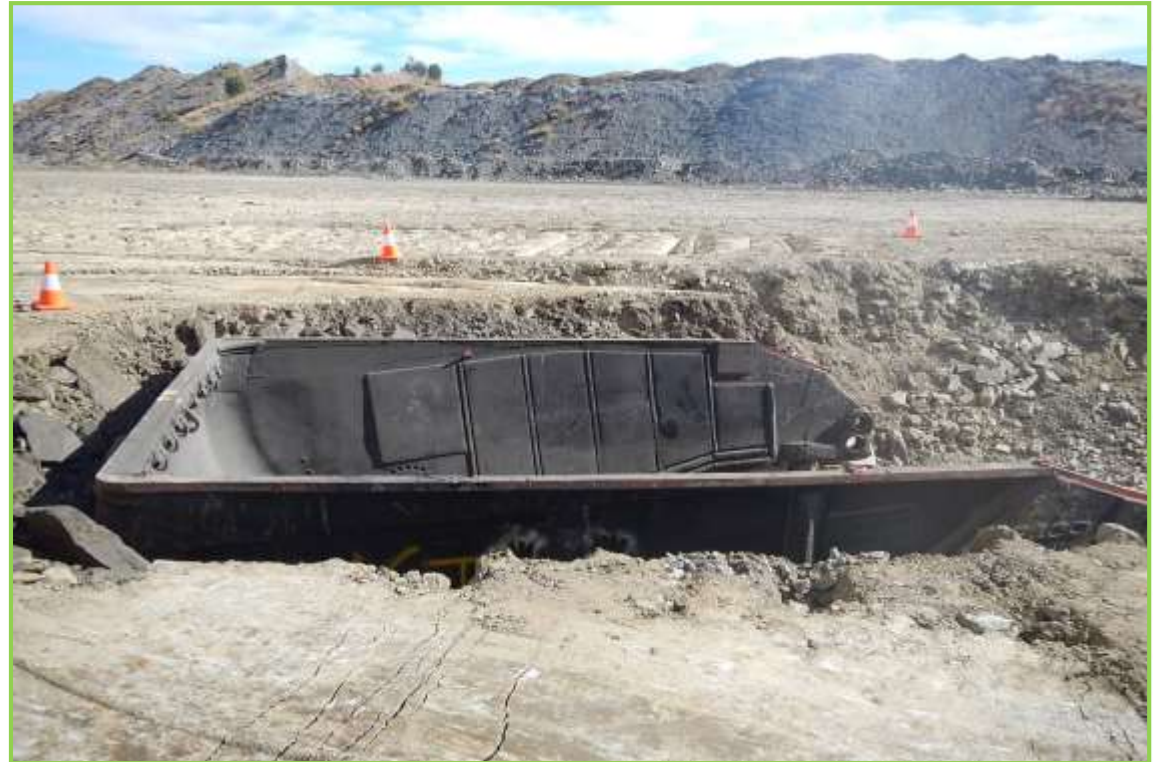
Image of capsule after works completed and dragline has walked off.
