Pulley String Catcher

The Problem

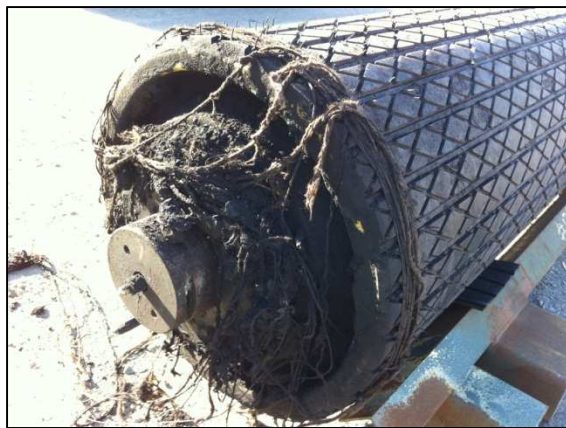
It was identified that over a period of twelve months, there were seven of the same failure modes on the loop take up pulleys on the longwall panel belt. An excessive buildup of string (as in Figure 1), from the edge of a damaged conveyor belt, had wrapped itself around the end of the pulley and worked its way into the labyrinth seal. This resulted in bearing failures and having to change the pulleys out.

FIGURE 1: Buildup of string on pulley

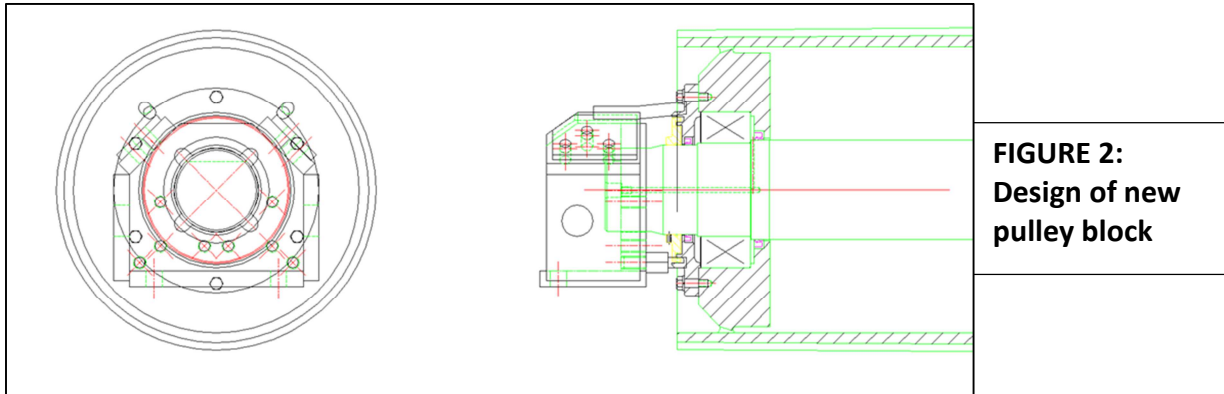
The original conveyor pulley block design didn't allow for visual inspections to check for sufficient lubrication in the labyrinth seal and string build up on the shaft. The conveyor had to be isolated and guards removed to conduct these inspections.

The design was reviewed by the conveyor engineer, and after consultation with the conveyor engineering team, a new design was created. A change management proposal and a risk assessment were prepared for the new design – the ‘pulley string catcher’. This could be used for visual inspection of string build up and lubrication of the labyrinth seal, without isolating the conveyor. The device had also been shaped to catch the string before it has the chance to enter the labyrinth seal, thus reducing the number of pulley change outs required. The new design was sent to an external source for engineering checks and manufacturing.

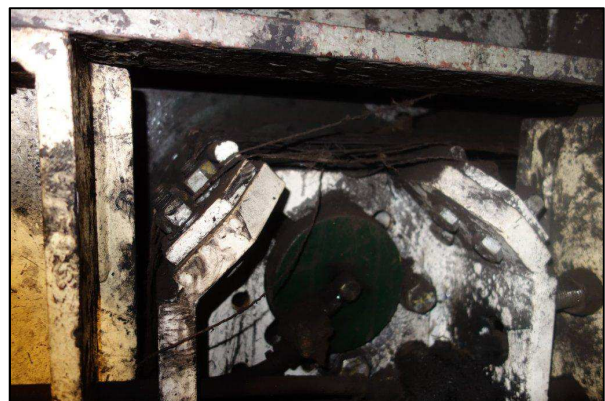
FIGURE 3: String gathering on 'pulley string catcher'

Since the 'pulley string catcher's' have been implemented there has been no buildup of string around the pulley shaft and improved monitoring of pulley lubrication. The expectation is that the conveyor string from the belt will be captured on the catchers and this will be removed prior to it damaging the pulley seals. With the improved monitoring of the sealing arrangement there have been no events where the conveyor has been required to be stopped to rectify issues.

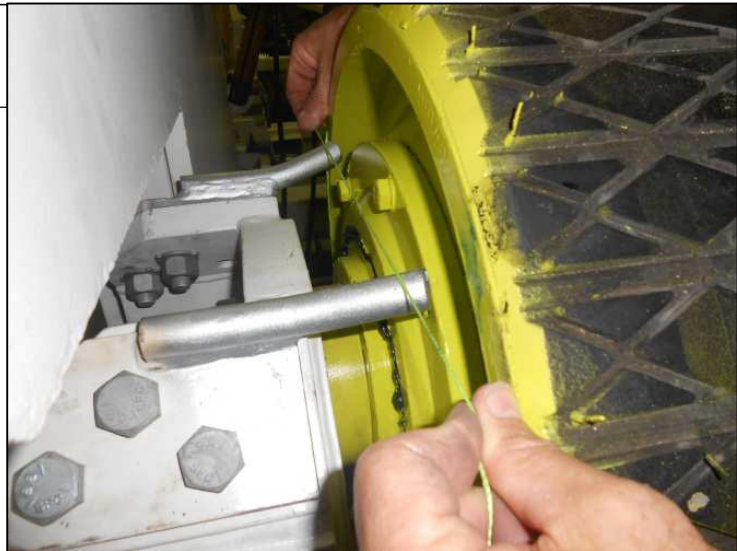
FIGURE 4: Pulley blocks being set up

The purchase and supply of the 'pulley string catchers' for all conveyor pulleys on the next longwall belt have already arrived on site and installed. The catchers are fairly straightforward to manufacture, transport and install. The design could easily be adjusted to suit another conveyor system.

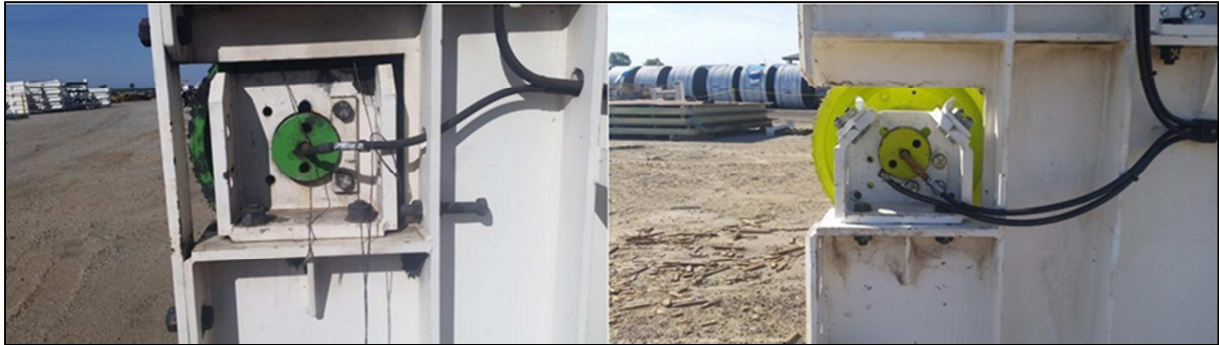
FIGURE 5: Before and after set up on the small diameter pulley in the LTU

The pulley block has been specifically designed to simply retro fit out the existing pulley carriers. They also allow for safe and effective visual inspections, whilst the attached barrier device captures any string that may be dangling from a damaged belt. Overall, this new design improves the safety of the coal mine workers by reducing exposure, improves maintenance of the pulleys by allowing uncomplicated visual inspections and reduces the mine production downtime.
