Shuttle Car Cable Reel Interlock Valve Anglo American – Grosvenor Mine

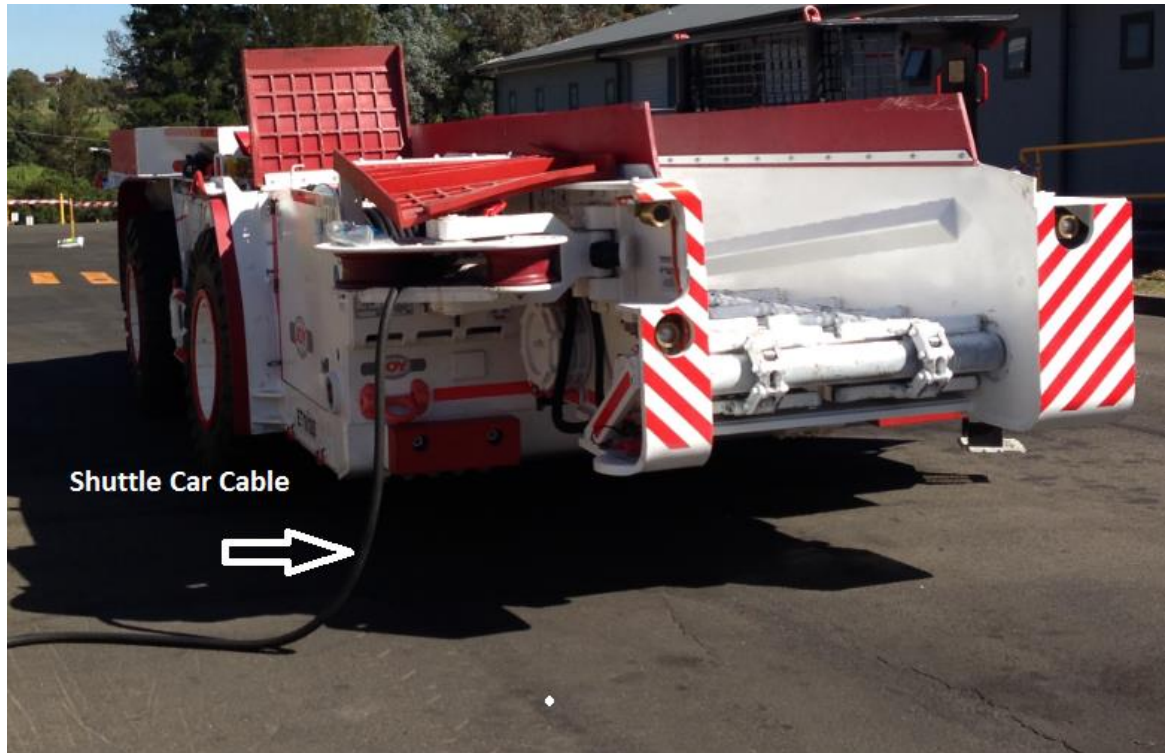
Image 1: Shuttle Car Cable

A known hazard for all underground coal mines operating shuttle cars in the development panel, is the possibility of the cable damage due to being run over by the car itself, which in turn results in cable failure with the potential of an arch flash occurring a flammable gas rich environment.

Shuttle Car cable damage has been experienced at Grosvenor in the past 12 months due to 2 root causes being,

1. Loss of Hydraulic pressure to the cable reel resulting in the cable not being reeled in when traveling towards the cable.
2. Cable reel failing to rotate due to coal build up, cable jam, component failure, etc.

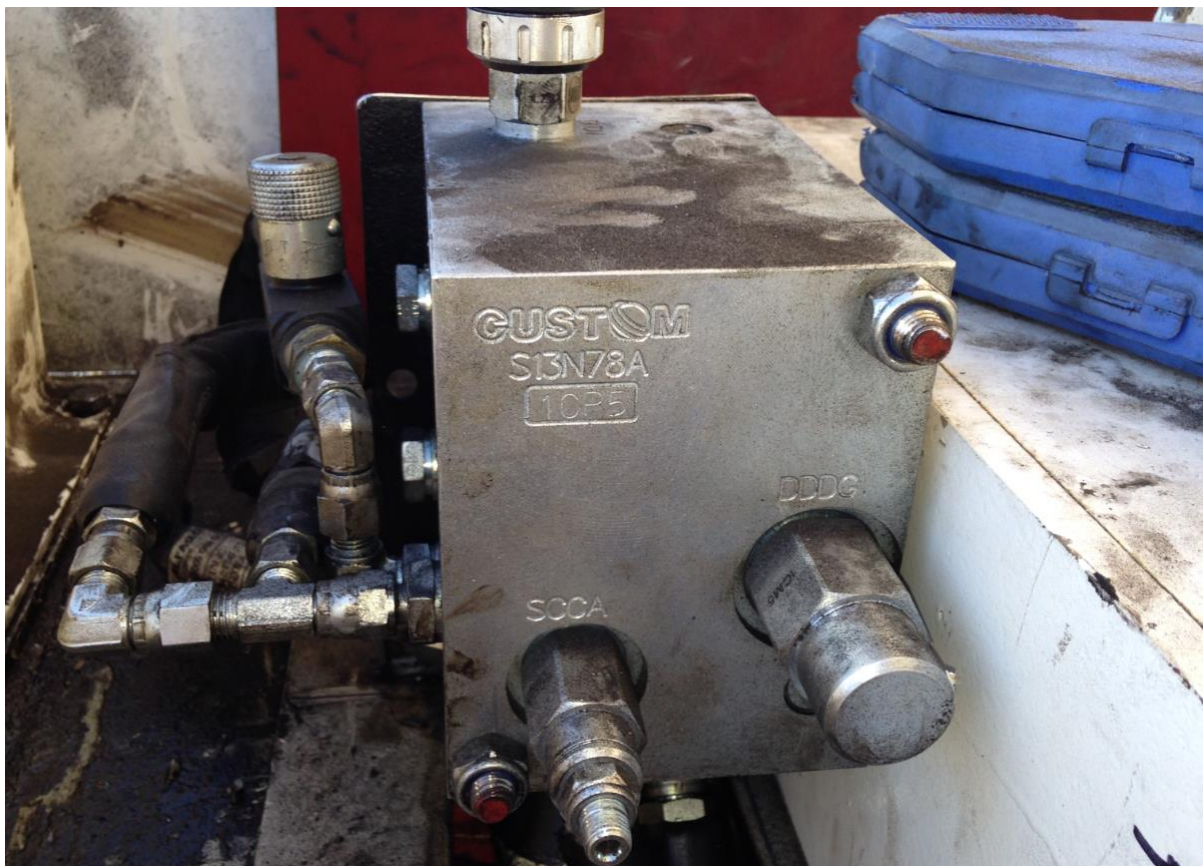
Image 4: Introduced Manifold

The hydraulic manifold also gives the ability to bypass the interlock to accommodate towing of the machine when there is no pressure applied to the cable reel and is locked during normal operation.

This has been in operation for the last month with no impact to the operation of the machine and zero cable damages have occurred from the first root cause above.
