Goonyella Riverside Mine

BHP Billiton Mitsubishi Alliance

Dipper Trip System Improvement Project

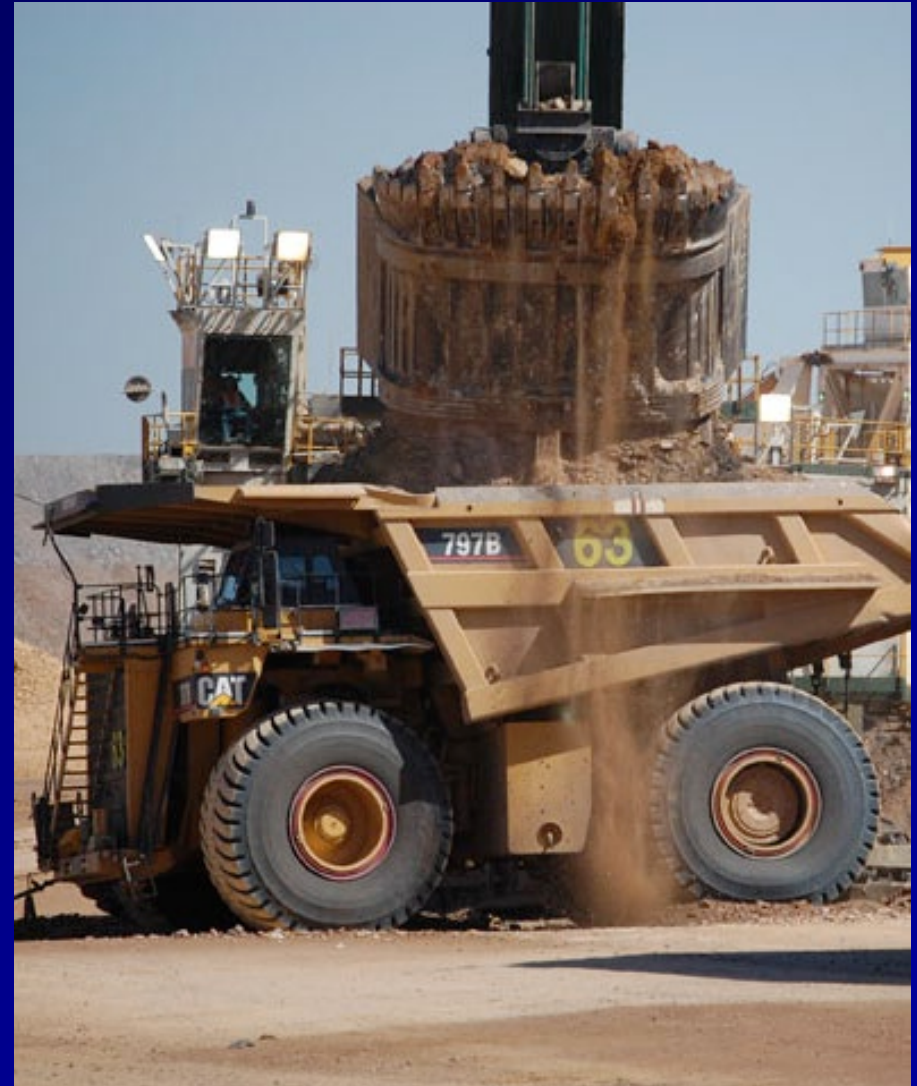
- *Dipper door trip failures would often result in the dipper contacting the trucks and its load causing the trucks to jolt.*
- *This created a hazard and had the potential to cause minor injury to the truck operator.*
