Holing Underground – An Example of the Swiss-Cheese Model

Name of Presenters Organisation: Rio Tinto – Kestrel Mine

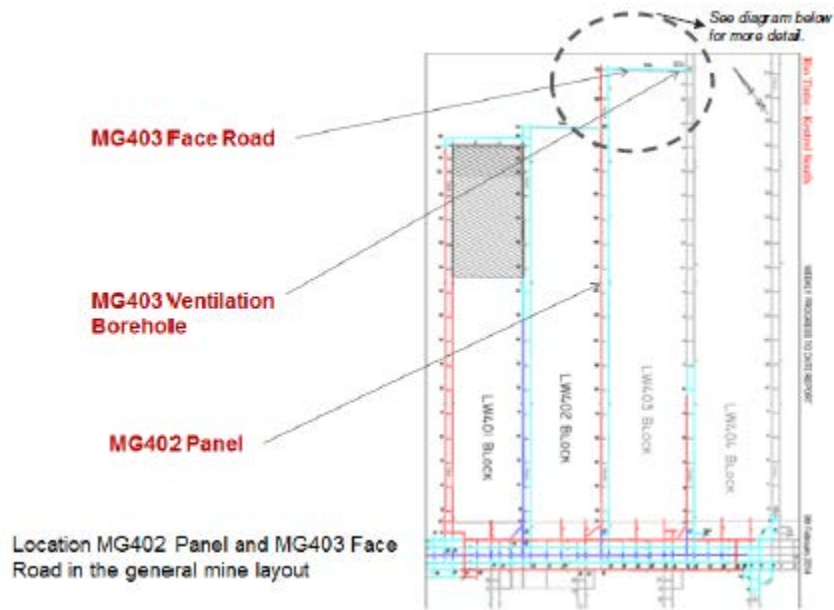
Figure 1 Faceroad and borehole location

It was determined the face road for the 403 panel would be developed as a single heading driven with a continuous miner. On reaching distance in the drive it was then determined the best way to continuously ventilate the heading was through the use of a 900mm borehole, thereby removing the requirement to apply forced ventilation into the heading. It was determined the 900mm diameter borehole would be used due to the efficiency advantages of a larger bore hole over the longer face, the reduced cost for a single-hole installation, the potential for the installed bore hole to have the capability as a rescue path and the availability, at the time, of a drill rig capable of drilling a hole this size.

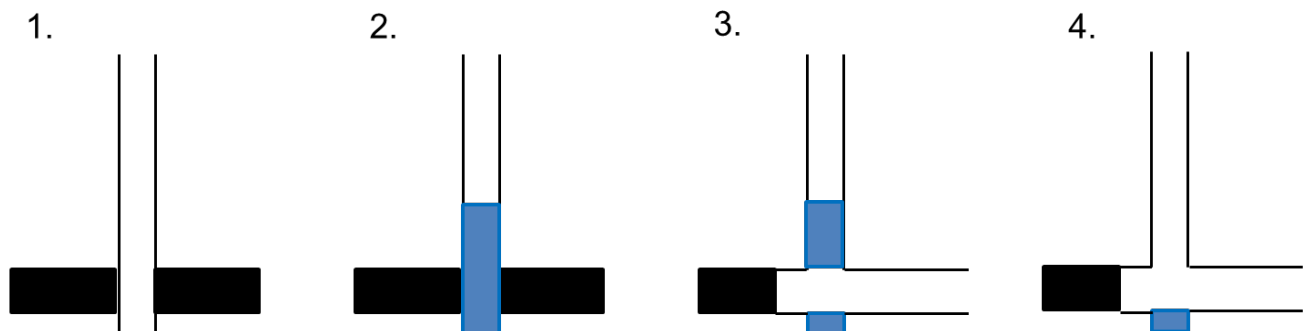
Figure 2 Borehole intersection methodology

The methodology for completing the ventilation circuit consisted of four steps; 1. drill the borehole to intersect the seam, 2. backfill the hole with grout, 3. intersect the grout-filled hole with the continuous miner, 4. then ream out the remaining grout to open the hole to the underground workings.
