David Bond – GM Health, Safety & Security Thiess Global Mining

The purpose of this session is to create a greater understanding of potential hazards associated with heavy vehicle tyres and rims, with particular focus on the 49" EV style rim assembly.

49" EV Style Rims – Technical Review

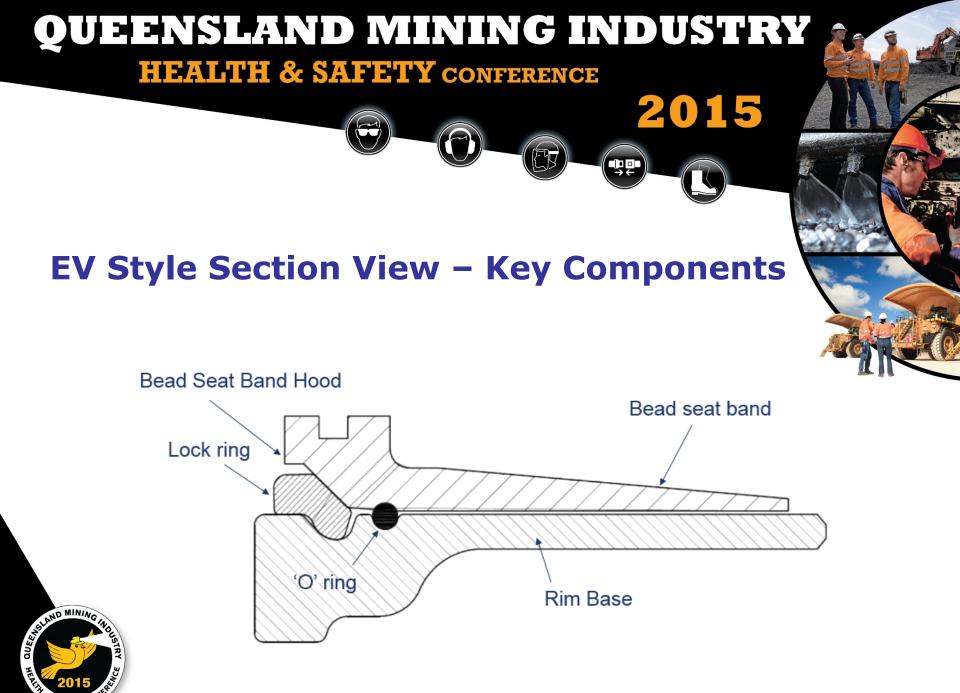
- Simulations involving similar componentry, under similar loading and overloading conditions were conducted to explore conditions that either permit, or prevent a lock ring to eject.
- Hydraulic jacks were used to simulate pressure on the components.
 The lack of stored energy in the hydraulic jacks ensured safety during these simulations.
