Risk Analysis/Adaptation DM-M3 Ingersoll Rand Drill

Warwick Lidbury

Safety Manager, Bulga Coal Surface Operations, Bulga Coal Management Pty Limited

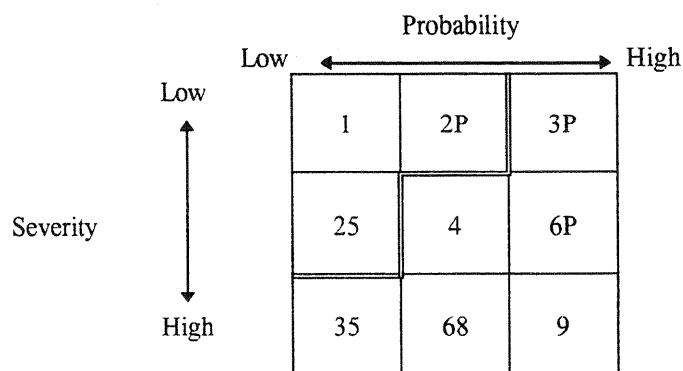
Establish a hazard ranking criteria to establish what recommendations are mandatory. The hazard ranking was simplified and was

Areas below the double line to have more stringent barriers imposed on them.
