Carbon Fibre Vent Tube Project

Xstrata Coal – Oaky North

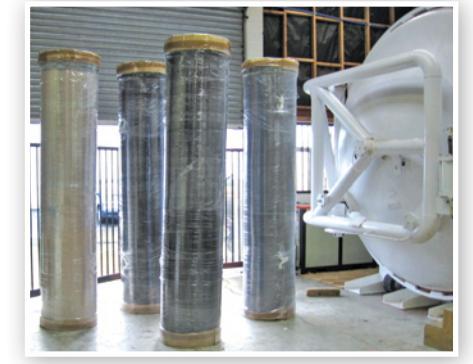
Picture showing autoclave unit and 4 prototype carbon fibre tubes

After discussion and mine visits from Graeme Rivers and Cary Watts of Rivers Carbon Fibre, sufficient capital was invested to manufacture a suitable ventilation tube from carbon fibre. Four prototypes were made with different blends of material and then the preferred option was tested and selected by Oaky North personnel.

Being the first to use the material for this purpose in Australian Coal there was an extensive testing and approvals process that had to be undertaken to gain approval for use underground. This included fire resistance and conductivity or electrical resistance testing.

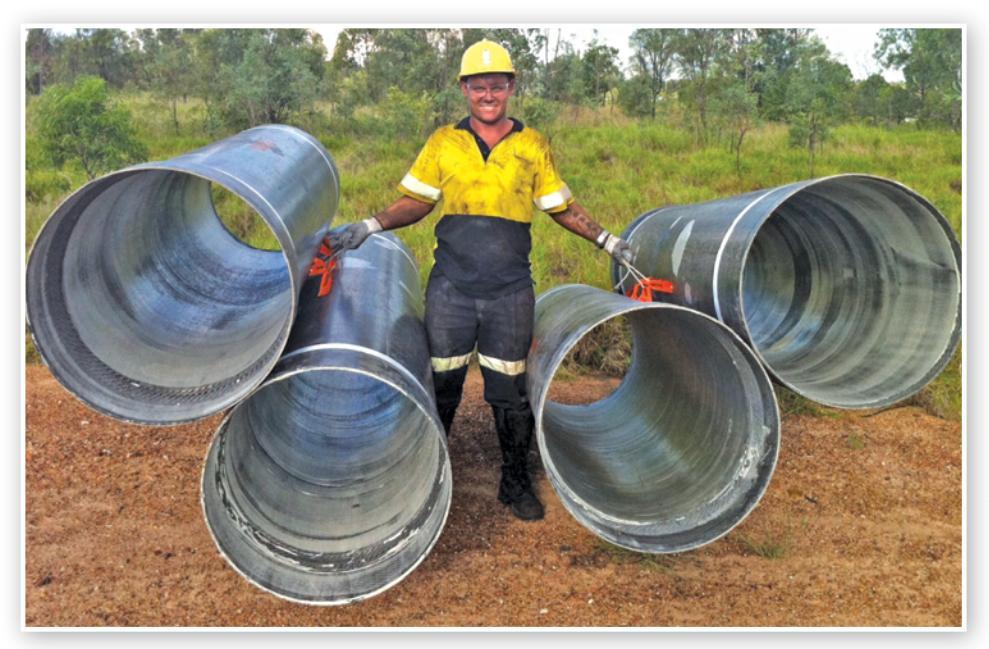
An Oaky North team member demonstrates the lightweight nature of the new carbon fibre vent tubes

- Total weight is now approximately 9kg just 30% of the original weight;
- The tubes have been pressure rated to over 50kpa without structural failure, (maximum auxiliary fan pressure approximately 8kpa. i.e. 6 to 1 safety factor);
- They are extremely durable and do not splinter; meaning a longer lifetime, less raw material usage in production and a lighter environmental impact
- High level of quality assurance a tracking tag is placed on each tube for historical data collection and maintenance history;

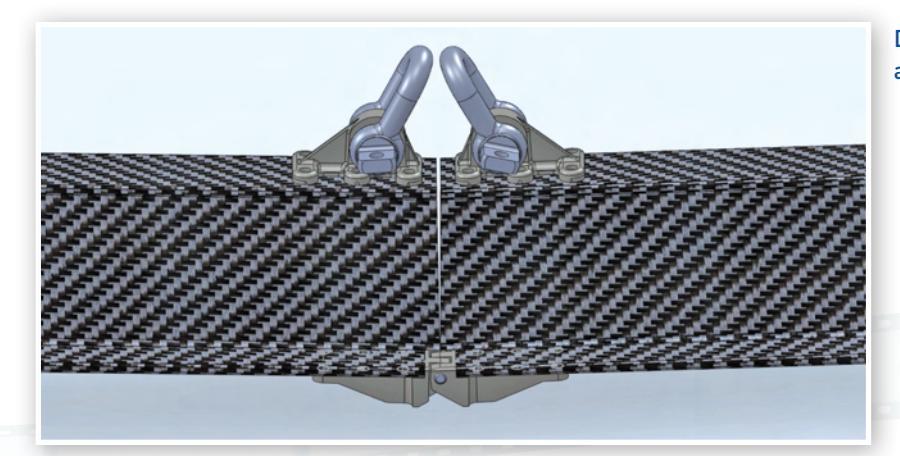
Drawing of longwall monorail, this unit is 10 kg against original steel beam and joiner weight of 36kg

In accordance with the Oaky Creek risk management process, the present focus is on the longwall mining process where the most regularly manhandled heavy equipment sections are mono rail beams (see drawing) and conveyor structure. The aim of these projects is to reduce the exposure of the mineworkers to the risk of injury by reducing the physical weight of these components without reducing structural integrity and longevity of the component.
