## CHPP Tag Readers

### Xstrata Coal Queensland – Newlands Surface Operations

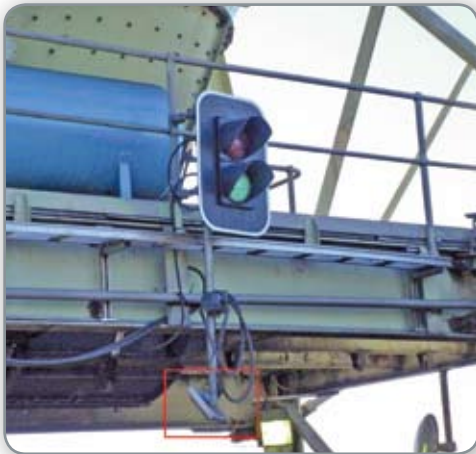
- A project team was created to work with an external supplier on the development and implementation of a viable and effective solution.
- After reviewing alternatives, the use of a tag reader system was selected, designed and implemented to determine when it was safe for the reject truck to proceed under the rejects bin.
- The solution includes entry lights and reader and an exit reader.
- The tag reader system is superior to normal standards as it does not use optics or radar that may be affected by the environment they are installed in or a sequence of events that may be misinterpreted.

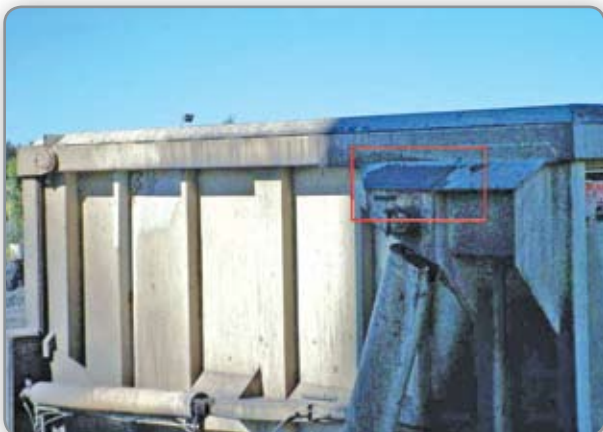
- The tag reader reads a dedicated number from the tag.
- From the numbers and the channel the numbers are received on, the control system is able to determine the position of the cabin.

- When the truck leaves the drop zone, the reject dump bin control is disarmed.
- The system is rearmed when the cabin of the truck passes under and past the drop zone.
- Traffic lights on the bin and SCADA screen indicate the system status.
- The tag readers may be utilized in the future to aid in the positioning of the trailers to improve loading of trailers.

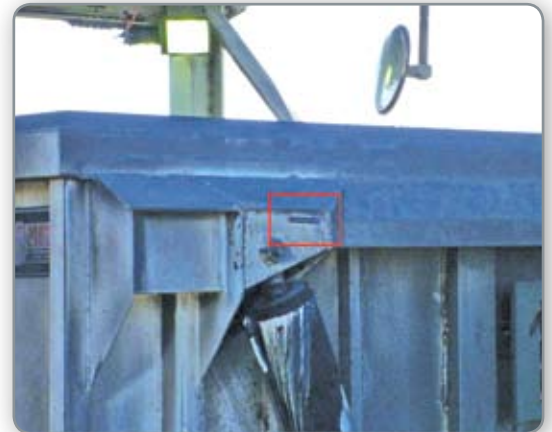
- Engineer / Redesign – Isolation. The tag reader system disarms the gate control when the trailer is detected leaving the drop zone.
- The gate control is armed when a trailer is detected entering the drop zone.
