IMPROVED SAFETY AND EFFICIENCY WITH GROUND SUPPORT AND REHABILITATION PRACTICES AT THE X41 COPPER MINE, MOUNT ISA MINES.

Iain Thin (Senior Rock Mechanics Engineer), Steve de Kruijff (X41 Copper Mine Manager) and Stewie Beetham (X41 Copper Mine Development Superintendent)

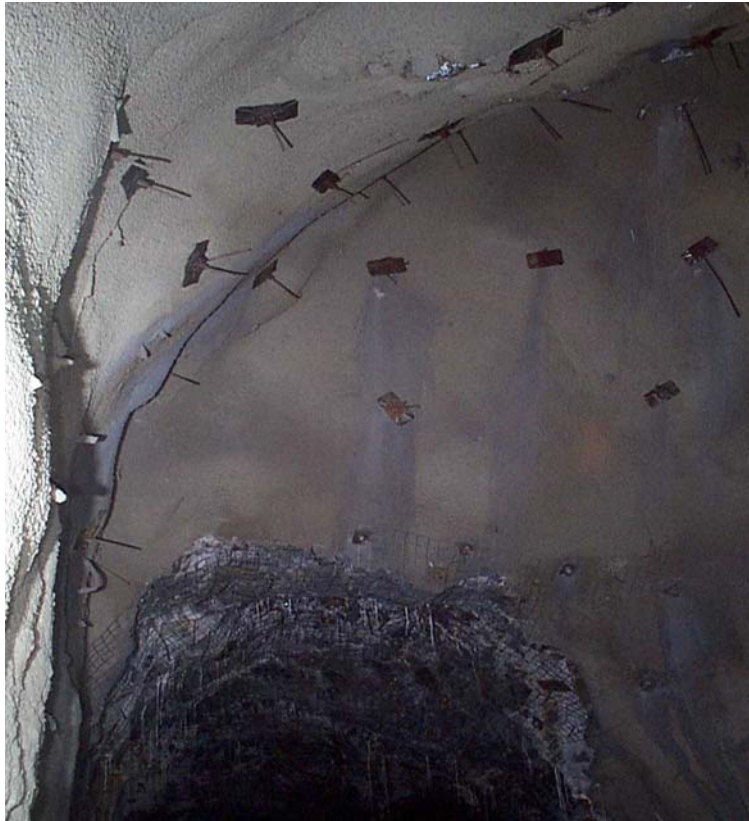
formed into large cathedral shaped openings (see Figure 1). Maintaining access through these areas for subsequent stoping can be a slow and costly, but necessary, process.

Figure 1: A 'cathedral' profile following rehabilitation.

The ground support and reinforcement that is usually installed as part of the rehabilitation process involves a combination of Garford cable bolts and steel fibred shotcrete (see Figure 1). Depending on the exposed ground conditions, split sets or dry PAG bolts and sheet mesh are installed prior to the installation of the cable bolts and shotcrete.

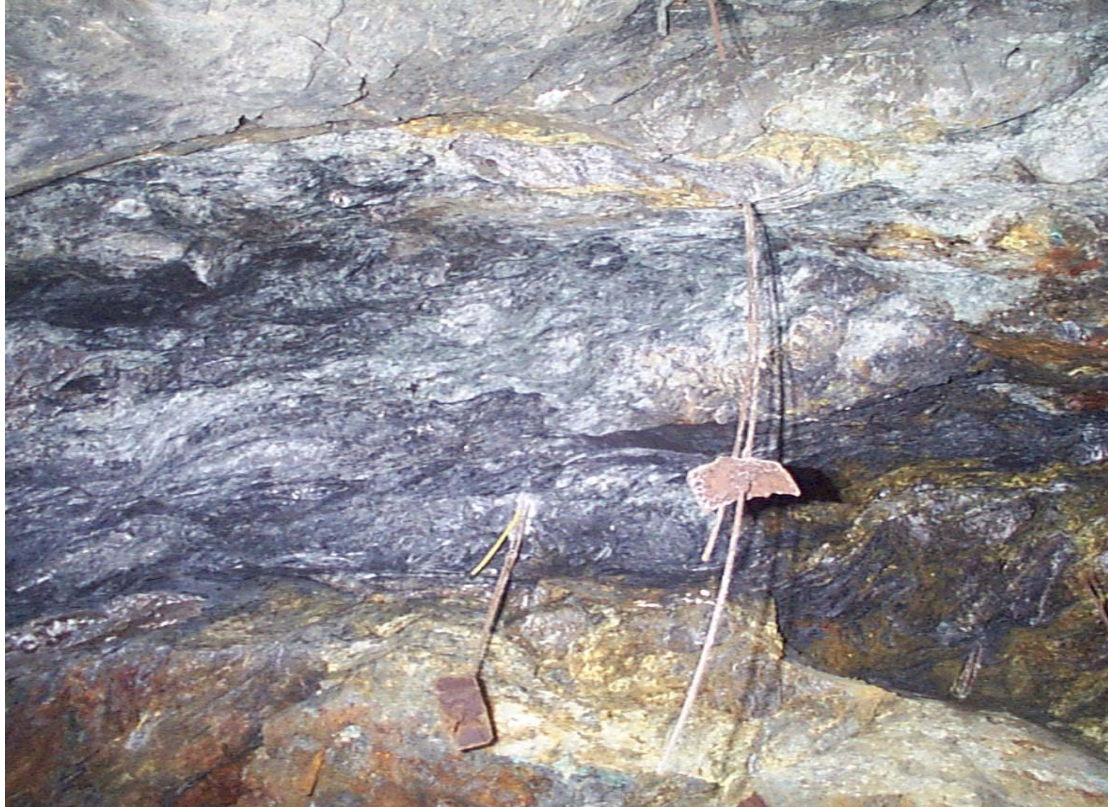
The common ground failure mechanism consists of rock unravelling from around the installed support and reinforcing elements, rather than the steel failing itself (Figure 2). This would be an indication of inadequate support. There are no common predominant joints sets that have been attributed to a re-occurring type of ground failure mechanism.

Figure 2: Unravelling of ground from around twin strand Garford cable bolts installed in the sidewall. Poor ground conditions associated with the J46 fault.

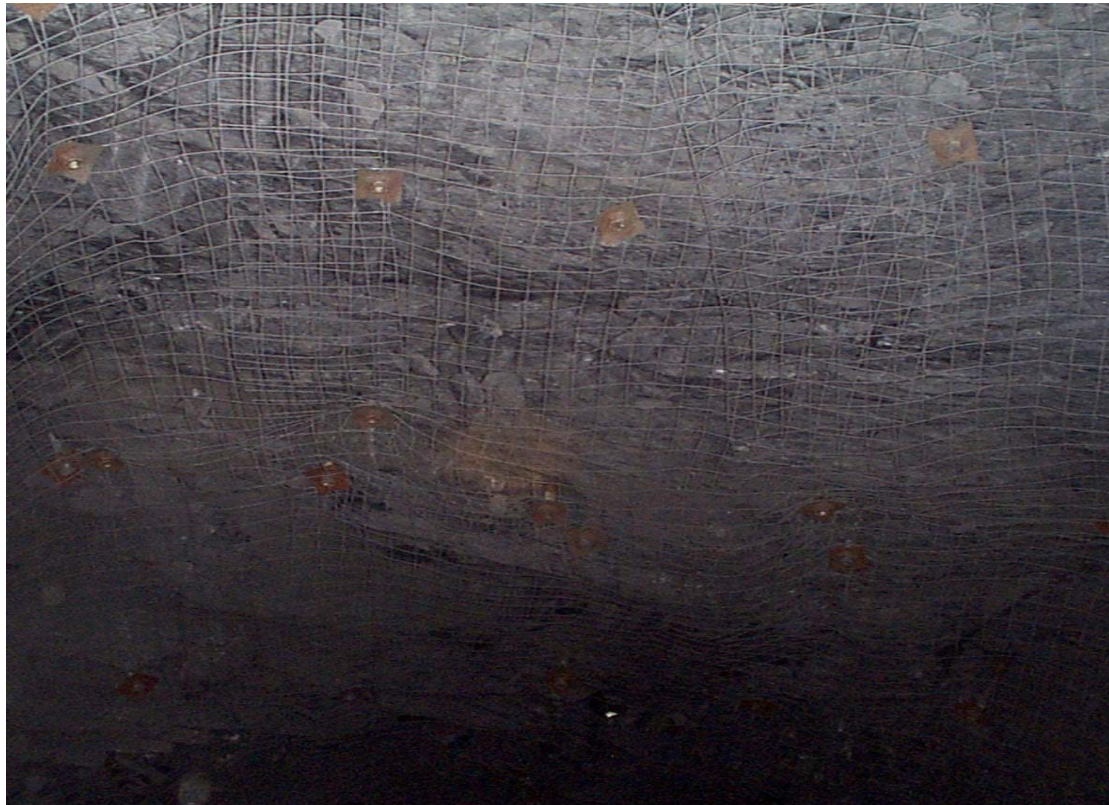
Figure 3: Sheet mesh and split sets installed tight against the back of a development drive.

As a passive form of support, meshing forms an integral part in providing a safe working environment. Mesh provides surface restraint at the exposed excavation boundary. The sheet mesh used at the Copper Mine is a 5.0 mm gauge wire, with 100 mm square apertures. Overall dimensions for each sheet is 2.4 metres wide and 4.0 metre long.

Mesh is not designed to carry excessive loads of broken rock, and can be easily damaged by flyrock from blasting when installed very close to an active face. This is particularly the case when the sheet mesh has not been tightly installed against the rock face. However, mechanically installed sheet mesh can usually be installed tight against the rock face (see Figure 3). With such a configuration, even though the ground may have failed, the failure is arrested from progressing upwards - there is no space for the failed rock to occupy, and therefore no means for the failure to propagate.

From an analysis of falls of ground at the Copper Mine since 1997, it was seen that 55% of all falls were in the range <1 to 5 tonnes in size. The strength of sheet mesh, used in combination with the primary support elements, will support loads of up to 5 tonnes (provided the sheet mesh is installed tight against the rock surface). Since the introduction of sheet mesh, the number of falls up to 5 tonnes in size has reduced.

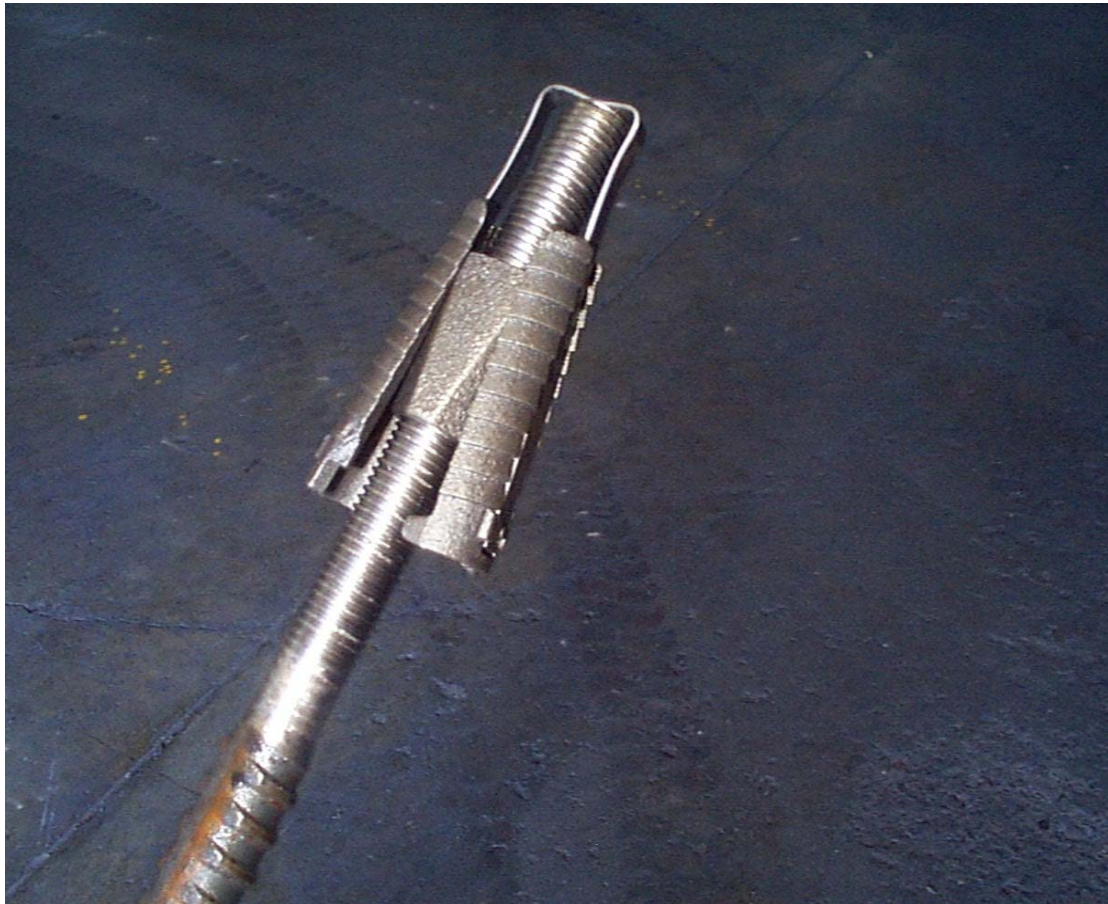
The PAG bolt is a standard dywidag bolt with a specially designed expansion shell (see Figure 4), which was developed 'in-house' at Mount Isa Mines. The bolt assembly is mechanically installed in the hole by means of the Tamrock Robolter. With the modifications to the shell anchor, immediate support can be generated even in a post cement grouted hole. The PAG bolt is now commercially available through ANI Arnall, under the product name MP bolt (Mechanical Point anchored bolt).

Figure 4: The PAG bolt.

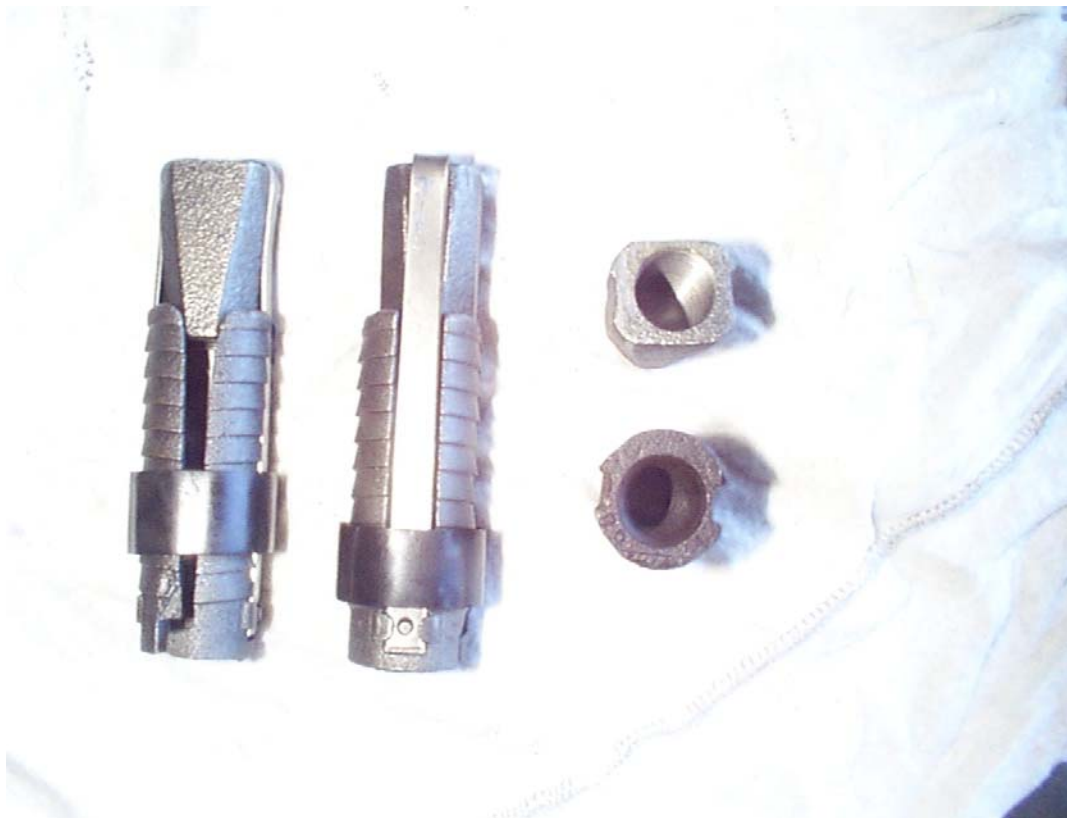
Further trials focused on a specially designed expansion shell anchor in order to improve on the unreliability of the various wedge designs (Tyler, 1999). Past attempts to push expansion shells into cement grout filled hole proved to be unsuccessful. As such, the point anchored expansion shells were trimmed down in order to allow the cement grout to be displaced as the bolt and shell was inserted into the pre-grouted hole (see Figure 5).

Figure 5: Modified expansion shell anchor for use with the PAG bolt. Note the differences between the trimmed and standard barrel.

- the modified shell anchor can engage when installed in a cement grout filled hole.
- the PAG bolt can be mechanically pushed through a thick grout (a W/C ratio of 0.4 or less).
- when pushed through cement grout filled steel tubes, full column encapsulation of the PAG bolt was achieved.
- push testing of 50 mm sections of cement grouted PAG bolts indicated little variation in the strength of the grout along the length of the bolt and shell.
- pull testing of cement grouted PAG bolts indicated full mobilisation of the ultimate tensile strength of the dywidag bolt occurring at embedment lengths of 250 mm or greater.
- pull testing of dry PAG bolts in both poor and good ground conditions resulted in loads in excess of 9 tonnes (testing taking place immediately following installation).
