CHPP Tag Readers

Xstrata Coal Queensland – Newlands Surface Operations

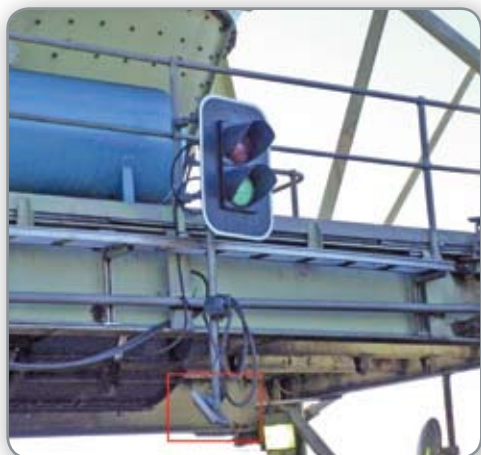
- The tag reader reads a dedicated number from the tag.
- From the numbers and the channel the numbers are received on, the control system is able to determine the position of the cabin.

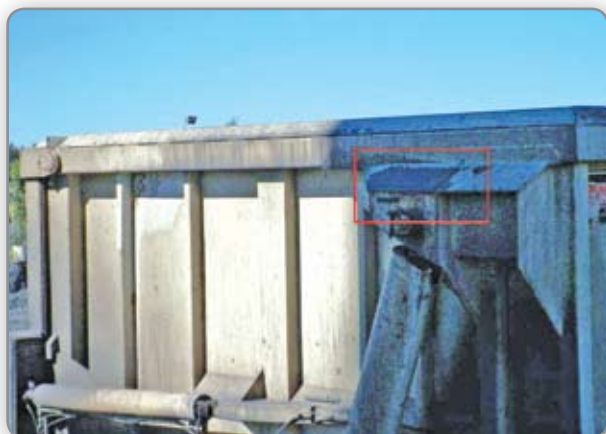
- When the truck leaves the drop zone, the reject dump bin control is disarmed.
- The system is rearmed when the cabin of the truck passes under and past the drop zone.
- Traffic lights on the bin and SCADA screen indicate the system status.
- The tag readers may be utilized in the future to aid in the positioning of the trailers to improve loading of trailers.

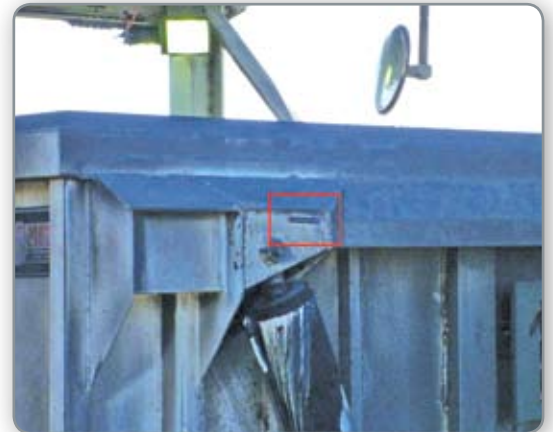
- Engineer / Redesign – Isolation. The tag reader system disarms the gate control when the trailer is detected leaving the drop zone.
- The gate control is armed when a trailer is detected entering the drop zone.
