Remote Control Bogging Light

MMG Dugald River

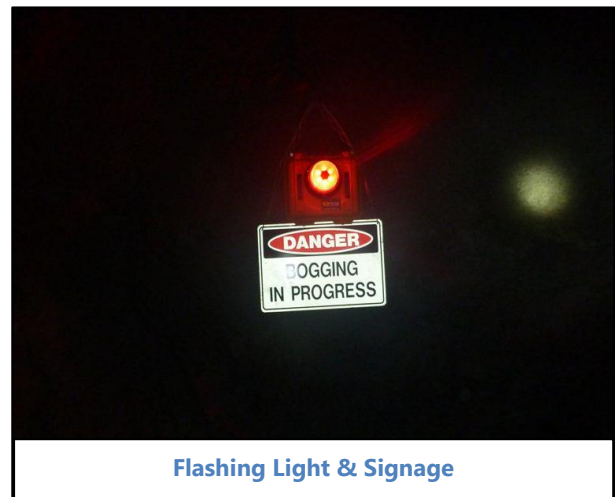
The solution to the problems outlined above was to install a light that did not require the operator to leave their cab. The result was a wall-mounted light that is activated remotely by the operator from the cab.

Flashing Light & Signage

1. New light being considerably brighter and clearly visible from any direction of approach.
2. As the light can be connected to the existing electrical boxes, it never goes flat.
3. Measureable boost in productivity due to increased asset utilisation of the loaders.
4. Potential reduction in maintenance costs due to the reduction in starting and stopping engines.
5. Lights always being turned on and off in line with safety procedures.
6. Likely reduction in musculoskeletal injuries.
7. Operators conforming to site procedures and not exiting with the loader still running.
8. Reduction in dust entering the cab.
9. Elimination of potential articulation crush injuries.
